# Technical Service Bulletin

## 24CK UPDATE – ECM/TCM Software Update (FED\_EMS)

September 12, 2017

Model(s)	Year	VIN Range	Vehicle-Specific Equipment
Audi R8	2017	See ELSA	See ELSA

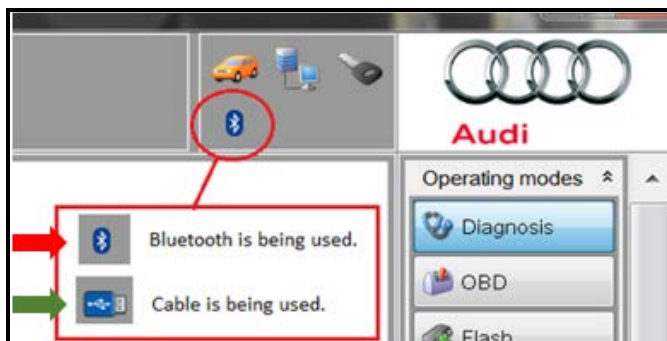
4. Attach the scan tool to the vehicle using an USB cable.
5. Confirm that the scan tool is communicating with the diagnostic head by USB <Green Arrow>. If the Bluetooth symbol is shown <Red Arrow> then disconnect the diagnostic head from the vehicle and then reattach the USB cable to the diagnostic head and then reattach to the vehicle.
