# Technical Service Bulletin

## 24DB UPDATE – TCM Software (FED\_EMS)

September 04, 2017

Model(s)	Year	VIN Range	Vehicle-Specific Equipment
A3	2017	See ELSA	See ELSA

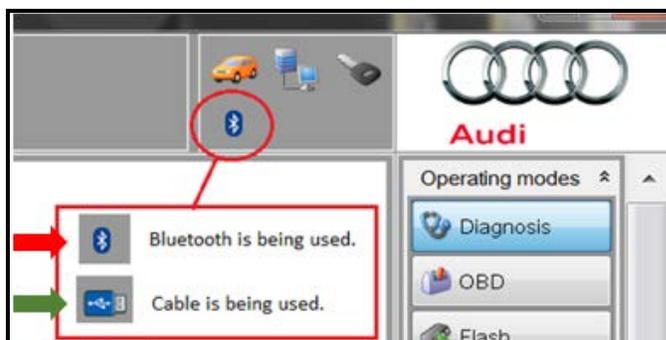
4. Attach the scan tool to the vehicle using an USB cable.
5. Confirm that the scan tool is communicating with the diagnostic head by USB <Green Arrow>. If the Bluetooth symbol is shown <Red Arrow> then disconnect the diagnostic head from the vehicle and then reattach the USB cable to the diagnostic head and then reattach to the vehicle.
