September 2017
SF533A-O
REVISED NOTICE

Subject: Instrument Cluster Update

Models Affected: Specific Freightliner 108SD, 114SD, and Business Class M2 models; and Freightliner Custom Chassis B2 school bus chassis (Thomas Built Buses Saf-T-Liner C2), and S2/S2C shuttle bus chassis manufactured January 12, 2015, through August 22, 2016, with Cummins ISB and ISL engines.

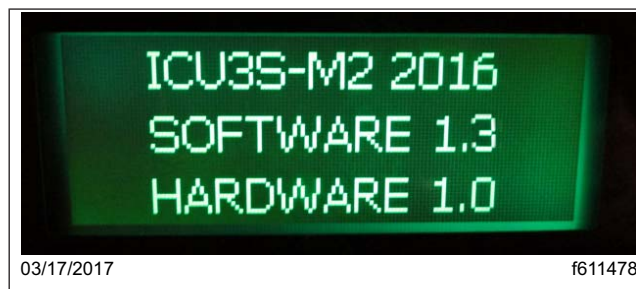
Fig. 1, ICU3S Screen Showing Software Version 1.3 (correct)

1. Check the base label (Form WAR259) for a completion sticker for SF533 (Form WAR261) indicating this work has been completed. The base label is usually located on the passenger-side door, about 12 inches (30 cm) below the door latch (trucks) or over the driver's window (buses). If a completion sticker is present, no work is needed. If a completion sticker is not present, proceed to the next step.
2. Park the vehicle, shut down the engine, and apply the parking brakes. Chock tires.
3. Press the ICU3S mode button until the software/hardware versions display on screen. Verify the software level of the ICU3S. See [Fig. 1](#).

If the software level of the ICU3S is 1.3, or higher, no further action is necessary. Continue with step 19.

If the software level is below 1.3, continue with the next step.

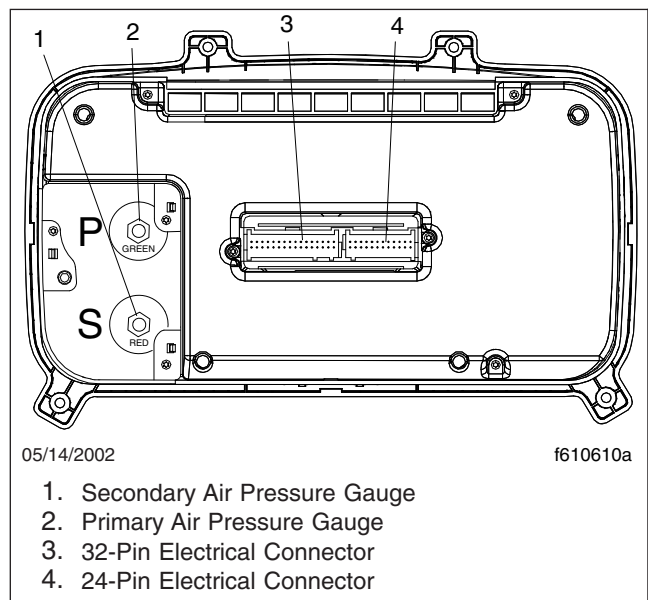
Fig. 3, ICU3, Rear View

Do not forcibly pull the ICU3S from the dash. This may dislodge electrical connections or air lines from the back of the ICU3S, causing damage to connections, lines, or the dash.

- Remove and retain the four screws that secure the ICU.
- Disconnect the two electrical connectors from the back of the ICU. See [Fig. 3](#).
