# Service Update

## 17247 Rear Suspension Rattle or Clunk

Reference Number: N172085950

Release Date: July 2017

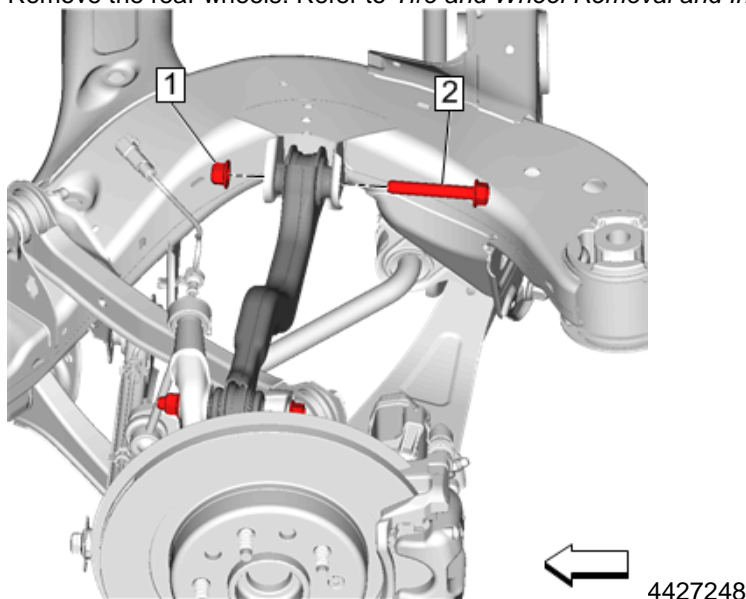
3. Verify the torque of the rear suspension upper lateral link inner bolt (2) is 90 Nm (66 lb ft).
  - If the torque is greater than or equal to 90 Nm (66 lb ft), proceed to the next step.
  - If the torque is less than 90 Nm (66 lb ft), replace the bolt. Refer to *Rear Suspension Upper Lateral Link Replacement* in SI.

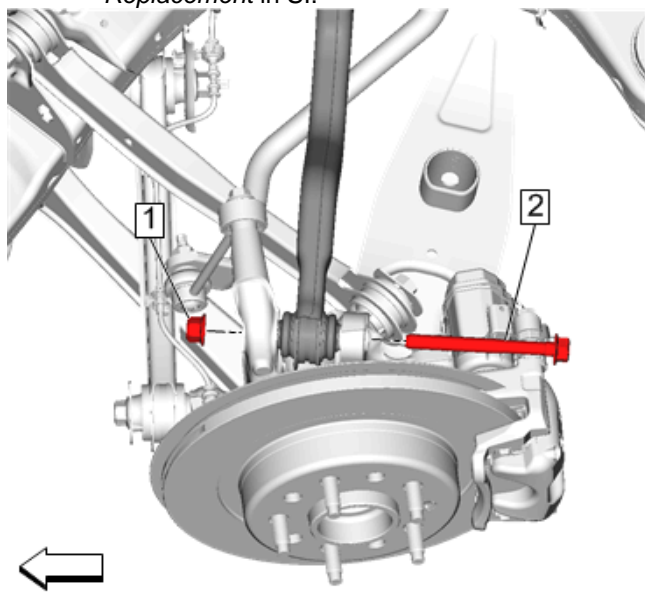
4. Verify the torque of the rear suspension upper lateral link outer bolt (2) is 90 Nm (66 lb ft).
  - If the torque is greater than or equal to 90 Nm (66 lb ft), proceed to the next step.
  - If the torque is less than 90 Nm (66 lb ft), replace the bolt. Refer to *Rear Suspension Upper Lateral Link Replacement* in SI.

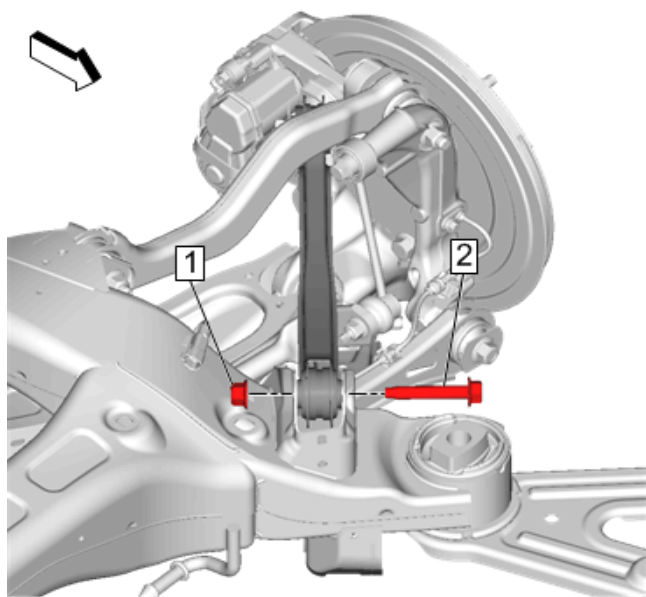
4427946

5. Verify the torque of the rear suspension upper trailing link inner bolt (2) is 90 Nm (66 lb ft).
  - If the torque is greater than or equal to 90 Nm (66 lb ft), proceed to the next step.
  - If the torque is less than 90 Nm (66 lb ft), replace the bolt. Refer to *Rear Suspension Upper Trailing Link Replacement* in SI.

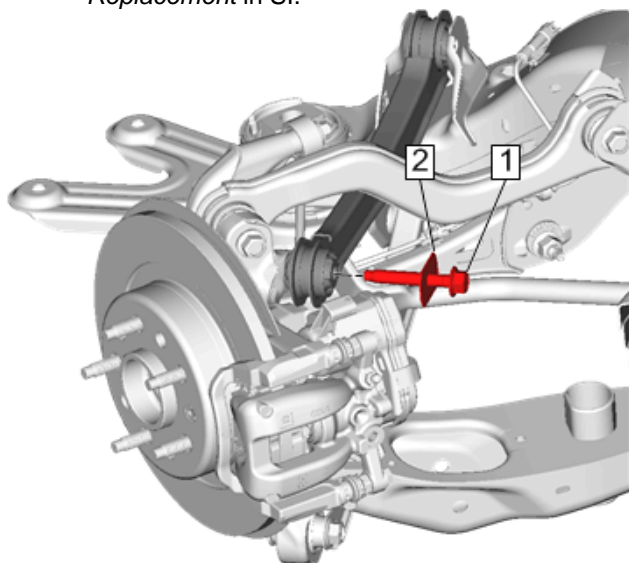
4427958

6. Verify the torque of the rear suspension upper trailing link outer bolt (1) is 90 Nm (66 lb ft).
  - If the torque is greater than or equal to 90 Nm (66 lb ft), proceed to the next step.
  - If the torque is less than 90 Nm (66 lb ft), replace the bolt. Refer to *Rear Suspension Upper Trailing Link Replacement* in SI.

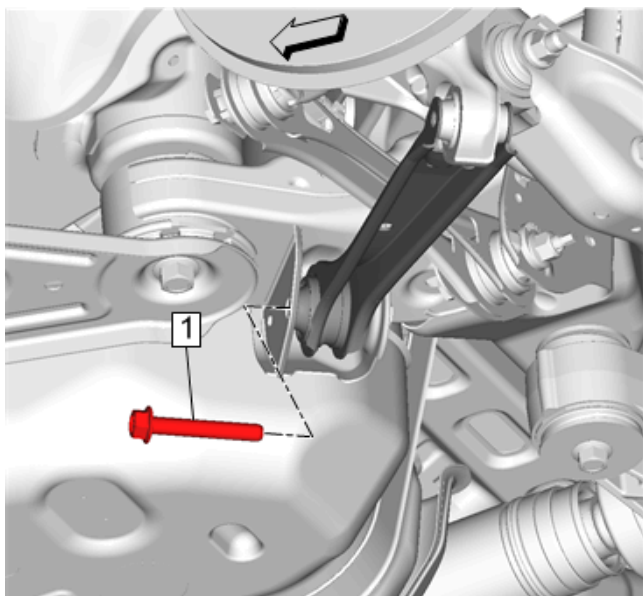
4694841

7. Verify the torque of the rear suspension lower trailing link inner bolt (1) is 90 Nm (66 lb ft).
  - If the torque is greater than or equal to 90 Nm (66 lb ft), proceed to the next step.
  - If the torque is less than 90 Nm (66 lb ft), replace the bolt. Refer to *Rear Suspension Lower Trailing Link Replacement* in SI.

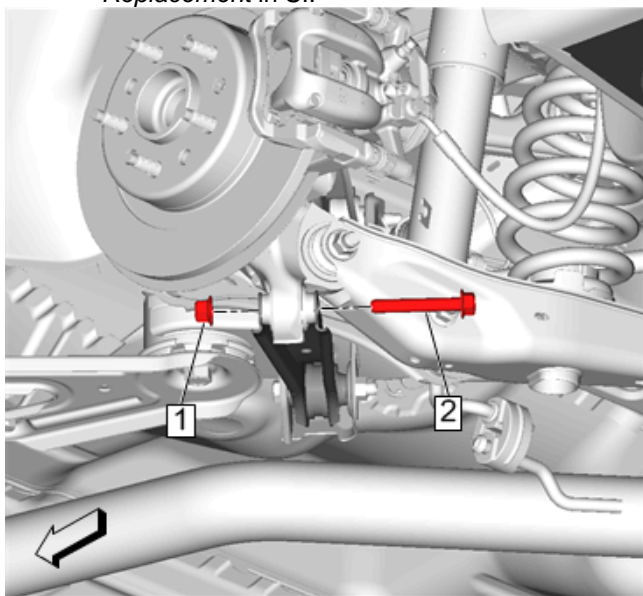
4452448

8. Verify the torque of the rear suspension lower trailing link outer bolt (2) is 90 Nm (66 lb ft).
  - If the torque is greater than or equal to 90 Nm (66 lb ft), proceed to the next step.
  - If the torque is less than 90 Nm (66 lb ft), replace the bolt. Refer to *Rear Suspension Lower Trailing Link Replacement* in SI.
9. Install the rear wheels. Refer to *Tire and Wheel Removal and Installation* in SI.
