Service Update

17257 Half Shaft Outer Joint Micro Cracks

Reference Number: A172096270

Make	Model	Model Year		RPO	Description
		From	To		
Chevrolet	Sonic	2017	2017

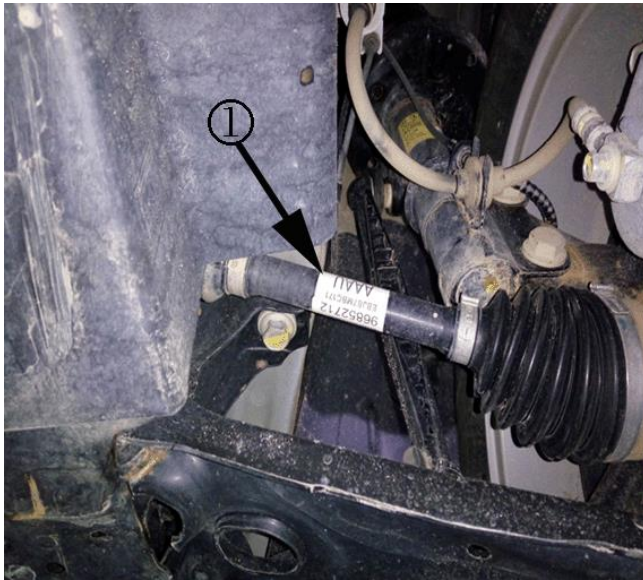
4829597

2. Locate the driver side front wheel drive shaft label (1).
