# Service Update

## 17249 Chuggle Drive Quality

Reference Number: N172096510

Release Date: July 2017

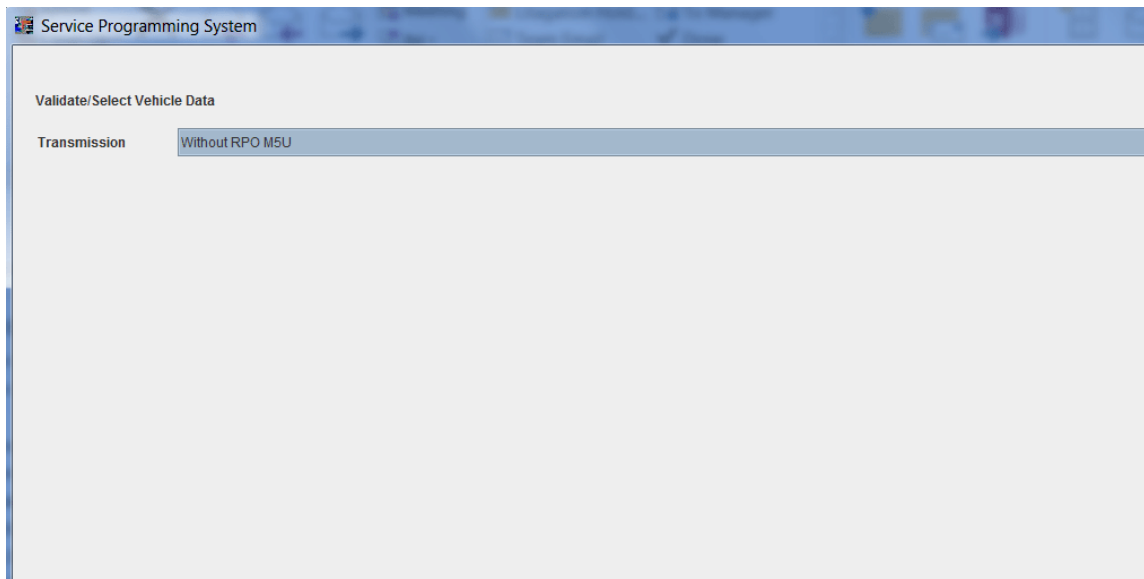
**Note:** If prompted, select Without RPO M5U.

1. Install *EL-49642* SPS Programming Support Tool.
2. Access the Service Programming System (SPS) and follow the on-screen instructions.
3. On the SPS Supported Controllers screen, select K71 Transmission Control Module - Programming and follow the on-screen instructions.
