Service Update

17285 Wheel Liner Screw Exposed Under the Hood

Reference Number: N172104970

Make	Model	Model Year		RPO	Description
		From	To		
Cadillac	CT6	2018	2018

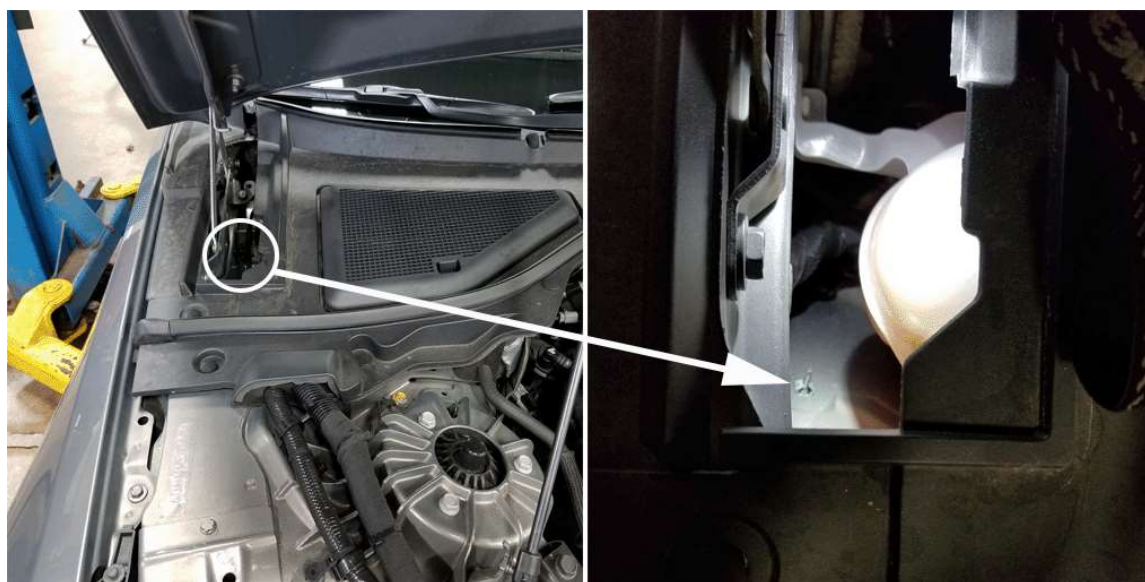
4840494

Condition	Certain 2018 model year Cadillac CT6 vehicles may have potential interference between the main body harness and an exposed wheel liner screw under the hood. The customer may experience a no engine start, lack of power or stall condition.
Correction	Dealers are to place a plastic cap on top of the wheel liner screw.

2. Locate the exposed wheel liner screw.
