Service Update

17266 Misrouted Heater Core Hose Contacts Brake Vacuum Pipe

Reference Number: N172092900

Make	Model	Model Year		RPO	Description
		From	To		
Chevrolet	Equinox	2018	2018	LYX	1.5L Engine

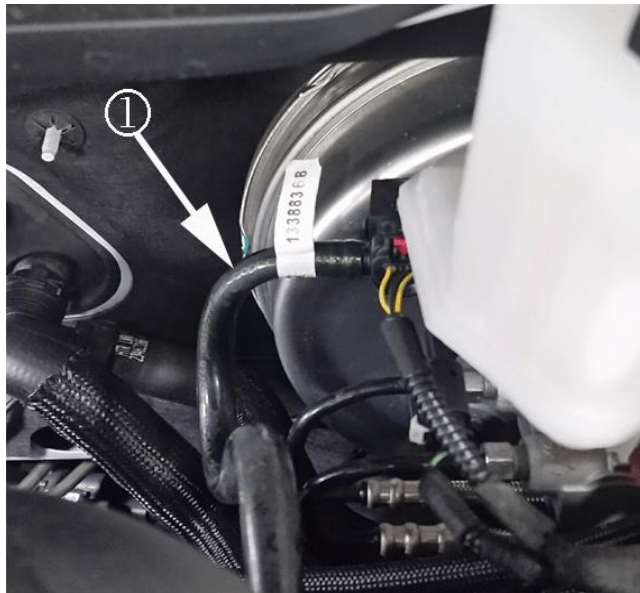
4757626

2. Locate the power brake booster vacuum pipe (1).

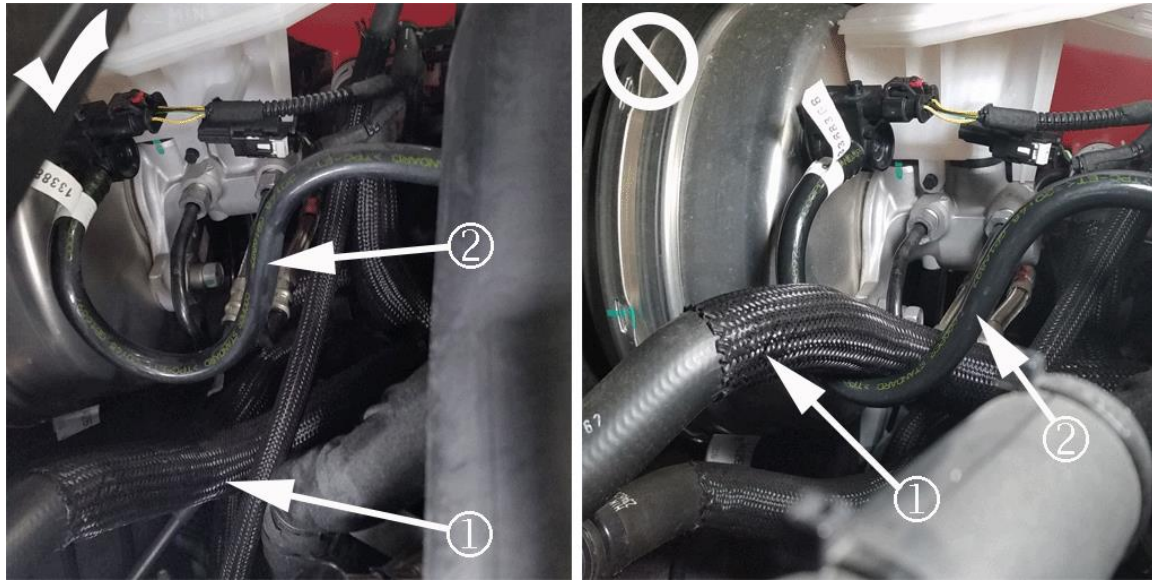
4830136

3. Verify the heater inlet hose (1) is NOT contacting the power brake booster vacuum pipe (2).
 - If the heater inlet hose is NOT contacting power brake booster vacuum pipe, no further action is required.
 - If the heater inlet hose is contacting the power brake booster vacuum pipe, inspect the power brake booster vacuum pipe for damage.
 - If the power brake booster vacuum pipe is NOT damaged, proceed to the next step.
 - If the power brake booster vacuum pipe is damaged, replace the power brake booster vacuum pipe and proceed to step 5. Refer to *Power Brake Booster Vacuum Pipe Replacement (LYX)* in SI.
4. Disconnect the power brake booster vacuum pipe. Refer to *Power Brake Booster Vacuum Pipe Replacement (LYX)* in SI.
