Service Update

17298 Brake Pedal Performance - Wrong Fasteners

Reference Number: N172103820

Release Date: August 2017
Revision: 00

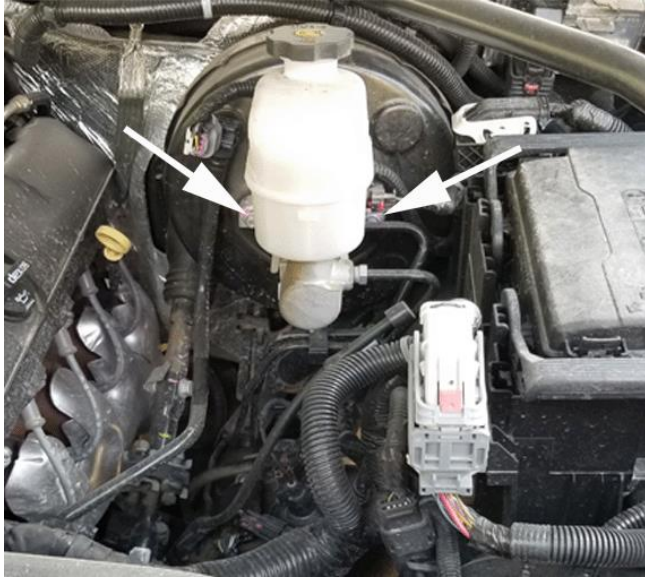
4846808

2. Locate the brake master cylinder nuts.

Caution: Only replace one brake master cylinder nut at a time. Removing both of the brake master cylinder nuts at the same time may cause part damage.

3. Remove one of the brake master cylinder nuts. Leave the other brake master cylinder nut fully secured.
4. Install a NEW brake master cylinder nut and tighten to 33 Nm (24 lb ft).
5. Repeat steps 3 and 4 for the other brake master cylinder nut.
6. Remove fender covers and close hood.
