Service Update

17289 Incorrect Battery Positive Cable Protection

Reference Number: N172105130

Release Date: August 2017
Revision: 00

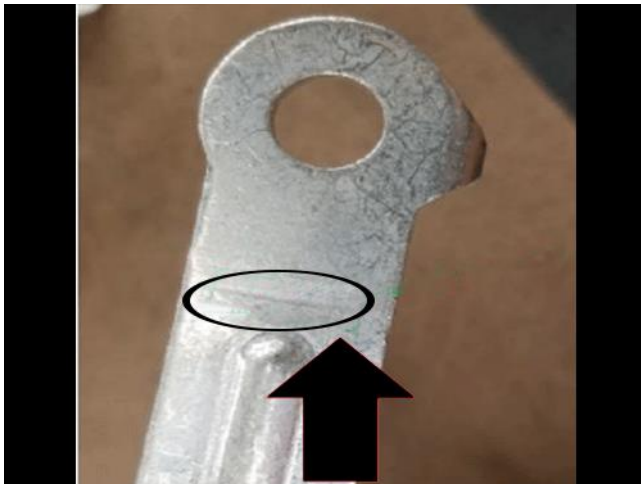
4846983

Important: Do not allow shrink tube to be installed past the line shown above.

6. Measure 30 mm (1.81 inches) from the center of the positive battery cable terminal hole.
