Customer Satisfaction Program

16185 No Start or Loss of Propulsion

Reference Number: N162060520 and N162070470

Release Date: August 2017
Revision: 00

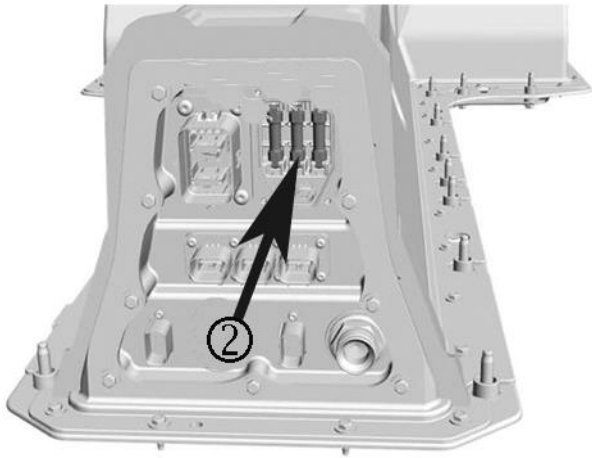
4850139

Condition	On certain 2017 model year Chevrolet Volt vehicles, the high voltage interlock connector behind the high voltage battery disconnect relay fuse block cover may be susceptible to becoming recessed back into the high voltage battery disconnect relay assembly. This may cause an electrical disconnect which could result in a loss of vehicle propulsion and/or a no start condition. The malfunction indicator lamp may be illuminated and DTC P0A0C – "high voltage system inter-lock circuit low" may be set. A "Shift To Park" message may also be displayed. Additionally, a subset of these vehicles may have a condition in which the 15A fuse in the high voltage battery disconnect relay may prematurely open. The open fuse may prevent the low voltage battery from being charged by the 14v DC power module. If this were to occur, the vehicle will provide warning to the driver and eventually lose electrical power. Once power is drained from the 12 volt battery, the vehicle may lose propulsion and will not start.

Replace the 15 amp (2) high voltage battery disconnect relay fuse. Refer to *High Voltage Battery Disconnect Relay Fuse Replacement (Front - BDU)* in SI.
