# Preliminary Information

PIP5416B Instrument Panel Cluster (IPC) Warning Lamps And / Or MIL Are Illuminated Diesel Exhaust Fluid (DEF) Message Displayed Various DTCs Set (Inspect Wiring Harnesses for Chafing).

**Models**

Brand:	Model:	Model Years:	VIN:		Engine:	Transmissions:
			from	to		
Chevrolet	Colorado	2016 - 2018	All	All	2.8 LWN	All
GMC	Canyon	2016 - 2018	All	All	2.8 LWN	All
Involved Region or Country:		North America				
Additional RPO/s:		LWN				
Condition:		<p>Some customers may comment on any of the following conditions:</p> <p>Air conditioning may not cool or may blow hot air.</p> <p>A Driver Information Center (DIC) message is displayed.</p> <p>Instrument Panel Cluster (IPC) warning lamps are illuminated.</p> <p>Erratic or fluctuating engine oil pressure gauge.</p> <p>One or more Diesel Exhaust Fluid (DEF) warning messages are displayed.</p> <p>The Malfunction Indicator Lamp (MIL) is illuminated.</p> <p>The engine may crank but not start.</p> <p>The engine may run rough or misfire.</p> <p>The Service Four Wheel Drive (4WD) message may illuminate.</p>				
Cause:		This may be due to chafing of the engine wiring harness, connector terminal concerns or a connector not fu

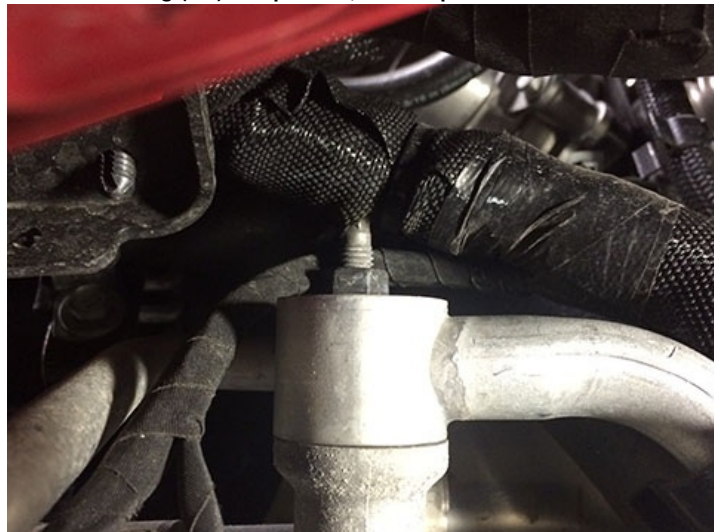
Air Conditioning (AC) compressor, AC compressor suction and discharge line manifold, AC line and AC compressor clutch.

Concerns in the area of the AC compressor, lines or suction / discharge pipes may cause:

The Check Engine Light to illuminate.

The Driver Information Center (DIC) may display a reduced power message or service power steering message.

The engine to run rough.

The Service Four Wheel Drive (4WD) Light or Stabilitrak light may illuminate.

A possible extended crank or a crank no start.

The oil pressure gauge may read erratically or read no oil pressure.

The Air Conditioning (AC) may not cool or blow hot air.

An open fuse in the Underhood Bussed Electrical Center (UBEC)

DTCs associated with chaffing in this area include:

B127E, C0306, C0321, C0398, C0800, P0117, P0119, P0340, P0341, P0406, P0483, P0522, P0628, P0641, P06A3, P0700, P20BB, P20BF, P227E, P24B1, U0073, U0077, U0121, U0131, U0140, U0151, U0415, U2099, U0401, U0415 and U0420.

If you encounter these scenarios, inspect, repair (as necessary) and route the wiring harness away from these possible chafe points.

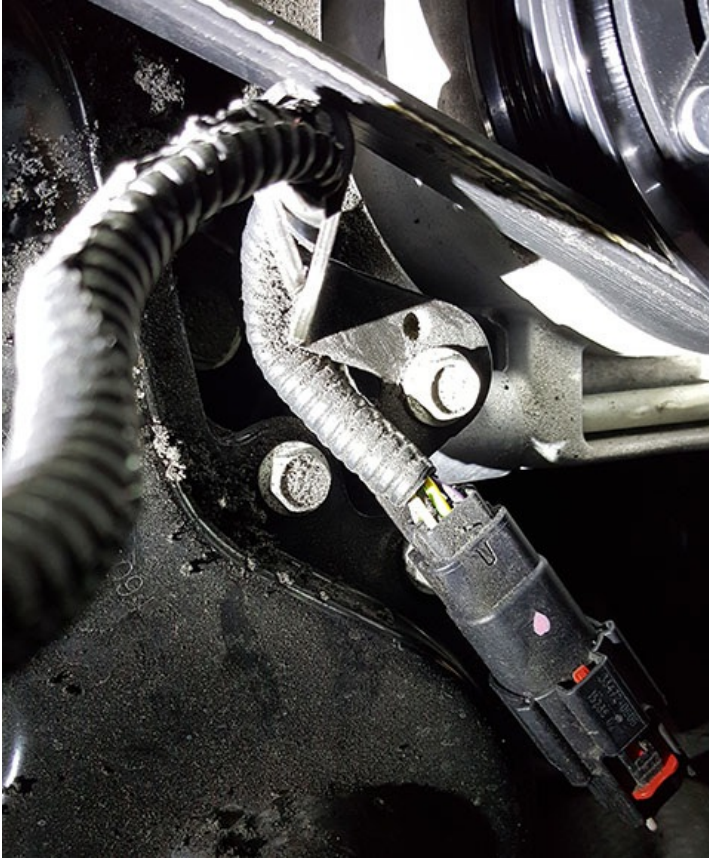
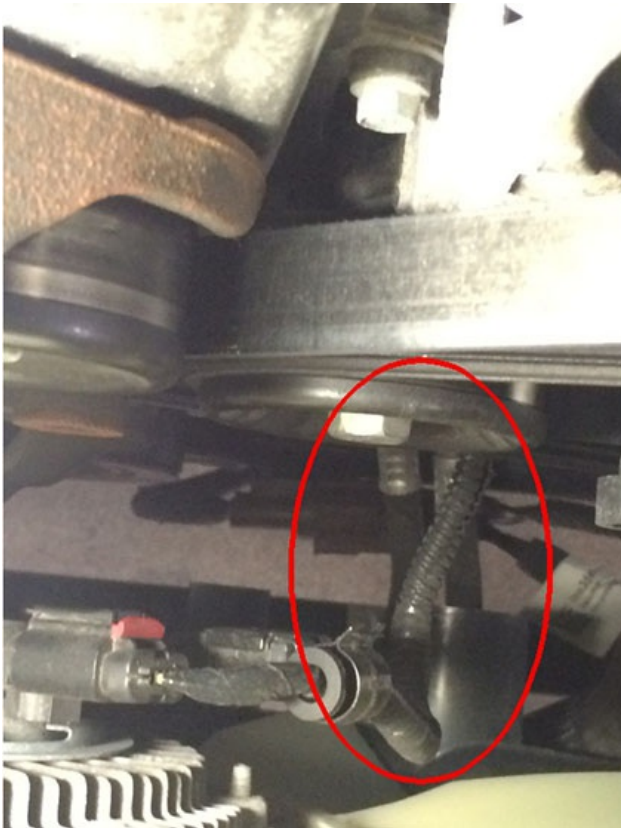
**Serpentine Belt.** The fan clutch wiring harness support bracket may be out of position allowing the harness to rub on the belt.

Concerns in the area of the serpentine belt may cause:

Various IPC warning lights to illuminate.

A crank no start concern.

The check engine light to illuminate.

The engine may run rough or misfire.

The Service Four Wheel Drive (4WD) light may illuminate.

The Stabilitrak light may illuminate.

The Air Conditioning (AC) may not cool or may blow hot air.

DTCs associated with chafing in this area may include:

C0273, P0526, P0480, P0336, P0526, P0641 and P0651.

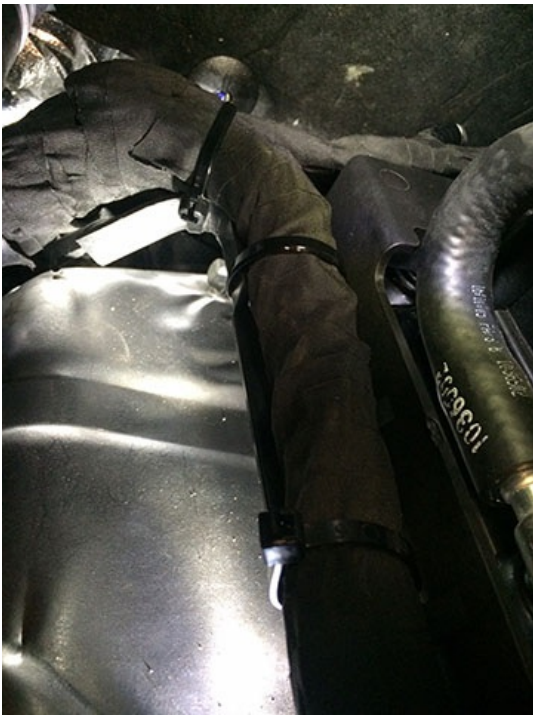
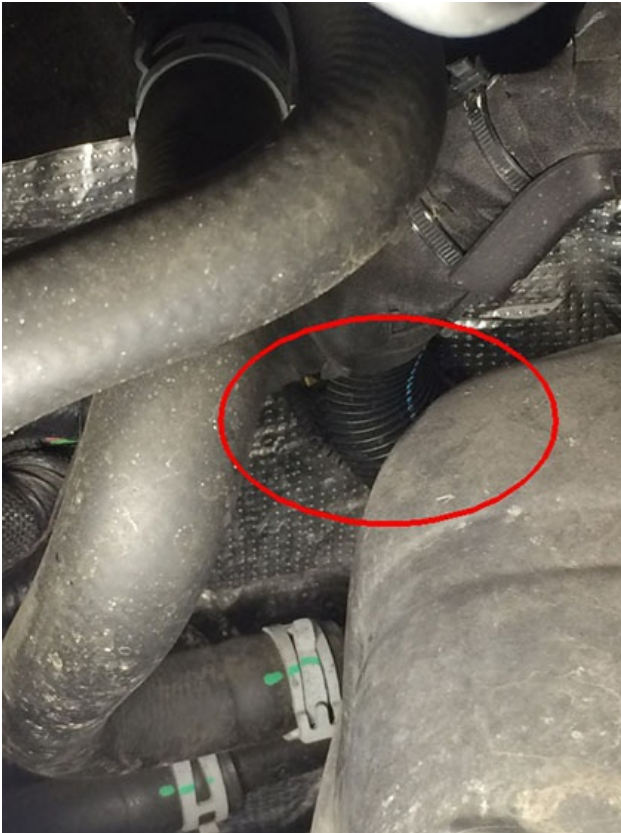
Right rear of engine. Check for harness damage on the exhaust heat shield as described in the latest version of bulletin [16-NA-081](#).

**Concerns in the area of the right rear of engine / exhaust heat shield may cause:**

**Various IPC warning lights to illuminate.**

**The Service Four Wheel Drive (4WD) light may illuminate.**

**The Stabilitrak light may illuminate.**

**The check engine light to illuminate.**

**The Driver Information Center (DIC) may display a reduced power message.**

**An open fuse in the Underhood Bussed Electrical Center (UBEC)**

**DTCs associated with chafing in this area may include:**

**B1011, C0306, P0201, P0202, P0203, P0204, P0410, P0575, P062D, P0697, U0073, U0100, U0121, U0140, U0415 and U0420.**

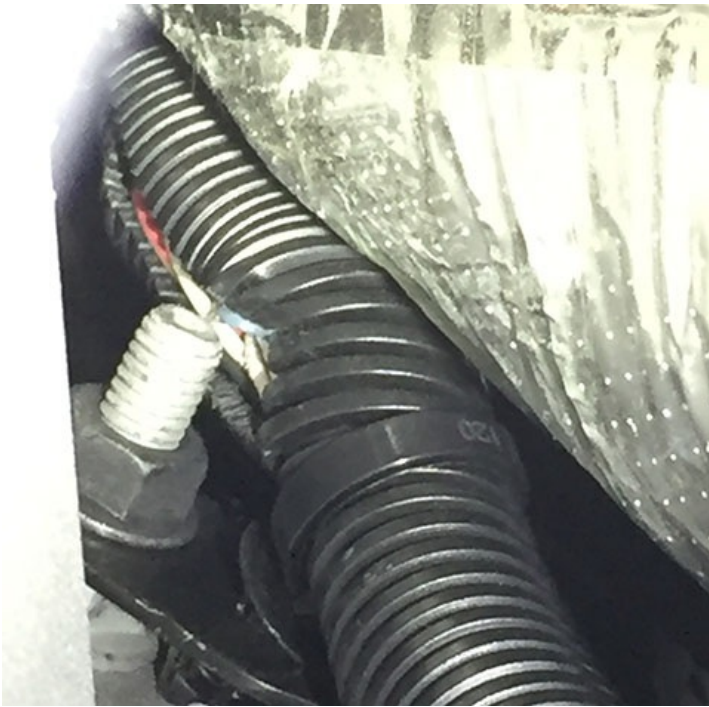
**Transmission bell housing bolt / stud.**

Concerns in the area of the rear of engine / transmission bell housing bolt / stud may cause:

Various IPC warning lights to illuminate.

The Service Four Wheel Drive (4WD) light may illuminate.

The Stabilitrak light may illuminate.

The check engine light to illuminate.

DTCs associated with chaffing in this area may include:

P0201, P0202, P0203, P0204, P0392, P0401, P0420, P062D and U0073.

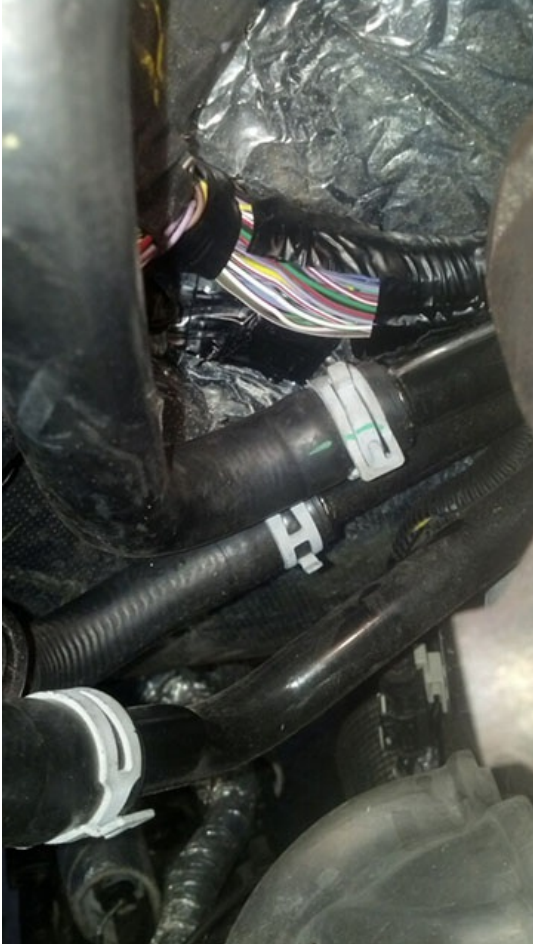
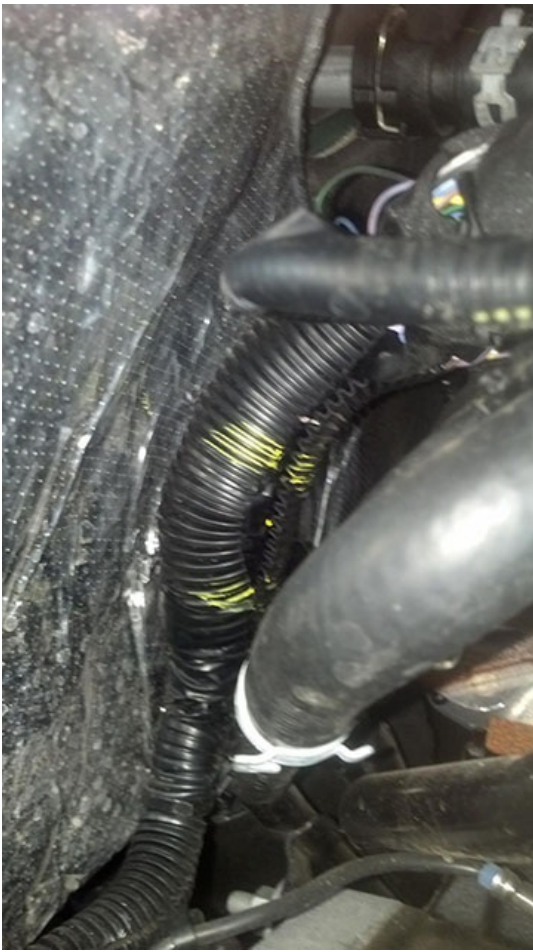
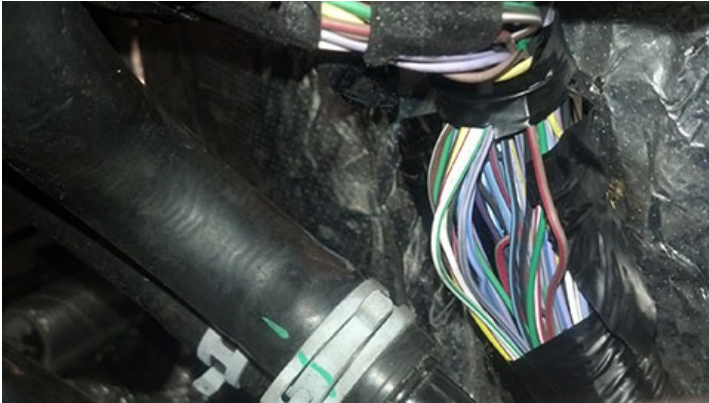
Coolant pipe and clamp tabs between engine and cowl.

Concerns in the area of the coolant pipe / clamp / clamp tabs between engine and cowl may cause:

Various IPC warning lights to illuminate.

The Service Four Wheel Drive (4WD) light may illuminate.

The Stabilitrak light may illuminate.

The check engine light to illuminate.

DTCs associated with chafing in the area may include:

B1011, P0575, U0073, U0100, U0121, U0140, U0415 and U0420.

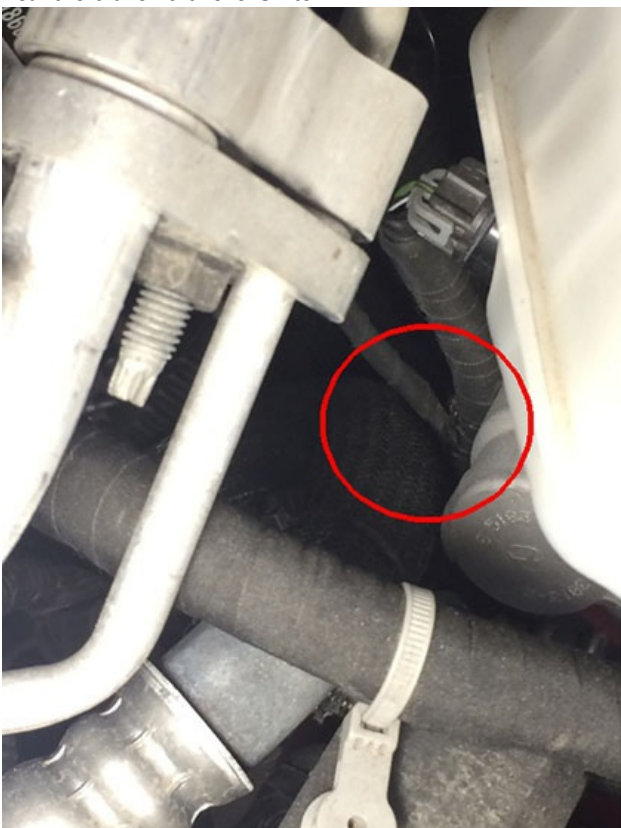
Near the brake fluid level switch.

Concerns in the area near the brake fluid level switch may cause:

The service brake light to illuminate.

The DIC may display that the brake fluid is low.

The check engine light to illuminate.

DTCs associated with chafing in this area may include:

C0273 and P0641.

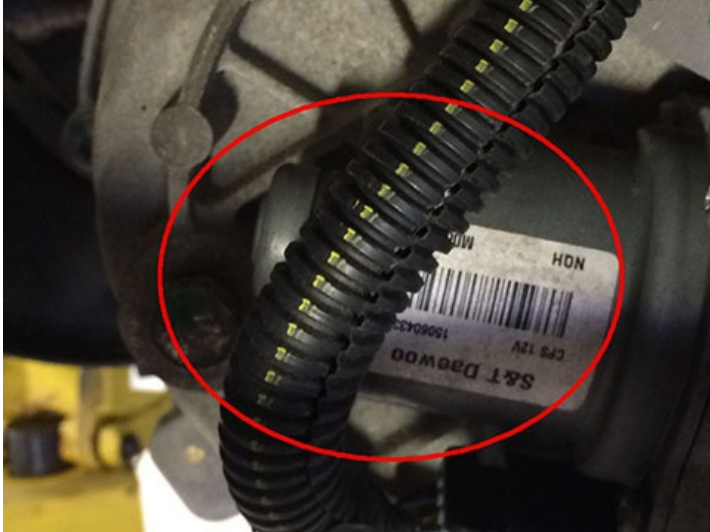
Transfer case encoder motor.

Concerns in the area near the encoder motor on the transfer case may cause:

Various IPC warning lights to illuminate.

DTCs associated with chafing in this area may include:

C0396.

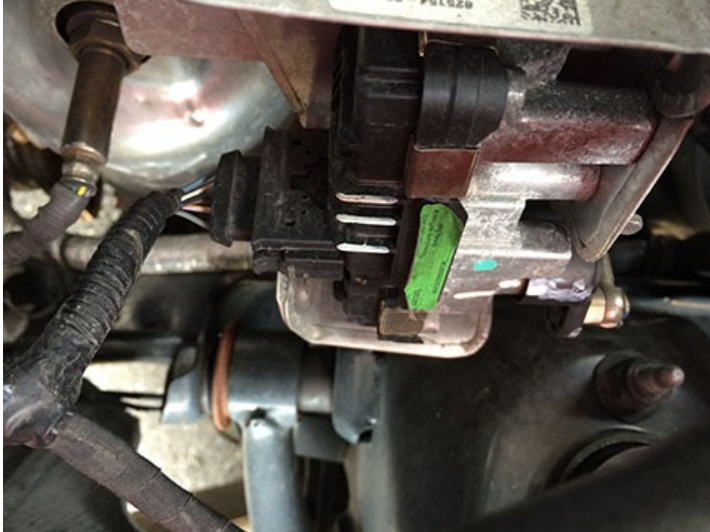
Turbocharger Vane Position Actuator Connector

Concerns with loose terminals or connector not fully seated at the Turbocharger Vane Position Actuator may cause:

The Check Engine Light to illuminate.

The Driver Information Center (DIC) may display a reduced power message.

The vehicle may have a low power concern.

DTCs associated with a loose connector or terminals include:

P0045 or P2599.
