Preliminary Information

PIP5487A 2017 6.6L L5P Duramax Coolant Leaks

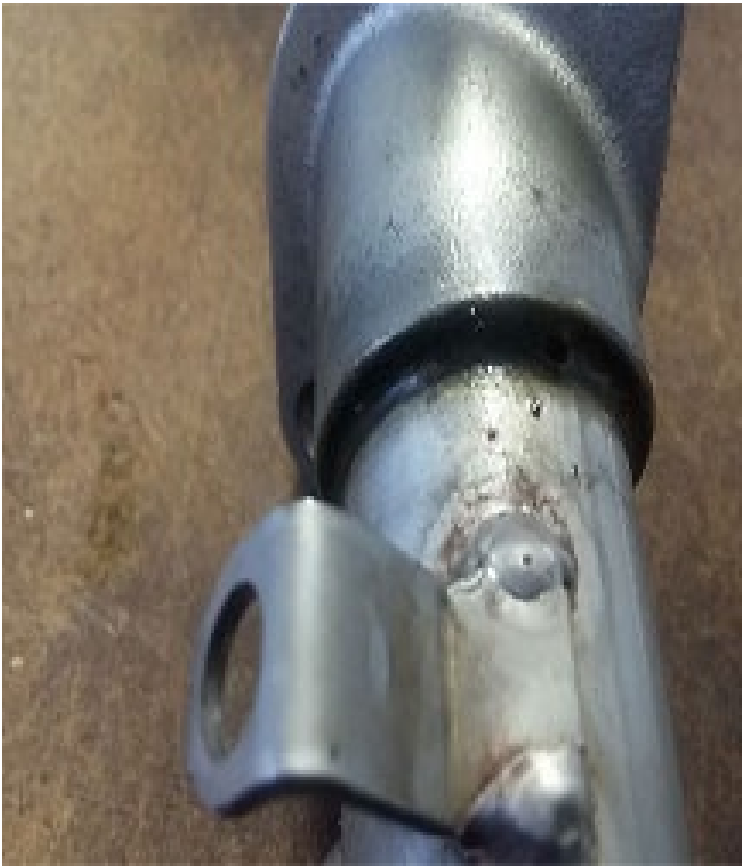
Welded flange leaking on the Exhaust Gas Recirculation (EGR) coolant return pipe. Refer to call out #1 in the above picture.

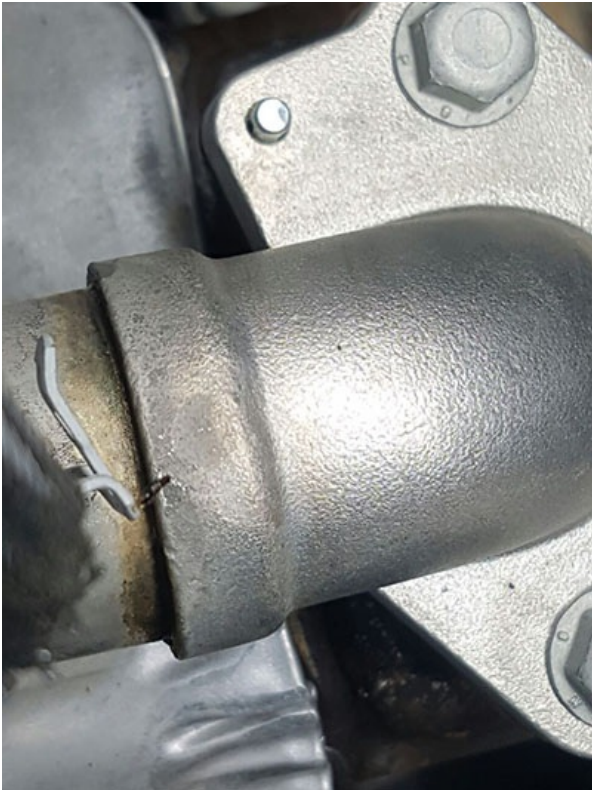
Welded flange leaking on the Exhaust Gas Recirculation (EGR) coolant feed pipe. Refer to call out #2 in the above picture.

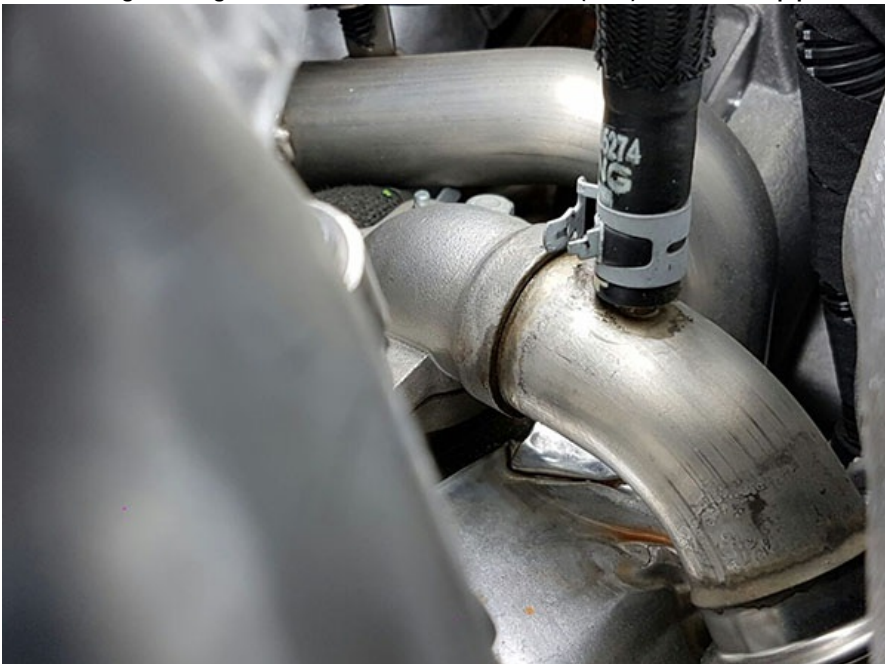
Another view of the leaking welded flange on the Exhaust Gas Recirculation (EGR) coolant feed pipe. Refer to call out #2 in the above picture.

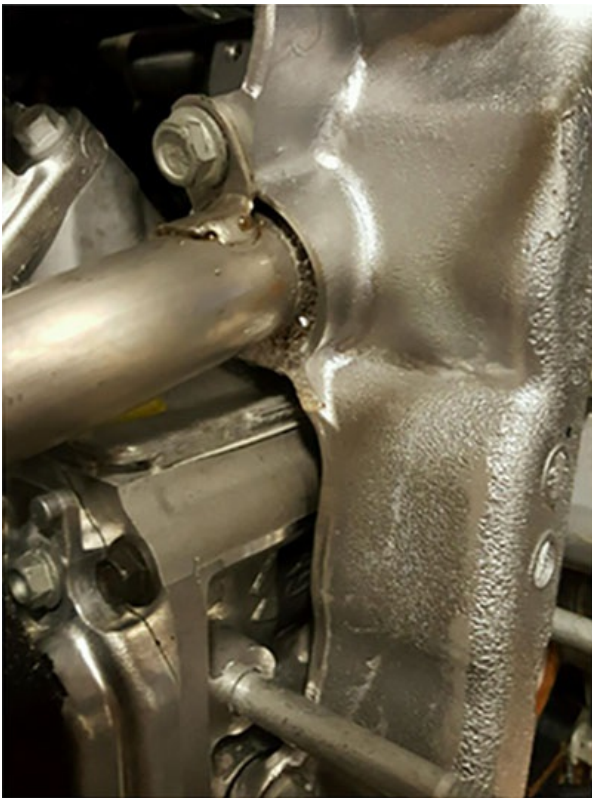
Coolant leak at the O-ring seal of the Exhaust Gas Recirculation (EGR) coolant feed pipe. Refer to call out #2 in the above picture.

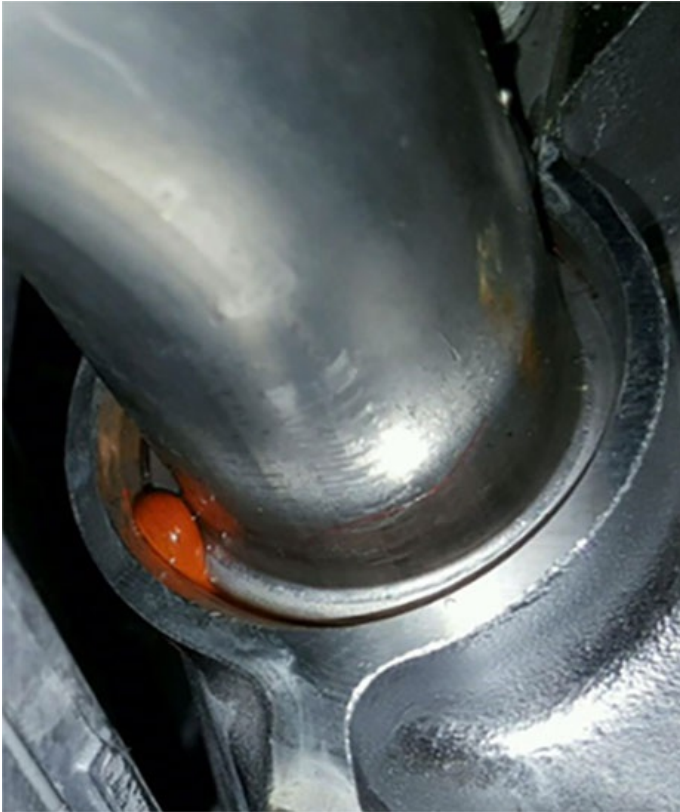
View of a rolled or pinched O-ring at Exhaust Gas Recirculation (EGR) coolant feed pipe. Refer to call out #2 in the above picture.

NOTE : The leak shown above could only be confirmed after removing the front accessory drive bracket and alternator.

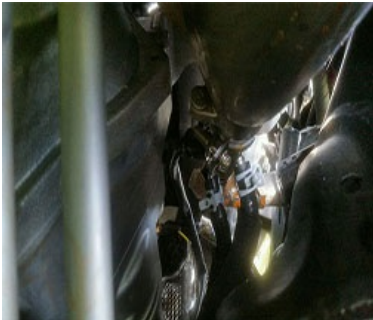
Coolant leaking from coolant hoses at the Emission Reduction Fluid Injector (DEF Injector).
