# **Preliminary Information**

PIC6127J (Volt) High Voltage Drive Motor Battery TAC Restriction and Exchange Program

Brand:	Model:	Model Years:	VIN:		Engine:	Transmissions:
			from	to	Liigilie.	Hallstillssions.
Chevrolet	Volt	2016 - 2018	All	All	L3A	MKV

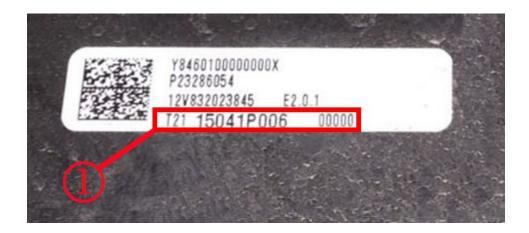
- 6.2 The battery has a battery identification tag that is located on the right side of the battery. Locate the tag and record the 16 digit battery identification number (BIN). The BIN is the bottom most number on the label and it starts with a "T" indicator (See Photo Below). If the battery is not out of the vehicle yet, you can find the BIN by installing the MDI and using GDS 2. Access the Battery Energy Control Module and look under the identification information section and the sixteen digit number will be listed under the parameter: Hybrid/EV Battery Pack Identification Number.
