Preliminary Information

PIP5519 Diagnostic Tip: Low Engine Oil Pressure and DTC P06DE After Major Engine Repairs

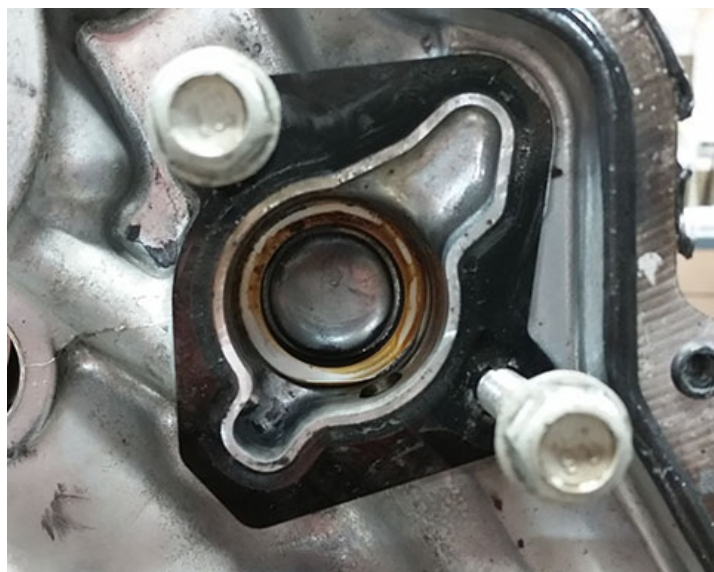
Correctly installed timing chain tensioner gasket allowing no leak path for pressurized oil.

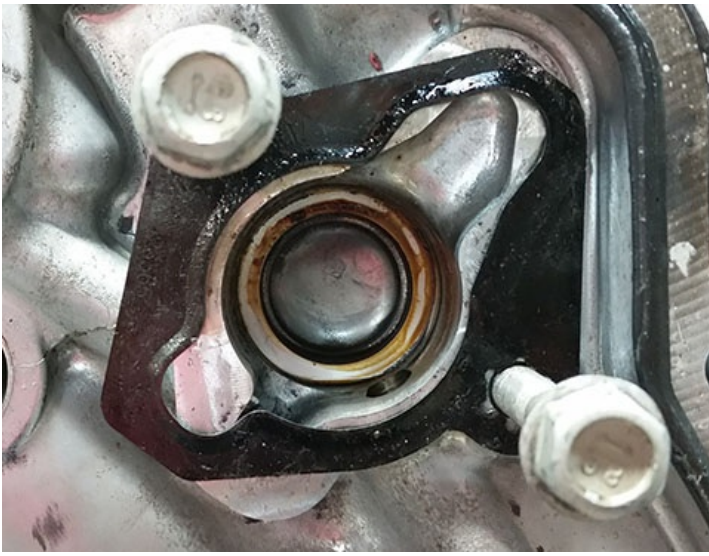
Improperly installed gasket showing leak path for pressurized oil to bleed off behind timing chain cover.

Verify the timing chain tensioner gasket has been installed correctly and is not out of position.

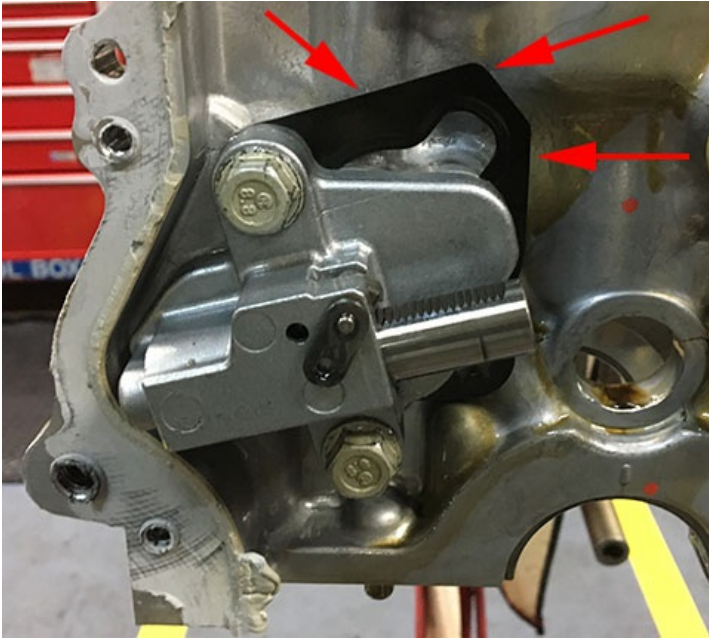
Improperly installed timing chain tensioner gasket allowing pressurized oil from tensioner passage to bleed off behind timing cover.

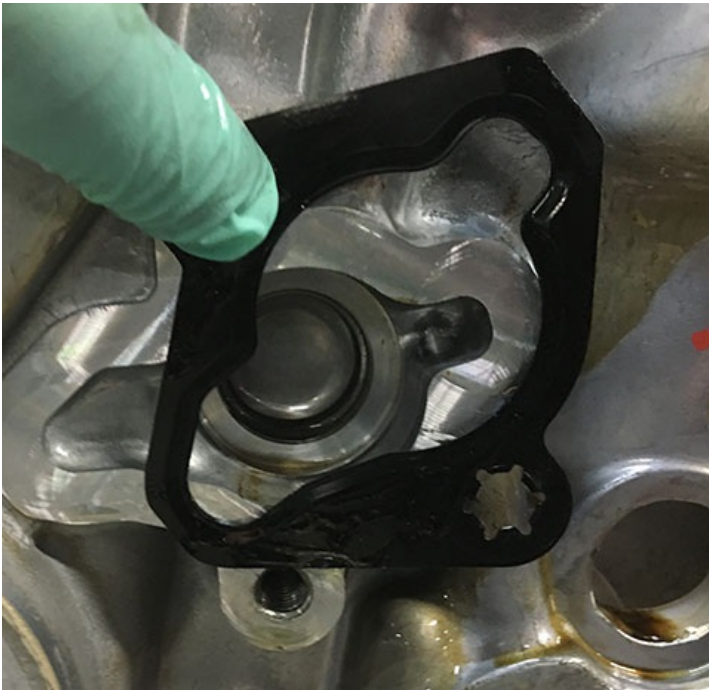
Same as above photo showing actual position of gasket once tensioner was removed.

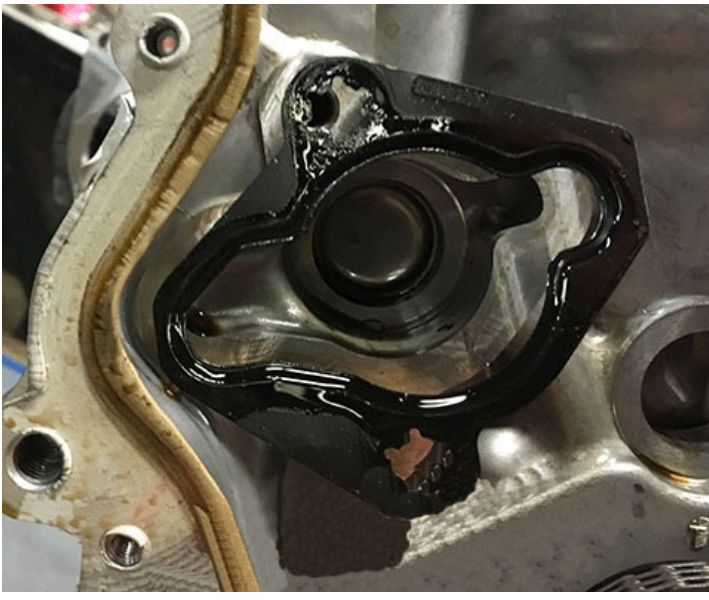
Tensioner gasket shown properly lined up in relation to mounting bolt holes.
