Preliminary Information

PIT4745D Dent/Ripple Appearance Around Wheel Well Opening

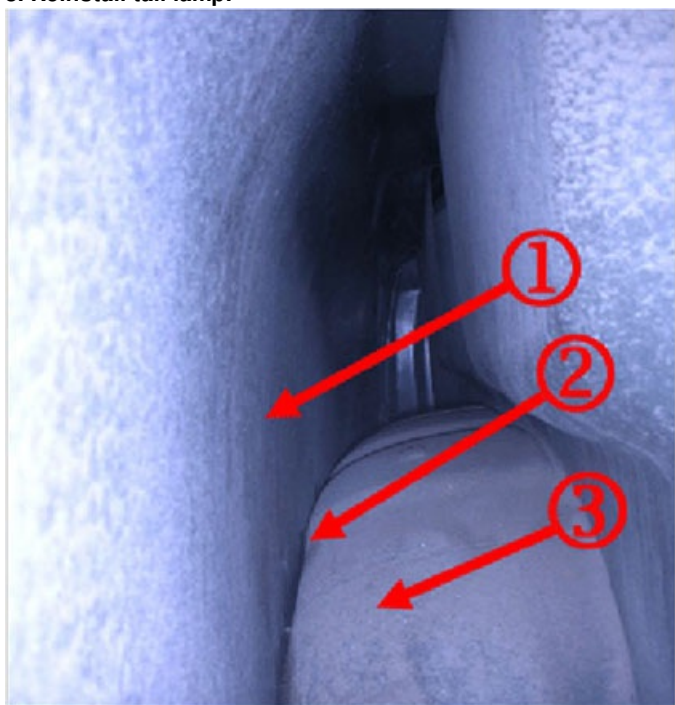
Raised dents or ripple appearance in the side outer panel of the cargo box around the perimeter of the wheel house opening due to the lodging of stone/aggregate/debris between the wheelhouse, and the side outer panel.

1. Side outer panel
2. Area where stone/aggregate/debris can get stuck
3. Wheelhouse

1. Remove the tail lamp to access the inner area of the side outer panel above the wheelhouse, see picture below.
2. Inspect for any stone/aggregate/debris. Remove as needed using a power washer and/or shop air blow gun.

4. Access the rear of the inner wheelhouse area through the tail lamp cavity; and the front of the wheelhouse from under the vehicle, and coat the inner hem of the wheel house to side outer panel, with 3M Rust Fighter I, or equivalent, see latest version of [01-08-51-003](#).

7. Apply enough undercoating to prevent stone/aggregate/debris from getting between the inner wheel house and side outer panel.
8. Reinstall tail lamp.
