Preliminary Information

PIT5251C EZ Lower Tailgate Opens Too Quickly / Additional Effort To Close

with EZ Lift and Lower Tailgate (RPO PPA)

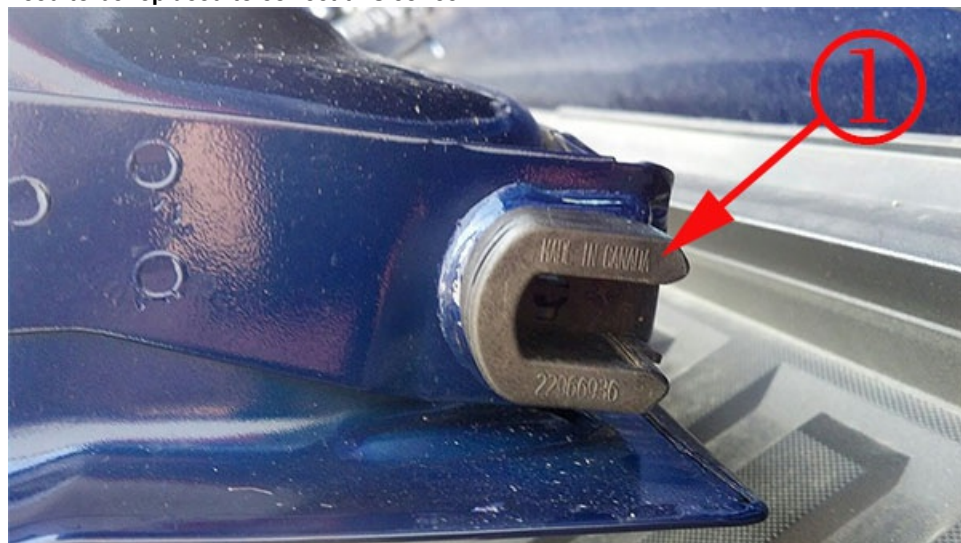
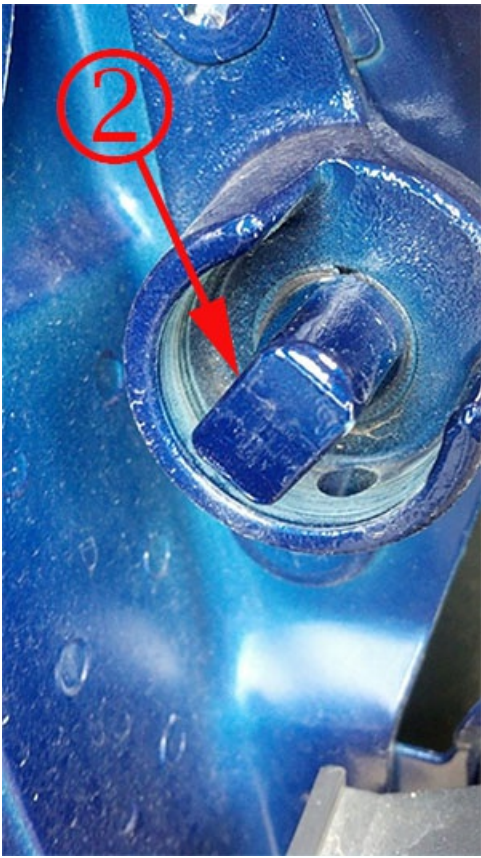
3. If the tailgate opens too quickly, inspect the right tailgate bushing. The right tailgate bushing (1) has a double flat design which keys/splines the tailgate to the dampener shaft (2). If the right tailgate bushing (1) becomes deformed/cracked/broken/etc., the dampener will no longer be keyed/spined to the tailgate. This can cause the tailgate to open too quickly. The tailgate bushing would need to be replaced to correct this concern.
