Preliminary Information

PIP5402C Check Engine Light MIL P015B, P1101 and /or P0101 Reduce Engine Power

Models

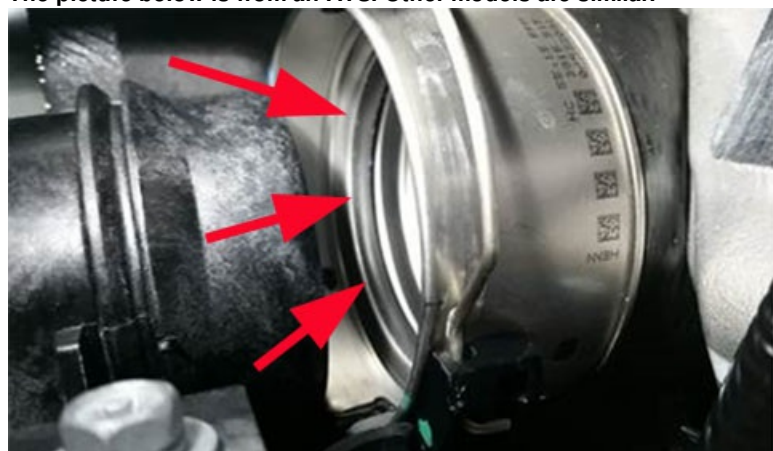
A customer may have a concern of the check engine lamp being illuminated and/or reduced engine power. When the technician scans the vehicle, diagnostic trouble codes P015B and/or P1101 will be set current or in history.

This coupler is located on the passenger side of the charge air cooler where the air duct slips into it. The arrows in the picture below are pointing to the O-ring seal being discussed.

The picture below is from an ATS. Other models are similar.

After following normal SI diagnostics, if a solution is not found, inspect for a missing/damaged O-ring seal in the charge air cooler coupler.

Note: It might be helpful to use the EEST GE 41413-A and introduce smoke into the induction/charge air cooler system to assist with isolating any further system leaks. Place a plastic disposable bag around the air filter during testing. With the engine off introduce smoke through a suitable intake vacuum port, allow several minutes for the smoke to move throughout the system, switching between nitrogen and smoke may help speed up the process. Visually inspect all related induction system components for signs of smoke indicating a potential leak.
