## Minor oil filler neck leak

| Topic number | LI01.20-P-063065 |
| Validity | Model 166/292 with OM642 LS Eco and NAG3 / as from model year 2015 |

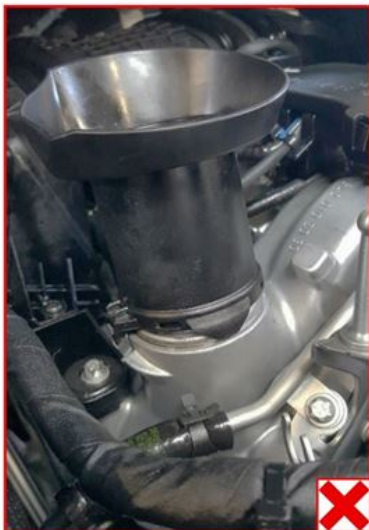
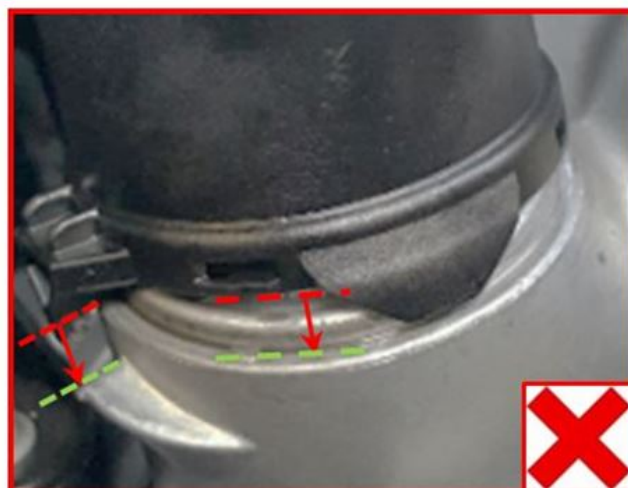
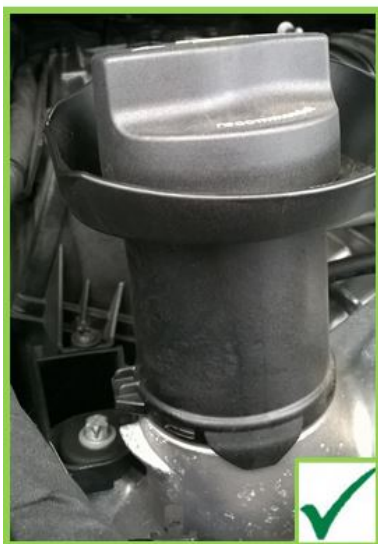
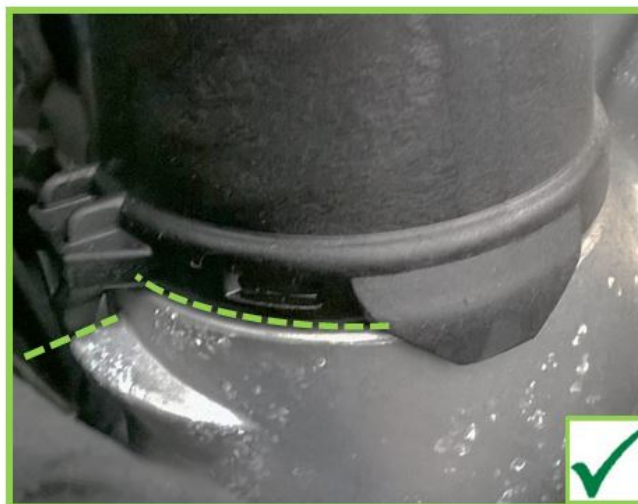
Referenzbild - reference image.JPG:

Minor oil leak on oil filler neck.

Note: The oil leak may cause alternator damage.

If the metal locks or the plastic guide at the side are bent or broken, the oil filler neck must be replaced.

See reference pictures for example of correct and incorrect installation.

Dismantle oil filler neck.

Check oil filler neck is correctly latched into place.

Remove any oil residue.
