Steering complaints: Repair guide

Topic number	LI46.00-P-066886
Version	1
Function group	46.00 General
Date	08-10-2017
Validity	MODEL 463
Reason for change	Specified damage code list adjusted.
Reason for block

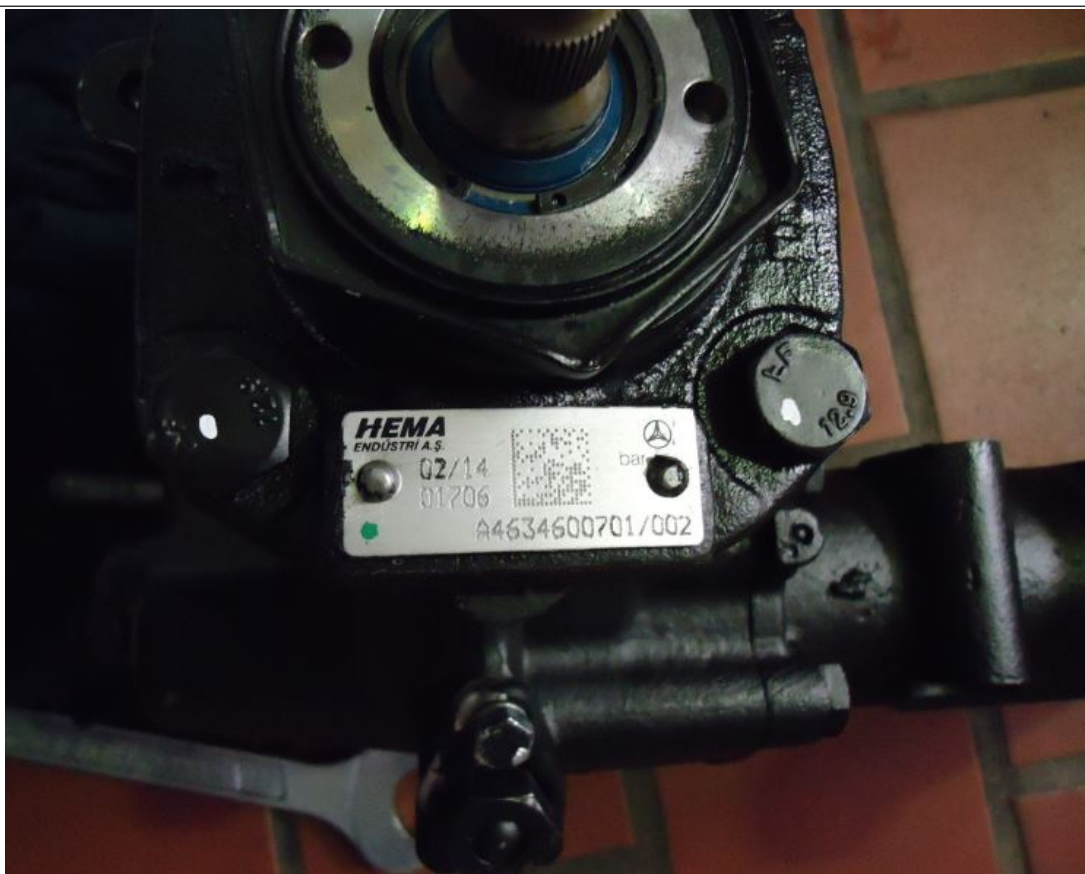
Typschild.JPG:

Attachments	
File	Description
Typschild.JPG	HEMA identification plate
Kappe Lenkung.pdf	Repair instructions "Replace cap of control plunger"

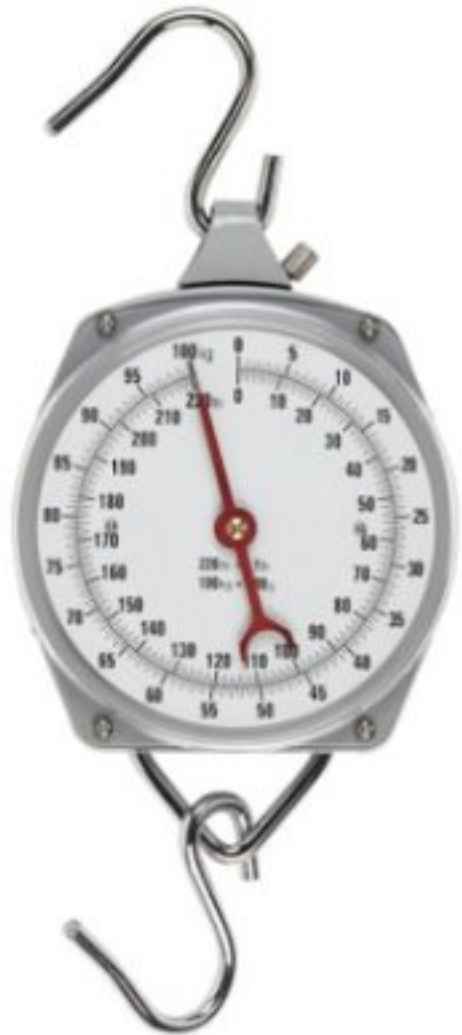
Kraftmessung.jpg:

Attachments	
File	Description
Kraftmessung.jpg	Force measurement at pitman arm: Example for measuring equipment
Hydraulikoel.jpg	Wear debris in hydraulic fluid. Red: Shavings Green: Normal wear debris

Measure the steering forces at the pitman arm. If the forces to the left and to the right differ by more than 50%, the steering gear must be replaced (see below: Work instructions "Replace steering gear").

1. Detach the drag link from the pitman arm at one end.
2. Then measure the force required to move the pitman arm to the left and right (with the engine running!). A commercially available spring balance, spring force meter, luggage scale or similar must be used for this; the scale should extend from 0 to 400 N (0 to 40 kg). The force measurement must be performed at a right angle to the pitman arm, uniformly and at the same height and also performed at the same speed to the left and right.
3. Difference between left and right: The greater force must be no more than 50% higher than the lower force. To work out the difference, multiply the lower force by the factor 1.5 and compare the result with the higher force.

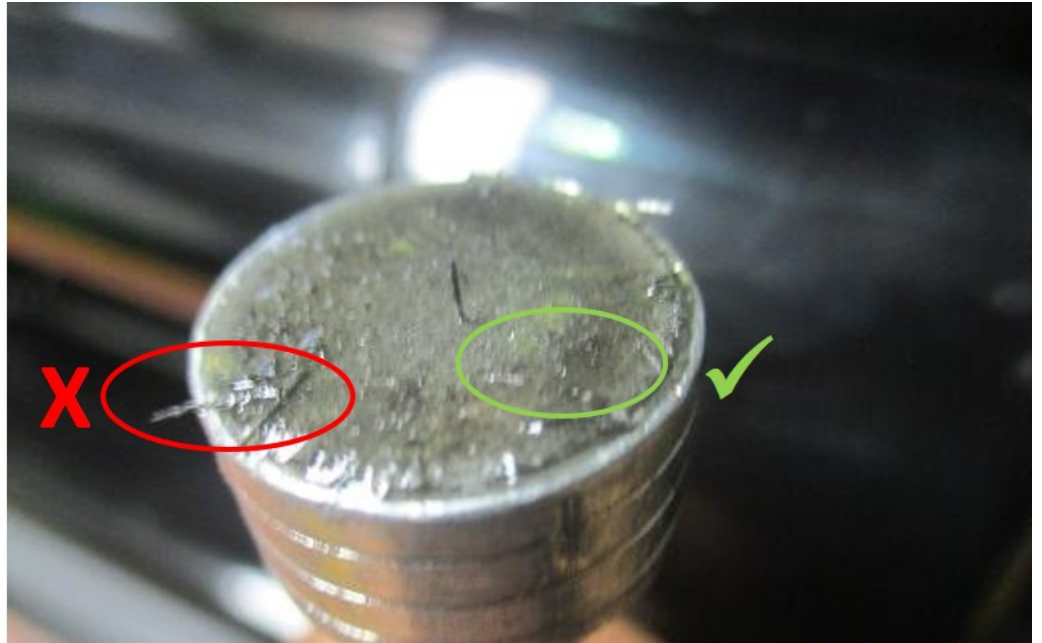
Hydraulikoel.jpg:

Note: Slight metallic wear debris/dust is normal and no grounds for complaint; parts should only be replaced if metal shavings are clearly identified (also see attachment).

Test method: Rub the wear debris between your fingers. If it feels like grains of sugar or salt, then it is metal shavings. If it feels like flour, then it is normal wear debris.

To do this, open the expansion reservoir of the power steering and hold a magnet in the hydraulic fluid for approx. 30 seconds with the engine running. If there are shavings in the hydraulic fluid, all oil-carrying components of the steering system must be replaced; flushing is not effective.
