Service Campaign Bulletin

Campaign No. 2017050009, August 2017

SUBJECT: **Models 166 and 292 Model Year 2017**
Correct Torque of Front Left and Right Torsion (Stabilizer) Bar Linkage Nut

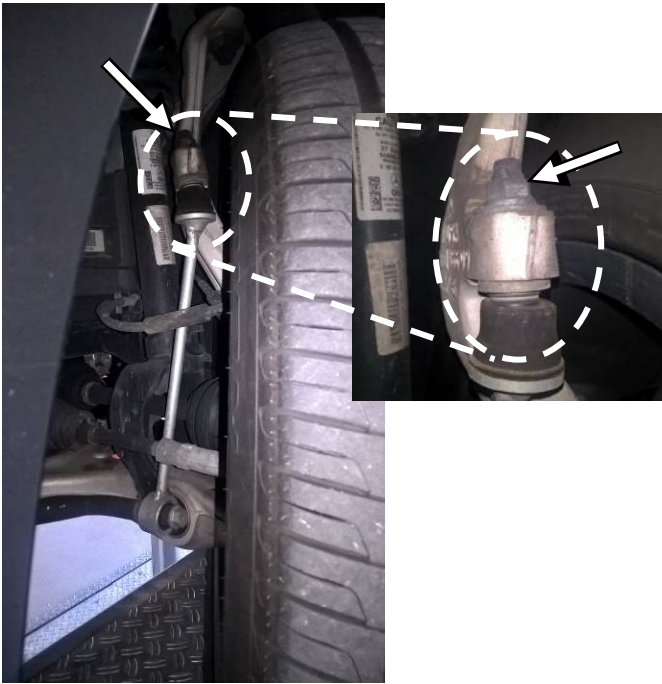
Figure 1

Daimler AG ('DAG'), the manufacturer of Mercedes-Benz vehicles, has determined that on certain MY2017 GLE-Class (166, 292 platform) and GLS-Class (166 platform) vehicles, the threaded connection at the torsion bar linkage at the front left and right might not have been torqued to manufacturer specifications. An authorized Mercedes-Benz dealer will correct the threaded connection at the torsion bar linkage.

Linkage nut (arrows, Figure 1) is located at bottom of steering knuckle.

1. Drive vehicle onto vehicle lift and raise.
2. **Nm** Torque front left and right torsion (stabilizer) bar linkage nut (arrows, Figure 1) to: 65 Nm.
