## Audio 20: Wrong date filed in system settings

| Topic number | LI82.85-P-066931 |
| Function group | 82.85 Navigation and Communication system (CNS, ICS, COMAND, FleetBoard) |
| Validity | Model 205 with code 506 (Audio 20 radio, navigation capable NTG5.5) and without code 355 and code 357.<br>Model 205, 253 with code 522 (Audio 20 radio, navigation capable NTG5) and code 154 and without code 355 and code 357. |

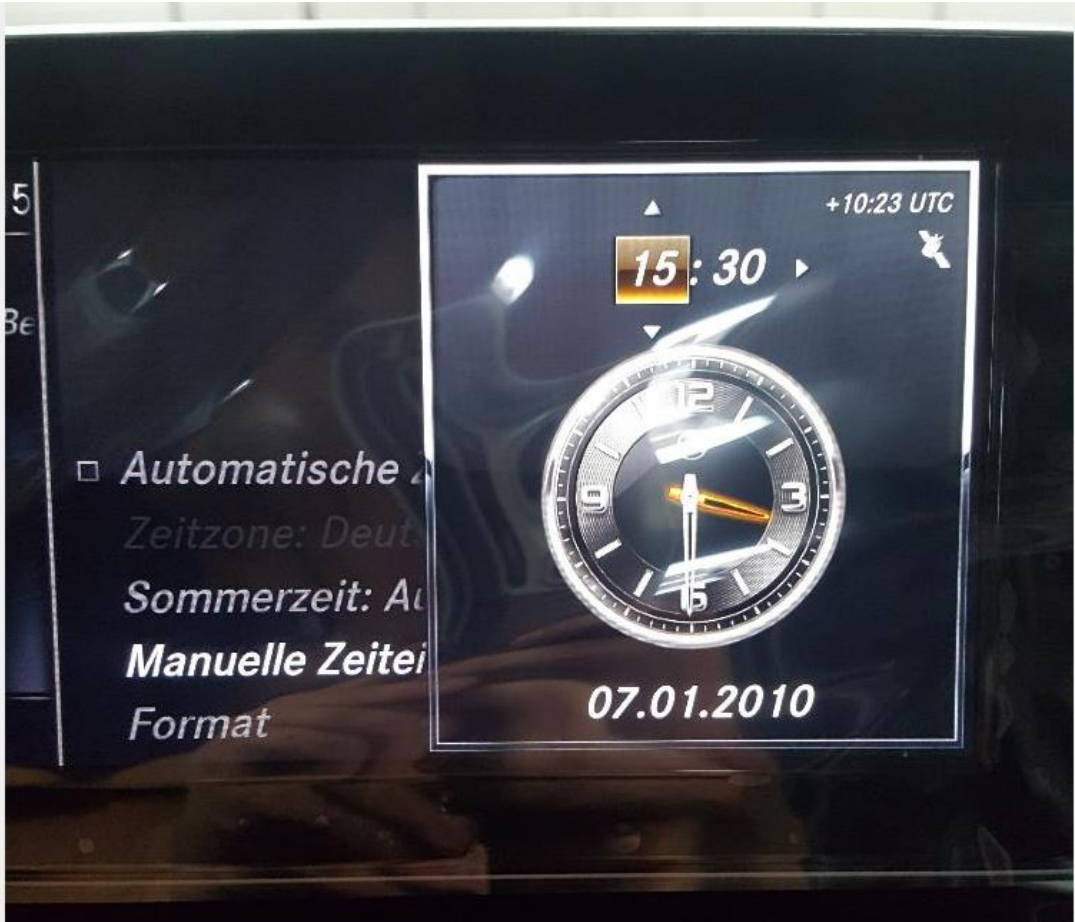
Date is incorrect and not adjustable.JPG:

- In the system settings for the Audio 20 control unit (A26/17) the wrong date is displayed and this cannot be corrected
- Internet radio inoperative
- MB-Apps nonfunctional
- Android Auto nonfunctional

| Attachments | |
|---|---|
| Date is incorrect and not adjustable.JPG | Picture of clock |

Software release of Audio 20 control unit (A26/17) may lead to the complaint.

As soon as a software update is available, it will be communicated to you through this TIPS document.

Important: Do not replace Audio 20 (A26/17) or the instrument cluster (A1) as the complaint may reoccur.
