## Switching noise from climate relay

Topic number	LI83.30-P-066810
Version	2
Function group	83.30 Air conditioning
Date	08-21-2017
Validity	Model 453
Reason for change	Damage code updated
Reason for block

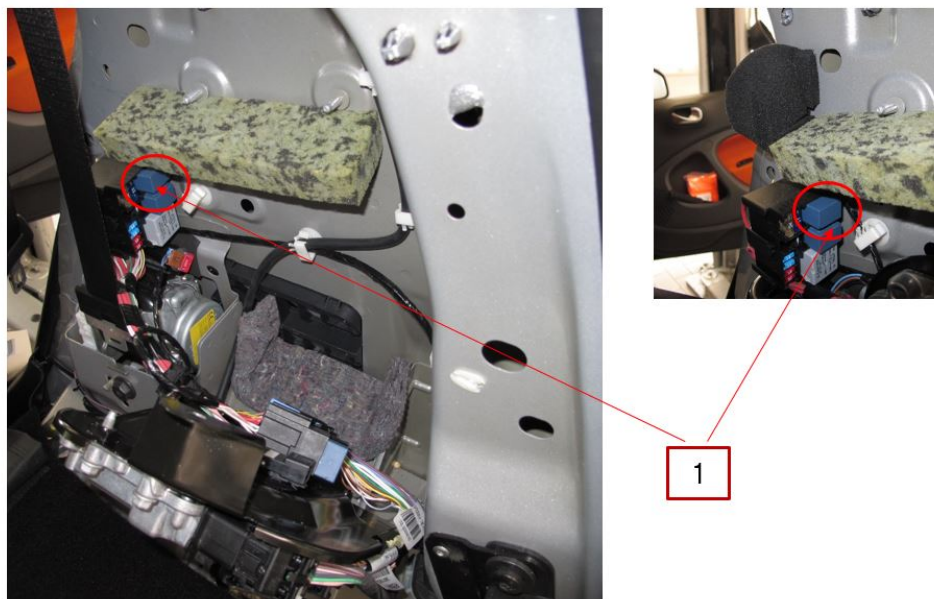
Anordnung Klimarelais SerieAlt.JPG:

Switching noise from the climate relay (right B-pillar)

Attachments	
File	Description
AnordnungKlimarelaisSerieAlt.JPG	Location of climate relay in production

Electrical relay switching noises.

The previous attachment point on the B-pillar (photo 1) moves to the rear of the engine control unit bracket (photos 2 and 3).

The climate relay can be relocated from the right B-pillar to the rear side of the engine control unit.

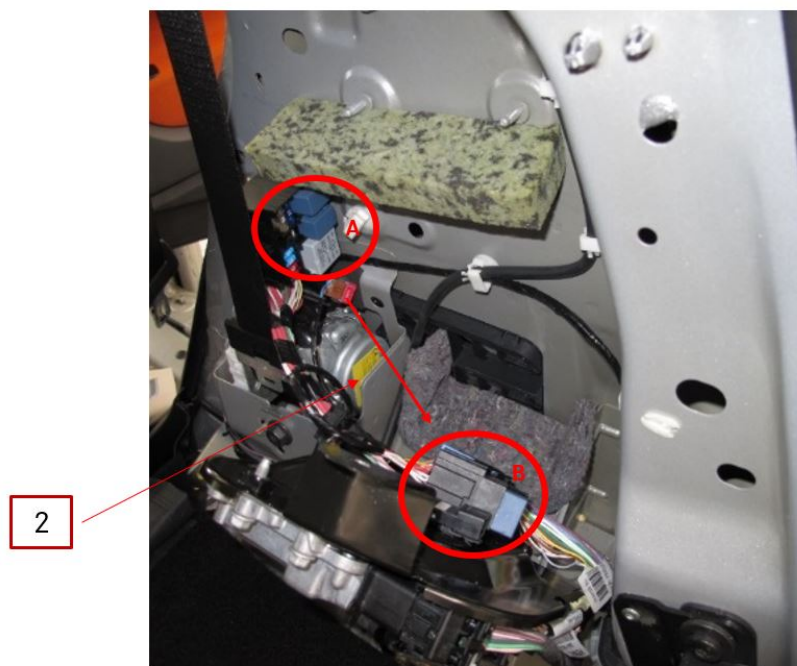
Massnahme Klimarelais-Versetzen.JPG:

Attachments	
File	Description
MassnahmeKlimarelaisVersetzen.JPG	Measure for relocating the climate relay
Neue Anordnung Klimarelais.JPG	Location of remedy for switching noise

To relocate or reposition, remove the engine control unit bracket and detach the interior wiring harness in the routing area.
