## Fault message "AIRMATIC" or "Active Curve System" in instrument cluster

Topic number	LI32.34-P-056198
Version	4
Function group	32.34 Anti roll governor (WR)
Date	08-25-2017
Validity	MODEL 166 with CODE 468 (Active Curve System) MODEL 292 with CODE 468 (Active Curve System)
Reason for change	Description for bleeding of ACS system and checking the production date on the valve block added
Reason for block

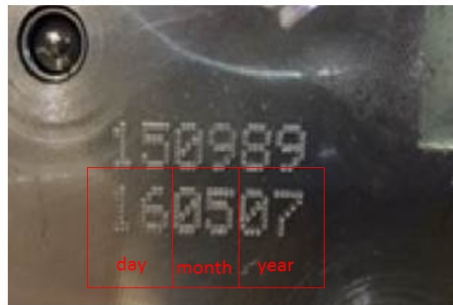
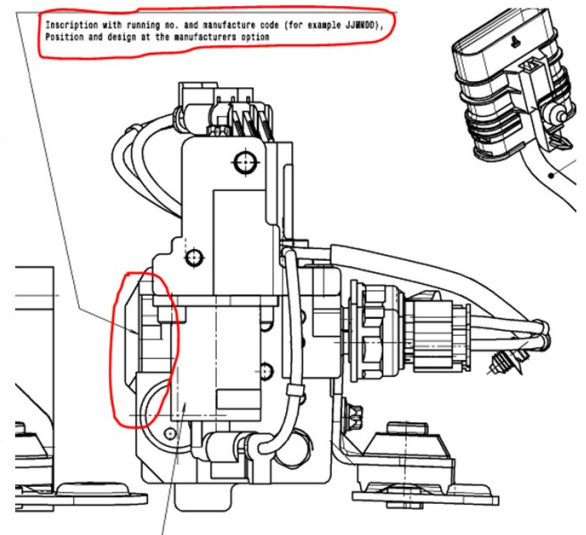
production date valve-block.jpg:

- Re. 1. Monitoring of pressures in ACS is too sensitive.
- Re. 2. Mechanical fault of rotation direction valve in valve block at front axle.
- Re. 3. Oil level too low, air in system.

- Re. 1. Perform XENTRY update: Flash software A166 902 5904 in ACS control unit.
- Re. 2. Check production date of valve block at front axle.
- Production date prior to April 1, 2017 - Replace valve block, see picture 1.
- Production date after April 1, 2017 - Please submit a PTSS case.
- Re. 3. Bleed hydraulic system with XENTRY (to be found in the roll control unit under the heading "Actuations").
- These instructions must be strictly observed:
- Check hydraulic fluid fill level and correct if necessary.
  - If foam forms in the reservoir during the bleeding process (picture 2), the bleeding routine must be interrupted until the foam has dissipated.

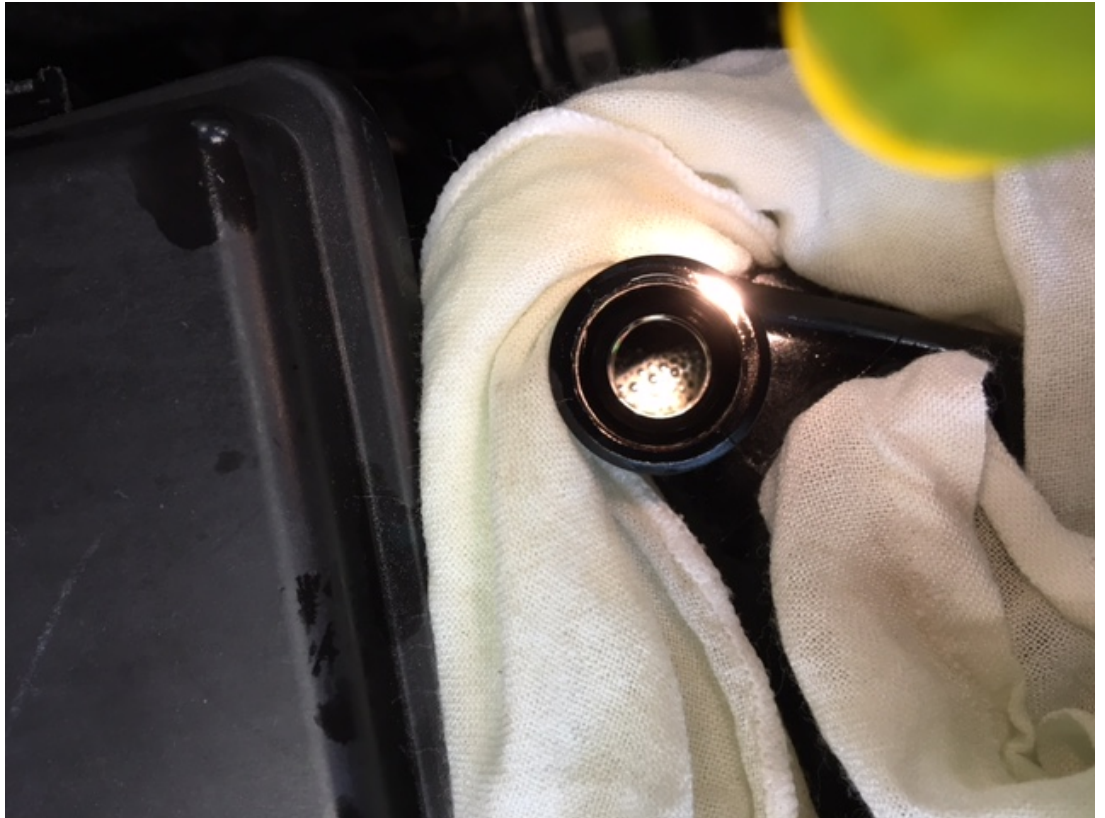
foam.JPG:

Note: Excessive foaming can cause the system to draw in air bubbles.
