## Pop-up roof (ASD) reverses direction intermittently (from the tilt position) when closing

Topic number	LI77.21-P-066975
Version	1
Function group	77.21 Panoramic roof
Date	08-31-2017
Validity	BR C117 with ASD (SA code 413) up to VIN 117N574350
Reason for change	
Reason for block

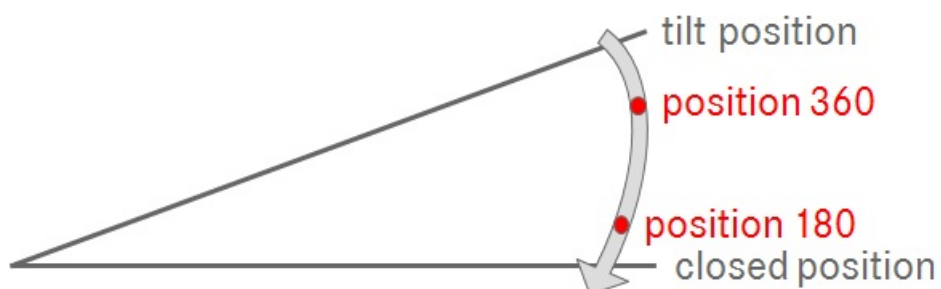
Bild 1\_roof positions\_ eng.jpg:

The reversing sequence usually starts from two critical positions (see picture 1):

- 360 position

- 180 position (with the roof almost closed, the distinction between closed and almost closed is very difficult or impossible to see with the naked eye)

The force at the moment arm of the roof at the 180 and 360 positions can be higher, causing a false activation of the pinch-protection

The permanent repair for vehicles with production date up to and including 05.04.2015 is:

Replacement of the left and right guide rails/roof mechanisms, in combination with

commissioning of control unit A98 (Panoramic sliding sunroof, PSD) to update the software/SCN coding:

The permanent repair for vehicles with production date as of 06.04.2015 is:

Commissioning of control unit A98 (Panoramic sliding sunroof, PSD) to update the software/SCN coding:
