## Rattling noises due to interaction between the 2nd seat row Bowden cable and bodyshell in trunk

Topic number	LI91.12-P-066989
Version	1
Function group	91.12 Rear seats
Date	08-31-2017
Validity	BR213 with SA287
Reason for change	Part number of felt strip added.
Reason for block

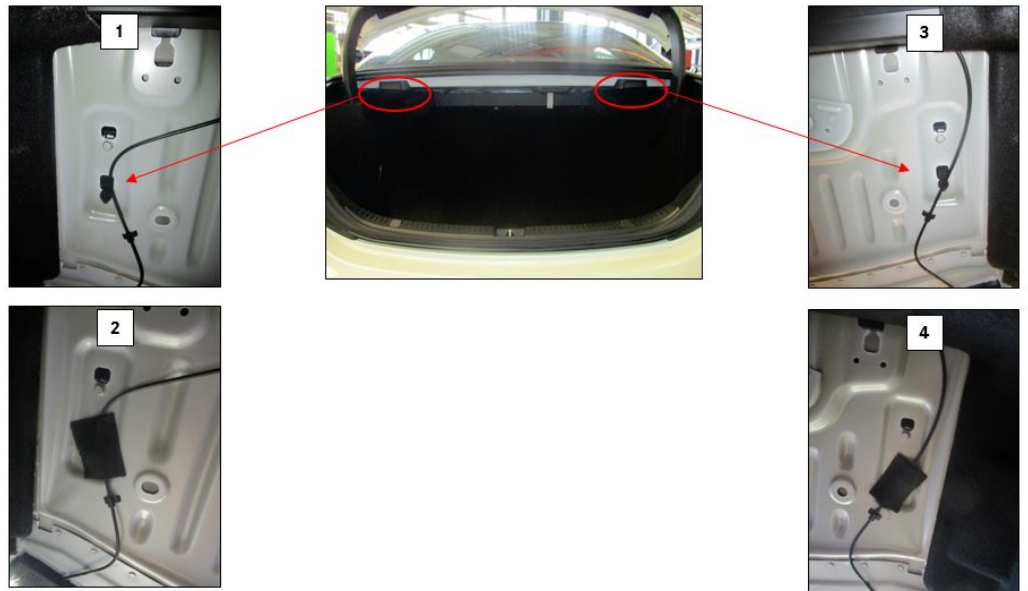
Pic.1.JPG:

Rattling noises due to interaction between the 2nd seat row Bowden cable and bodyshell in trunk

The Bowden cable of the rear seat backrest release starts to oscillate due to excitation from driving on rough roads. The interaction of the Bowden cable with the bodyshell in the trunk in the area of the rear shelf produces a rattling noise.

Attachments	
File	Description
Pic.1.JPG	1. Left without felt strip 2. Left with felt strip 3. Right without felt strip 4. Right with felt strip

Glue two felt strips (A123 899 00 97) to the catch or joint of the rear shelf (Pic1).
