Model(s)	Year	Eng. Code	Trans. Code	VIN Range From	VIN Range To
Golf, Jetta, Jetta SportWagen	2009-2012	2.0L TDI (CBEA, CJAA)	All	All	All

23 17 05 June 15, 2017 **2041063** Supersedes Technical Bulletin V231703 dated April 13, 2017 to update metadata.

MIL ON, No Start, or Rough Running with DTCs P0087, P0088 or P0191 Stored in ECM Fault Memory (TDI ONLY)

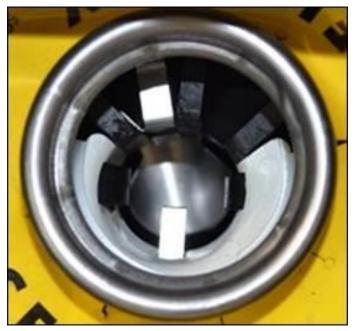
Figure 1. Misfueling guard installed in the filler neck.

Inspect the fuel filler neck for a properly installed and functioning misfueling guard (see figure 1). An installed misfueling guard is required for warranty coverage under the terms of the High Pressure Fuel Pump Limited Warranty Extension. Refer to the Warranty Policies and Procedures Manual and the applicable Warranty Policy and Procedures Bulletin(s) for coverage eligibility details.

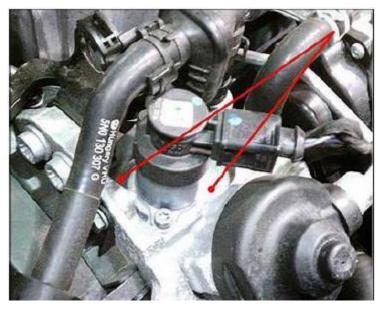
Figure 2. Surrounding Area

Prior to removing the N290 Fuel Metering Valve, the area surrounding the valve (Figure 2) must be clean and dried with compressed air to remove ALL debris from the area. See Repair Manual Group 20 Fuel Supply, General Information, Clean Working Conditions in Elsa.

If debris enters the fuel system, components may be damaged.

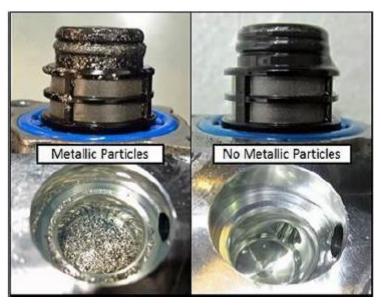
Figure 3. N290 Fuel Metering Valve and Valve Bore

1. Remove the N290 Fuel Metering Valve and inspect the valve and valve bore for the presence of metallic particles (see Figure 3).

2. If metallic particles are found on the N290 Fuel Metering Valve or in the valve bore (see figure 3), replacement of the high pressure fuel pump and major components in the fuel system is necessary. Proceed to Section B – Fuel Sample Pre-Analysis.

3. If no metallic particles are found on the N290 Fuel Metering Valve or in the valve bore, do not replace the high pressure fuel pump. Open a VTA case and contact the Volkswagen Technician's Helpline for further assistance diagnosing the vehicle, this bulletin does not apply.

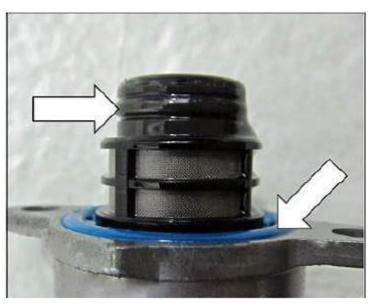
Figure 4. N290 Fuel Metering Valve O-rings

Prior to reinstallation of the N290 Fuel Metering Valve, ensure that both O-rings are not damaged. If they are damaged, the high pressure fuel pump must be replaced.

To prevent damaging the O-rings when reinstalling the N290 Fuel Metering Valve, lubricate the O-rings with diesel fuel **(see Figure 4).**

- 4. Install the N290 Fuel Metering Valve into the valve bore using light pressure.
- 5. Install and hand tighten both M5 fasteners, ensuring that the threads are clean and dry.

Pre-tighten to 2 Nm, then to 6.5 – 7 Nm.

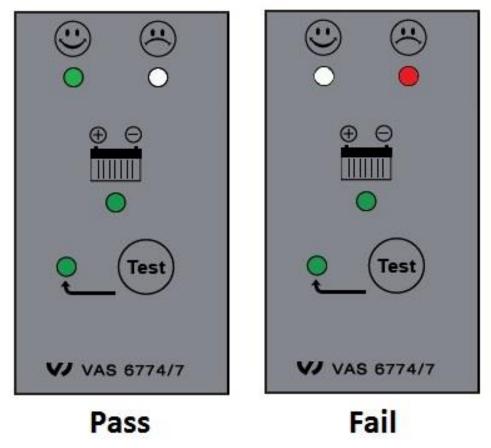
Figure 6

2b. A sensor head test must be performed next to check the fuel for gasoline residue. Follow the instructions included with the tool to perform a sensor head test. If the sensor head test results in a "Pass" continue to step 3. If the sensor head results in a "Fail" warranty coverage does not apply.

If the specific gravity is above 13 or below 9 the fuel has failed the test and warranty coverage does not apply.

3. If the sensor head test results in a "Pass" and the specific gravity test results in a reading between 9 and 13 you may proceed with section C – **High Pressure Fuel Pump Replacement and Fuel System Repair.**
