Emissions Recall – USA ONLY Code: 24CX

Subject	Inlet Air Box Housing Snow Flap Replacement & Oxygen Sensor Inspection/Replacement					
Release Date	June 01, 2017					
Affected Vehicles	U.S.A.: 2012-2014 MY Volkswagen Passat 2.0L TDI (GEN 2)					
	Check Campaigns/Actions screen in Elsa on the day of repair to verify that a VIN qualifies for repair under this action. Elsa is the <u>only</u> valid campaign inquiry & verification source.					
	 ✓ Campaign status must show "open." ✓ If Elsa shows other open action(s), inform your customer so that the work can also be completed the same time the vehicle is in the workshop for this campaign. 					
Problem Description	The snow flap in the inlet air box housing may remain partially to fully open. Should this occur, excess warm air could enter the air intake through the snow flap inlet.					
	The oxygen sensor will be checked during this service and, if measured degradation tolerances are met, the sensor will be replaced.

Subject: Emissions Recall 24CX - Inlet Air Box Housing Snow Flap Replacement & Oxygen Sensor Inspection/Replacement 2012-2014 Model Year Volkswagen Passat 2.0L TDI (GEN 2)

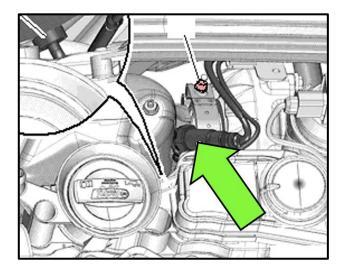
- Remove the engine cover.
- Disconnect electrical connector <arrow> for the heated oxygen sensor -G39-.
- Free up the wiring harness. •
- Loosen and remove the original heated oxygen sensor -G39- <arrow> from diesel particulate filter using the ring wrench 7-piece set -3337-.

- Install new heated oxygen sensor -G39- <arrow> ٠ (part number 03L 906 262 B) into diesel particulate filter using the ring wrench 7-piece set -3337- and torque to 50 Nm.
- Reconnect electrical connector and reinstall • engine cover.

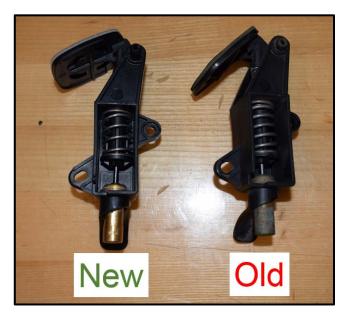
The new snow flap when at rest and at normal room temperature (70 F or 21 C) may appear to be extended in the closed position further than the old flap. This condition is normal.

- Install the new snow flap by pushing the flap in the direction of the arrow towards the closed position for easier installation.
- Install and tighten the two screws <1> to 1.6 Nm. •
