# Technical Bulletin

**87 17 06** September 20, 2017 **2048755**

**HVAC Recirculation Door Inoperative**

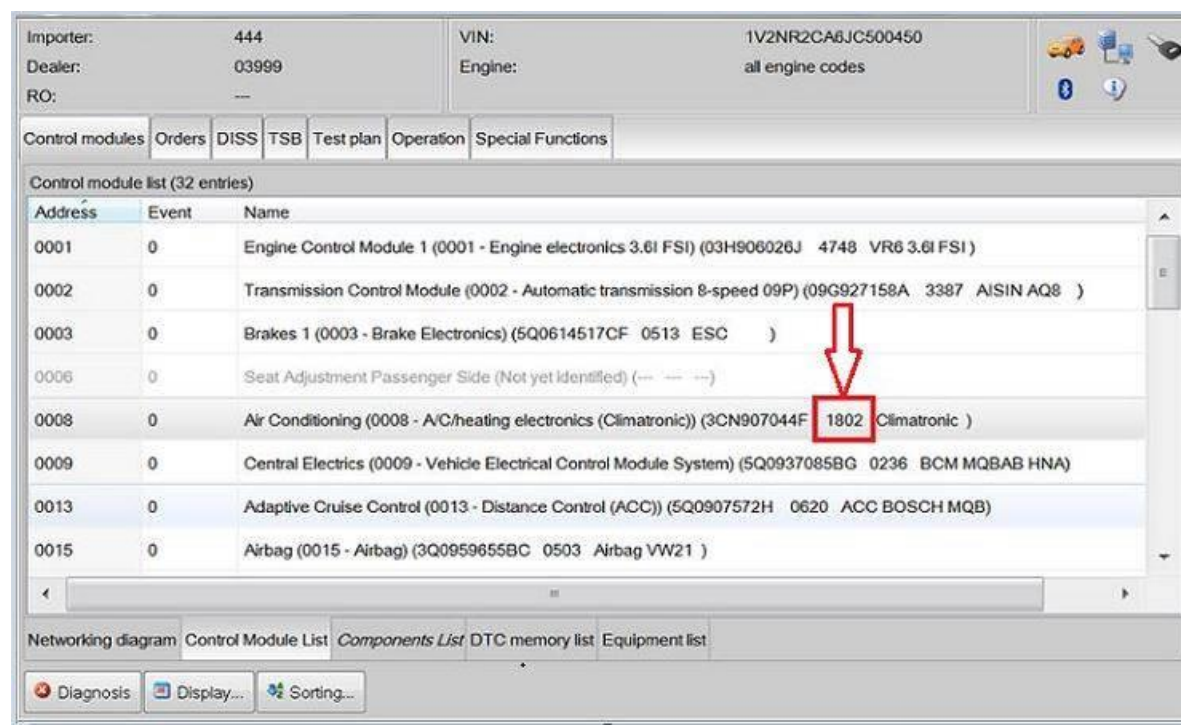
Figure 1

- Connect the Midtronics InCharge 940 (INC 940) or GRX3000VAS Tester/Charger or Volkswagen approved battery charger/maintainer to the vehicle's battery.
- Connect the VAS Diagnostic Tool.
- Using ODIS, check that the software level on Address 08 is 2002 (Figure 1).
