Technical Bulletin

97 17 01 June 7, 2017 2048106

Avoiding Contamination of the Oil Pressure Switches during Engine Repair

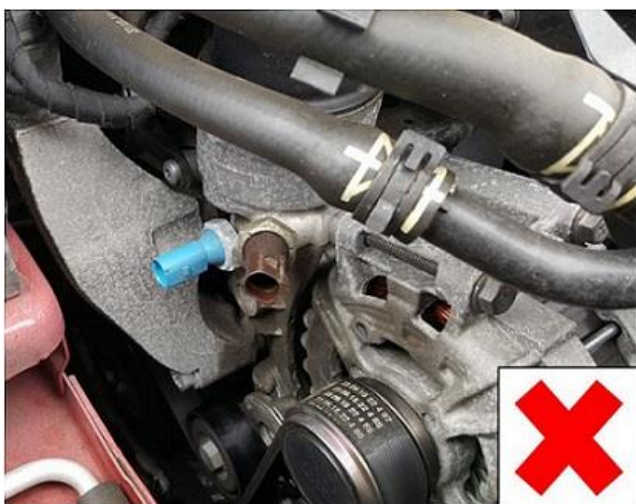
Figure 1. (Incorrect)

Oil pressure switches -F1- are not being protected during repairs, resulting in contamination and eventual failure of the oil pressure switches.

Damage caused by contamination is internal to the oil pressure switches and cannot be seen leading to future oil pressure switch failure.

To prevent contamination from entering the oil pressure switch body and causing internal damage, ensure the switch body is covered during any repair procedure that requires the oil pressure switch connector to be disconnected. See below Figure 1. & 2.
