Technical Bulletin

24 17 09 September 25, 2017 2045138 Supersedes Technical Bulletin 24-17-08 (V241708) dated August 7, 2017 to update Top Tier Fuel Brochure part number and update literature ordering site address.

MIL ON DTCs P2004, P2014 and or P2015 Stored in ECM Fault Memory

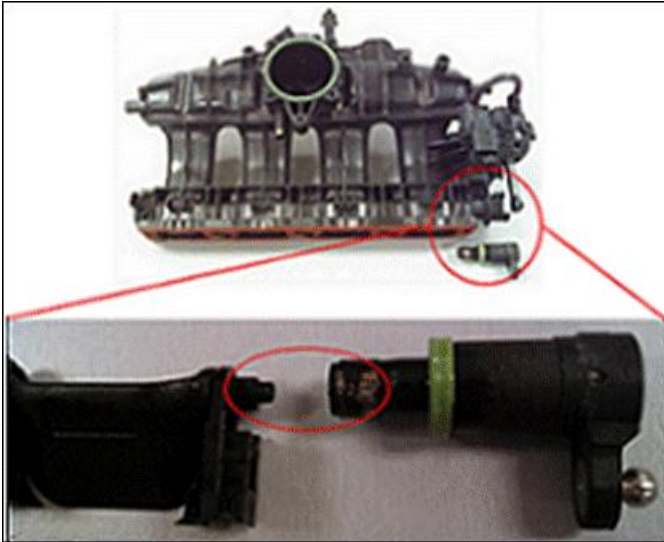
The intake manifold flap can separate internally and will not operate correctly with the regulator valve. See Figure 1. and Figure 2. for an example of a damaged flap disassembled.

If the carrier plate can be pulled out, the flap has separated and the intake manifold must be replaced. See Repair Group 24 Multiport Fuel Injection in Elsa.

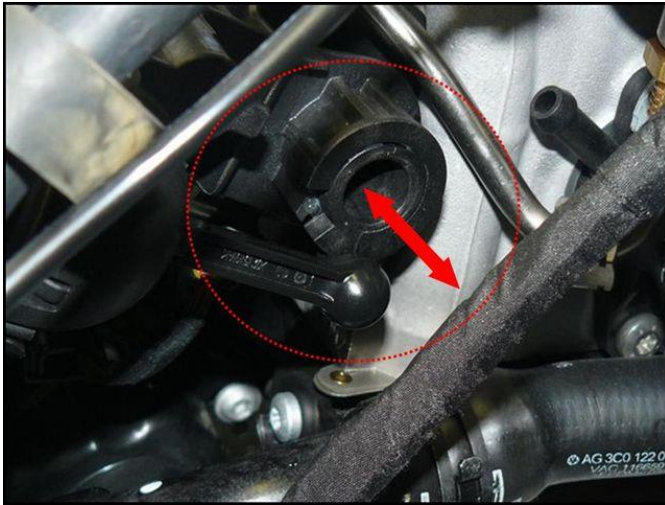
Figure 3.

- Remove the engine cover. See Repair Group 10 Engine Assembly in Elsa.
- Move the carrier plate by hand in an axial direction (Figure 3, red arrow) to check if the carrier plate can be pulled out.
