**Freightliner  
Service Bulletin**

# 46-41

## Adjusting Tilt Lock Force on TRW Steering Columns

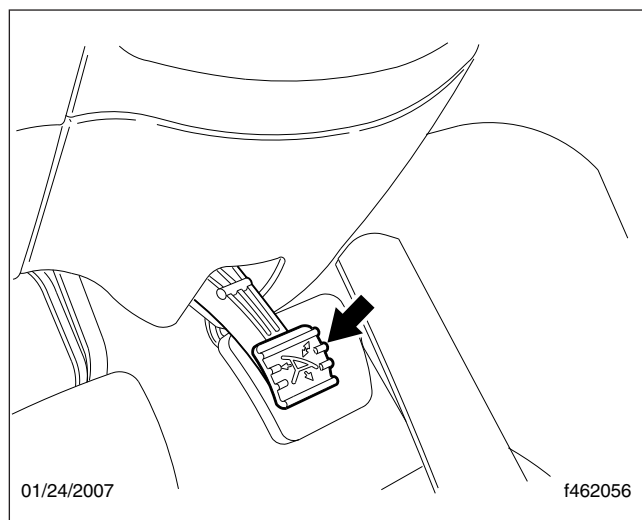
**Fig. 1, Foot Pedal on TRW Adjustable Steering Columns**

NOTE: TRW steering columns on truck models other than the New Cascadia have a tilt-adjust foot pedal (see **Fig. 1**). New Cascadia vehicles have TRW steering columns with a tilt-adjust hand lever.

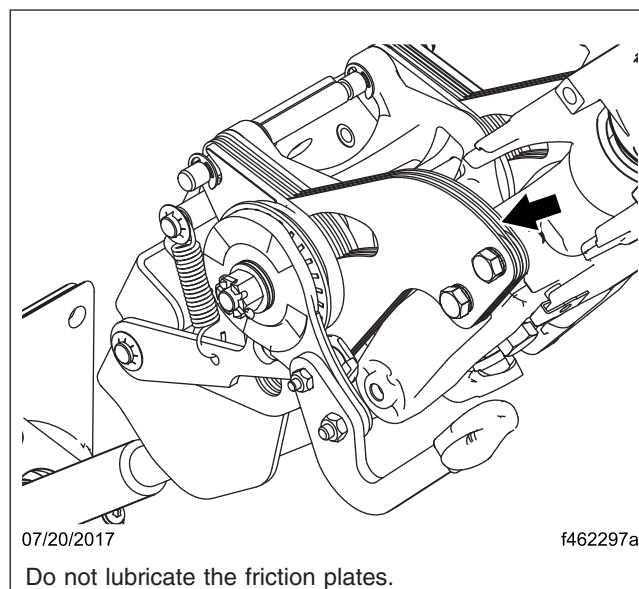
**Fig. 2, Friction Plates (New Cascadia steering column shown)**

**Do not lubricate the steering column friction plates (see **Fig. 2**). Lubrication of the plates may result in improper function of the column lock system and damage to the column.**
