## Service Information Bulletin

| SUBJECT | DATE |
|---|---|
| Diagnostics | July 2017 |

## 4 SPN 521730/FMI 5

TCM Driver GrS\_G2 - Failed Open

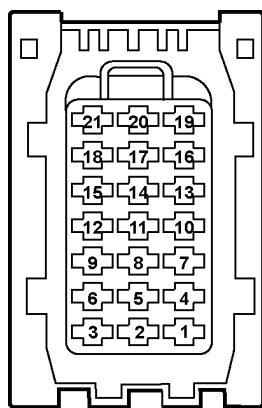
45801

1. Was the Transmission Control Module (TCM) just replaced?
  - a. Yes; remove TCM and inspect all X3 connector mating pins for damage. If damage is found, replace component as necessary. **DO NOT ATTEMPT TO STRAIGHTEN PINS.**
  - b. No; Go to step 2.
2. Disconnect the TCM X1 21-pin connector.
3. Turn the ignition ON (key ON, engine OFF).

4. Measure the voltage between pins 1, 2, 3, 4, and 6 of the TCM X1 21-pin connector (ignition/battery voltage) and ground. Is voltage less than 11.5 volts?
  - a. Yes; restore voltage to pins 1, 2, 3, 4, and 6 of the TCM X1 21-pin connector.
  - b. No; Go to step 5.
5. Turn the ignition OFF.
6. Measure the resistance between pins 16, 19, 20, 21 of the TCM X1 21-pin connector and the negative battery post. Is resistance greater than three ohms?
  - a. Yes; restore battery ground to pins 16, 19, 20 and 21 of the TCM X1 21-pin connector.
  - b. No; Go to step 7.
7. Are any AMT Solenoid faults (SPNs 521736 through 521752 FMI any) also present (active or inactive)?
  - a. Yes; replace the TCM and the Automated Manual Transmission (AMT) shift control unit. Clear faults after repair.
  - b. No; replace the TCM. Clear faults after repair.
