Coolant / Vacuum / Temperature fault codes - Check Engine Light with DTCs P003313, P0299FA, P0299FB, P226100, P261F71, P012800, and P012809

Topic number	LI07.09-N-063338
Version	8
Design group	07.09 Vacuum system
Date	07-11-2017
Validity	OM651
Reason for change	Software numbers for updated guided tests
Reason for block

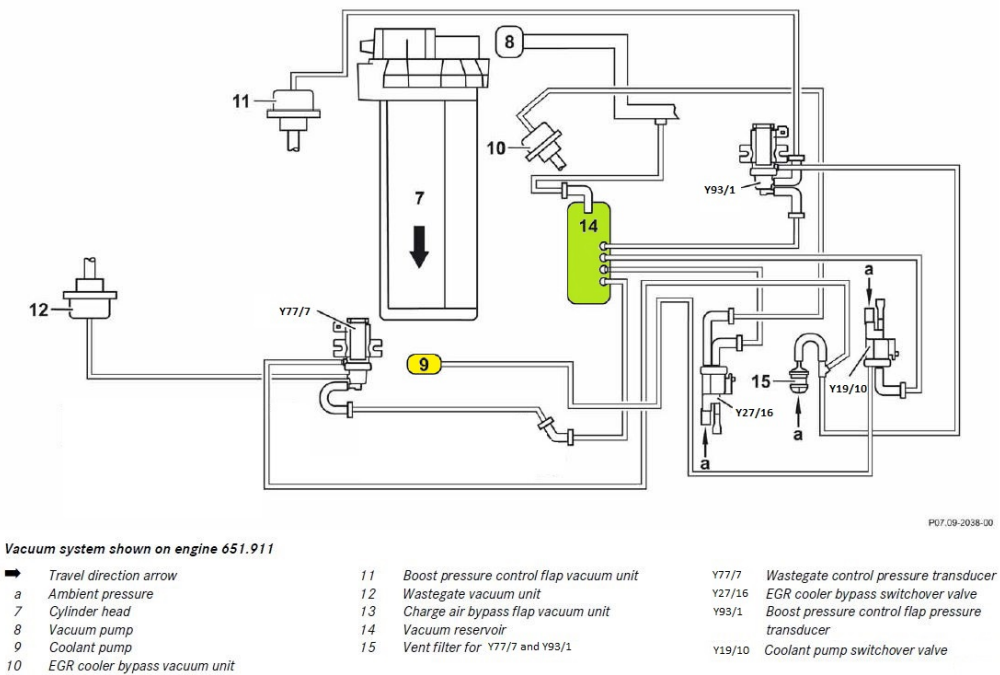
Sprinter OM651 vaccum
diagram.jpg:

-Yellow color --> part #9 --> connection point behind the coolant pump bracket

-Green color --> part #14 --> vacuum reservoir

1- Inspect the vacuum system for loose connections or cracked hoses (See Vacuum Diagram)

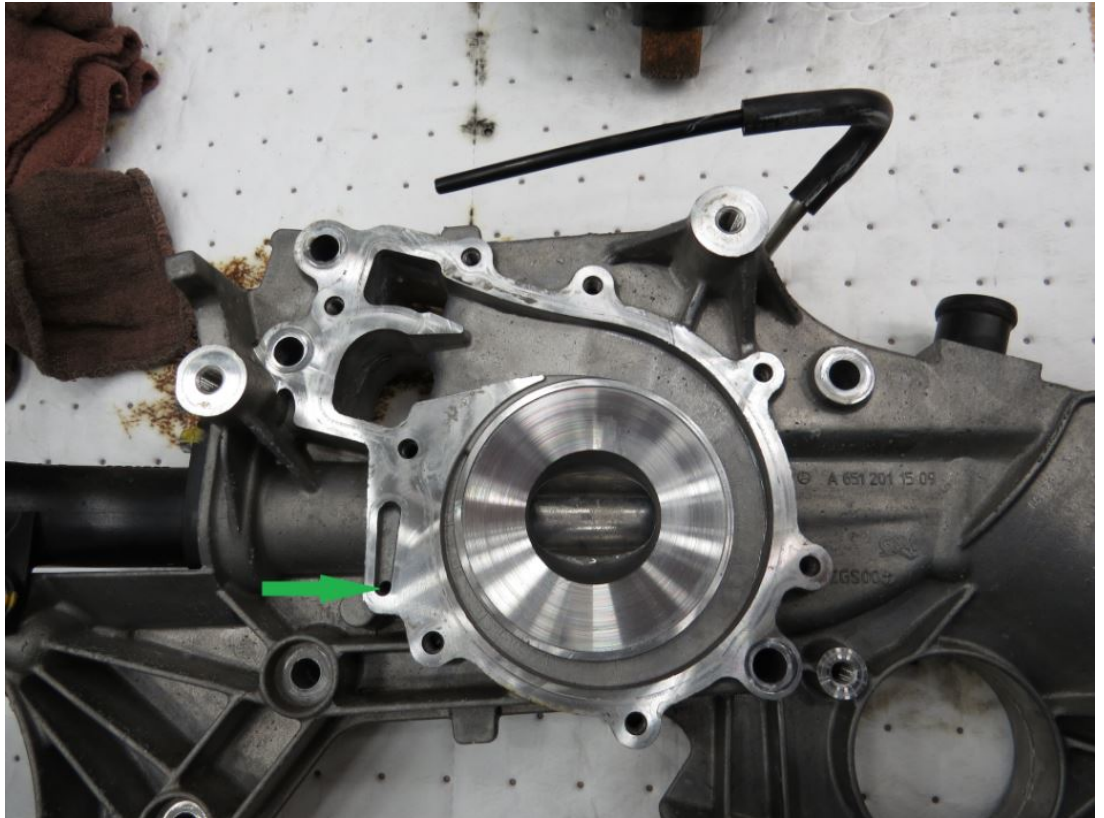
Mounting Plate.JPG:

-Water pump mounting plate

2- Smoke test or pressurize the system to detect a leak especially in the following known areas

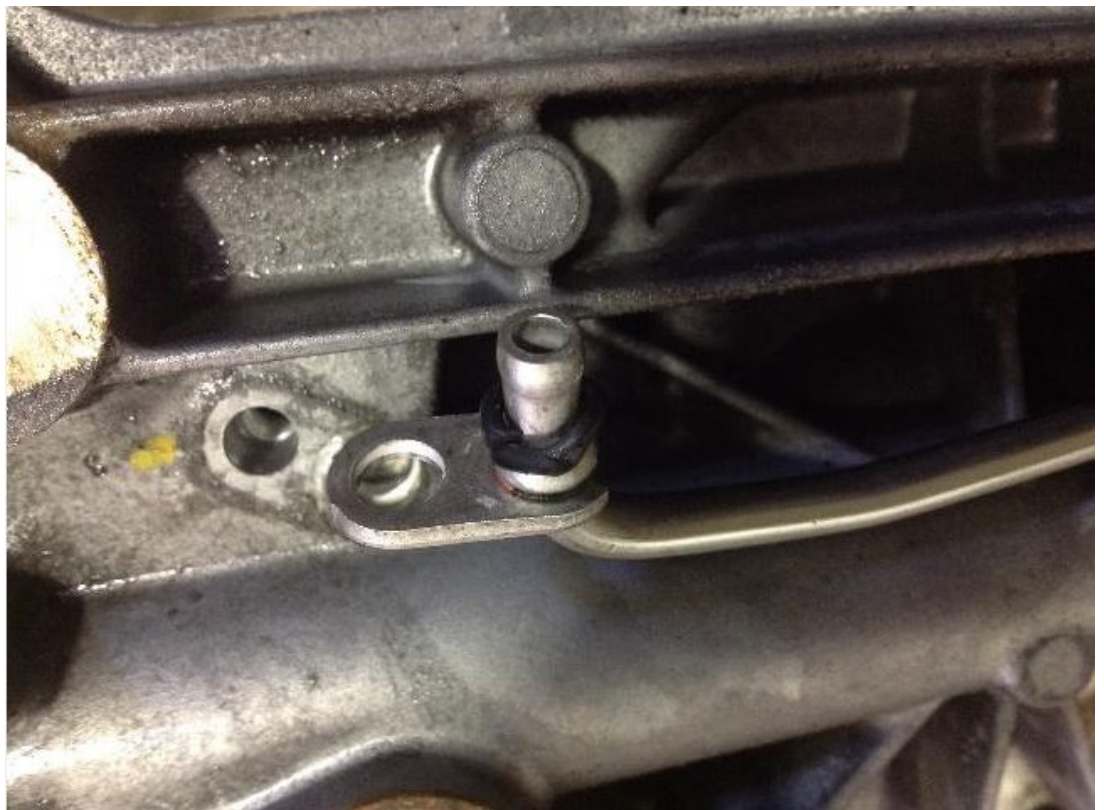
Vacuum connection on mounting plate.JPG:

-Vacuum connection on water pump mounting plate

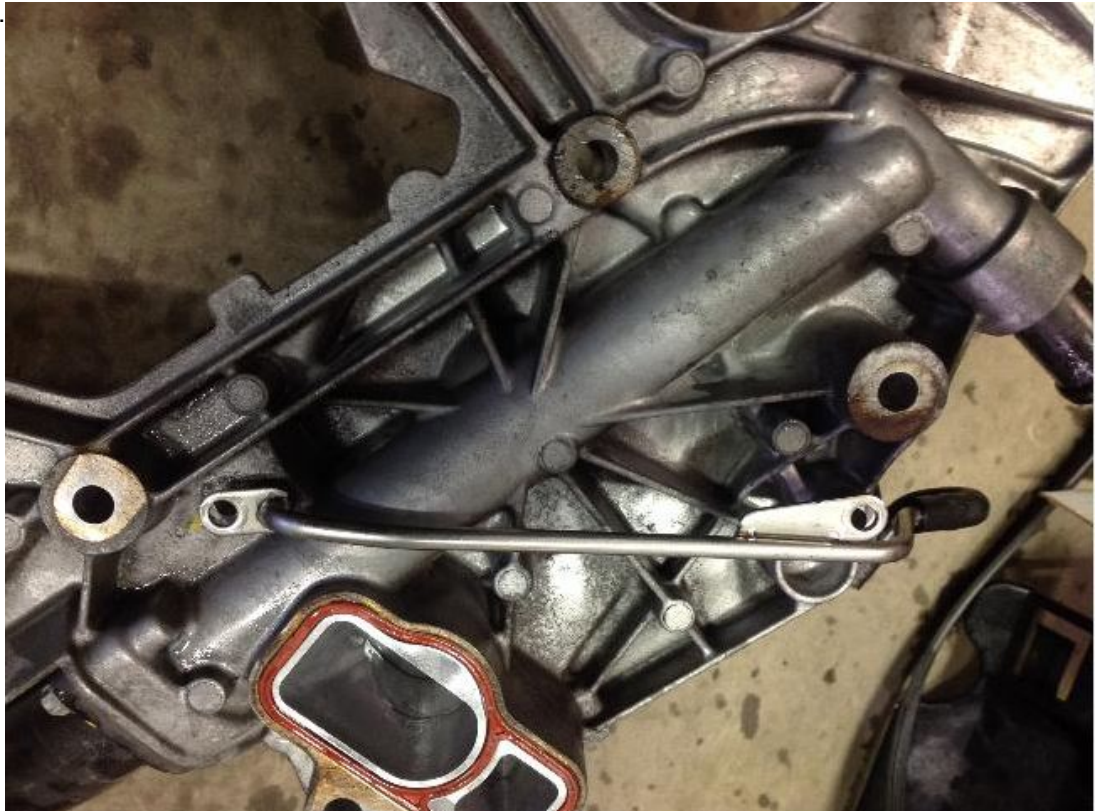
Water pump vacuum line.
JPG:

-Water pump vacuum line

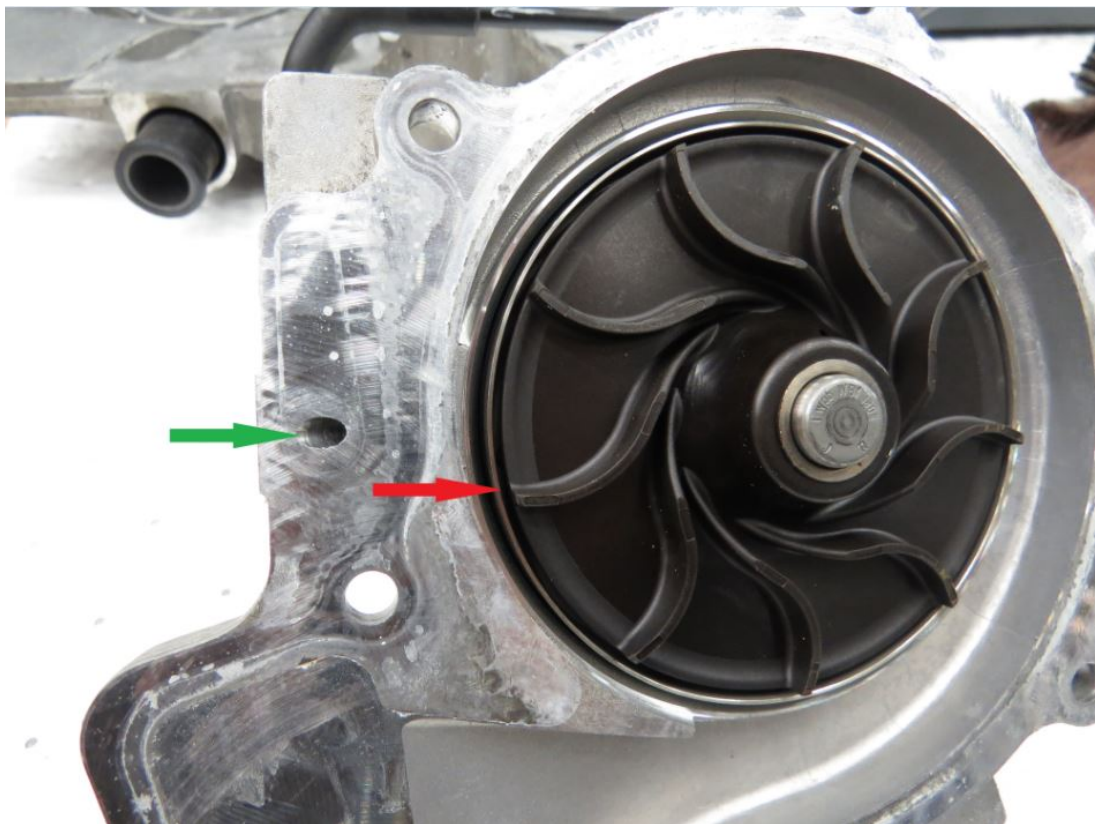
Water Pump.JPG:

-Water pump

5 - If coolant is found in the vacuum system replace the water pump, vacuum reservoir, change-over valve and clean the vacuum lines.

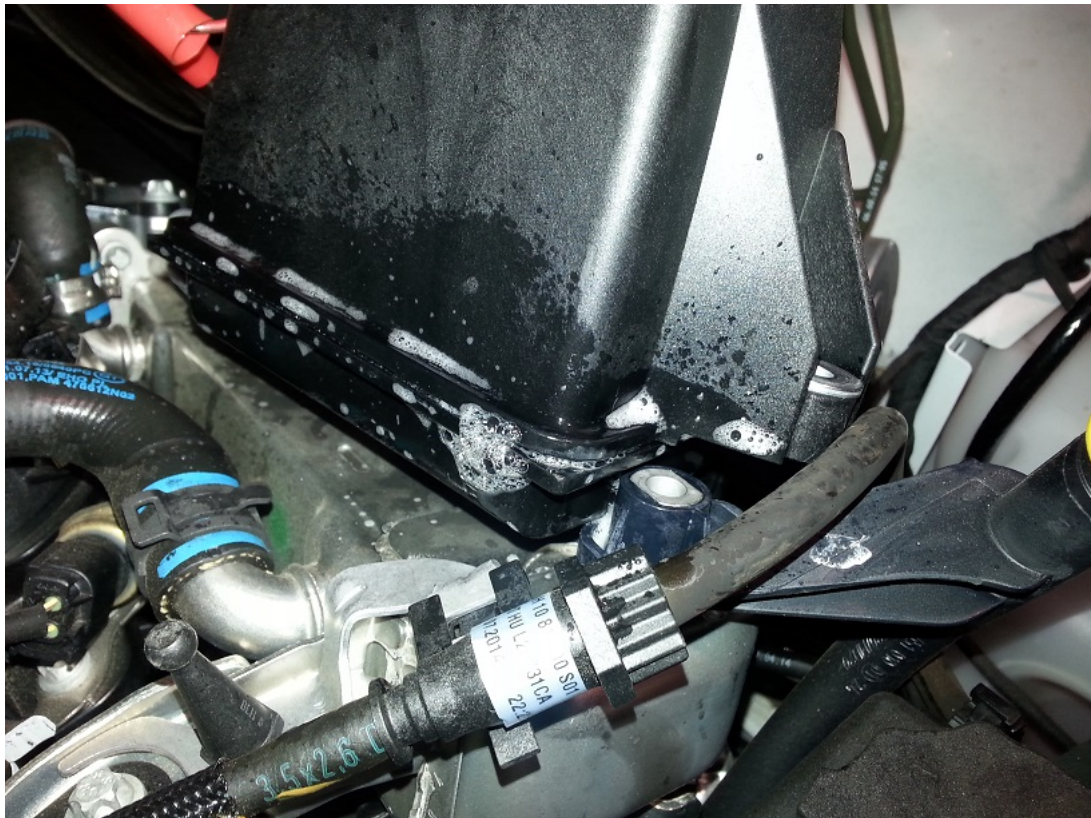
Leaking vaccum manifold.jpg:

-Vacuum manifold / Vacuum reservoir

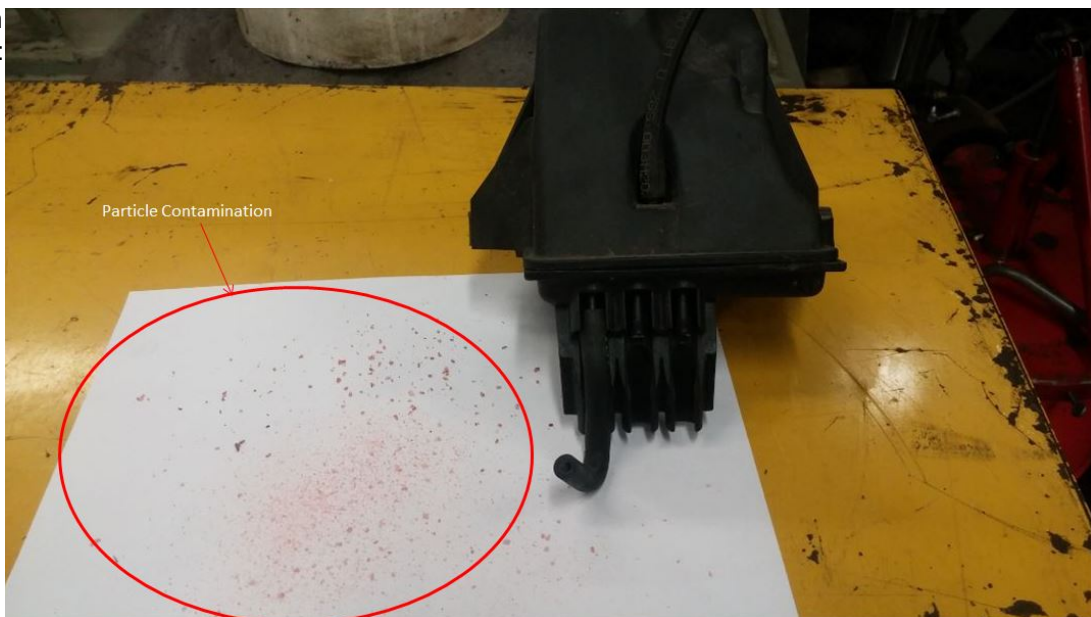
Particulate contamination of vacuum reservoir.JPG:

- Particulate matter

The vacuum reservoir is a sealed unit. Pictures attached show internal contamination of the vacuum reservoirs. The vacuum reservoirs were cut open for informational purposes only. DO NOT cut open the vacuum reservoir.

3- Remove vacuum hoses from vacuum reservoir and look for the following

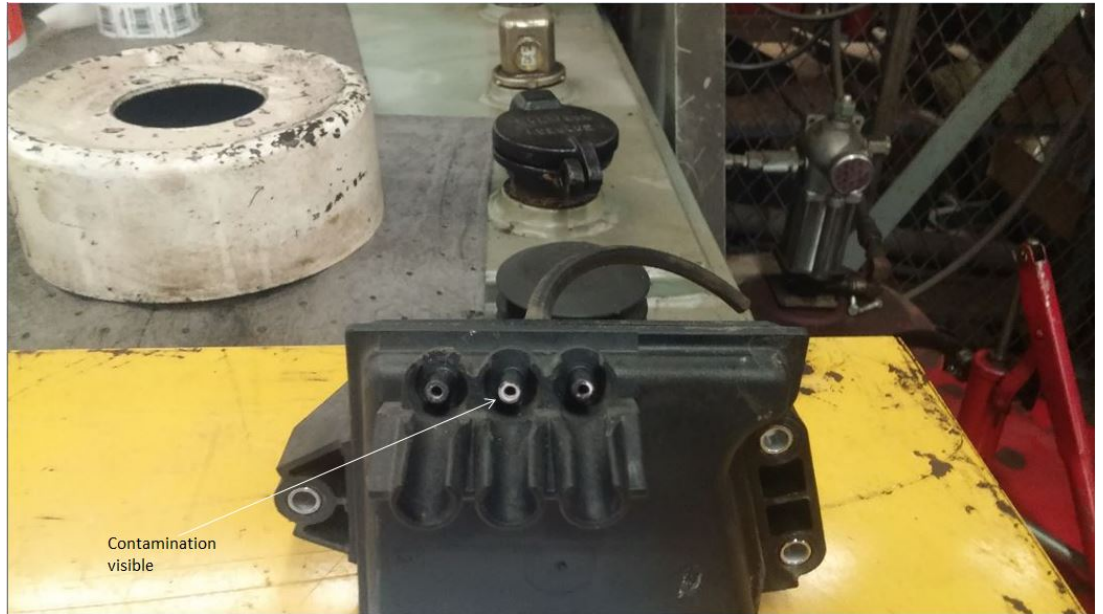
Vacuum reservoir contaminated output ports.jpg:

- Contamination of the inside of the vacuum connection

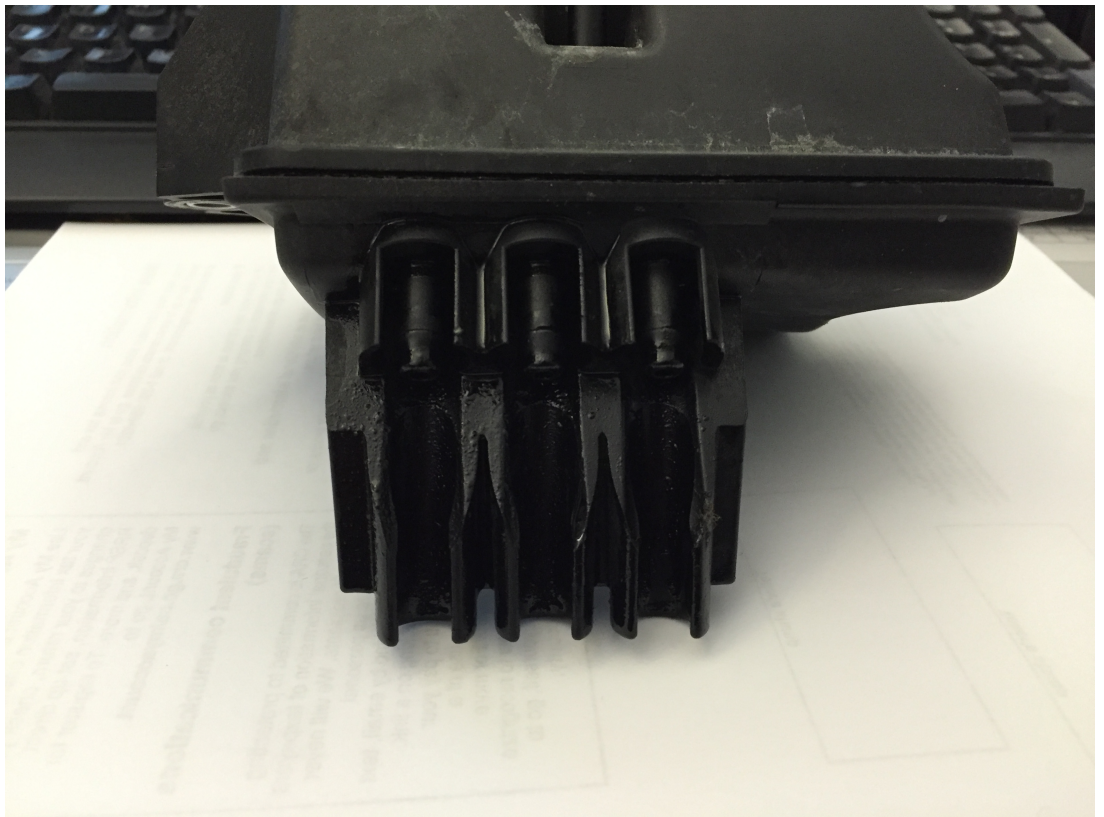
Liquid contamination vacuum reservoir.jpg:

- Any signs of coolant and / or oil on the inside of vacuum connections on the vacuum reservoir

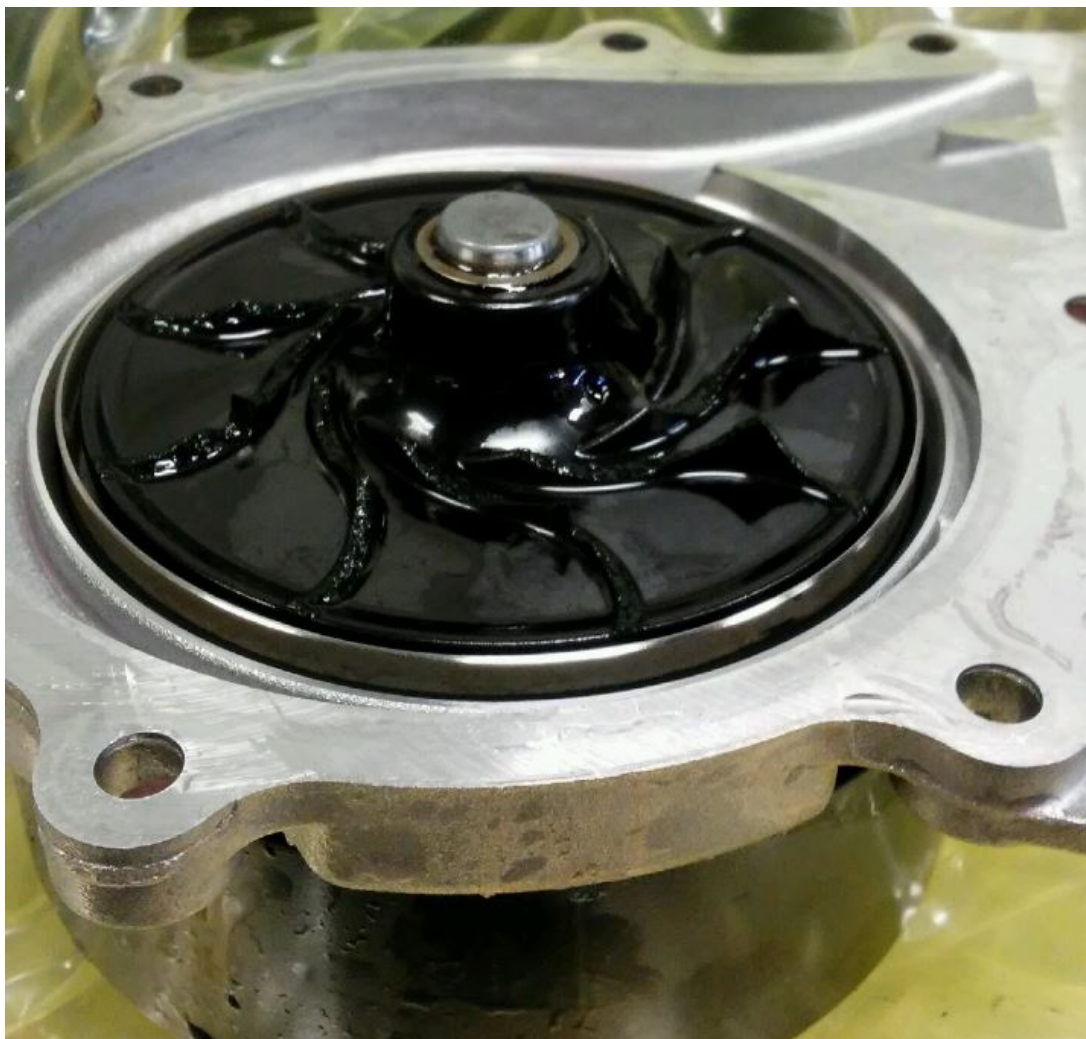
water pump impeller.
JPG:

- 1- Vacuum Leak
- 2- Damaged O-Ring
- 3- Contamination: Coolant or Oil
- 4- Damaged water pump impeller

7 - Remove and inspect water pump impeller for damage, replace as needed.
