Coolant / Vacuum / Temperature fault codes - Check Engine Light with DTCs P003313, P0299FA, P0299FB, P226100, P261F71, P012800, and P012809

Topic number	LI07.09-N-063338
Version	9
Design group	07.09 Vacuum system
Date	07-18-2017
Validity	OM651
Reason for change	Added additional vacuum tank information
Reason for block

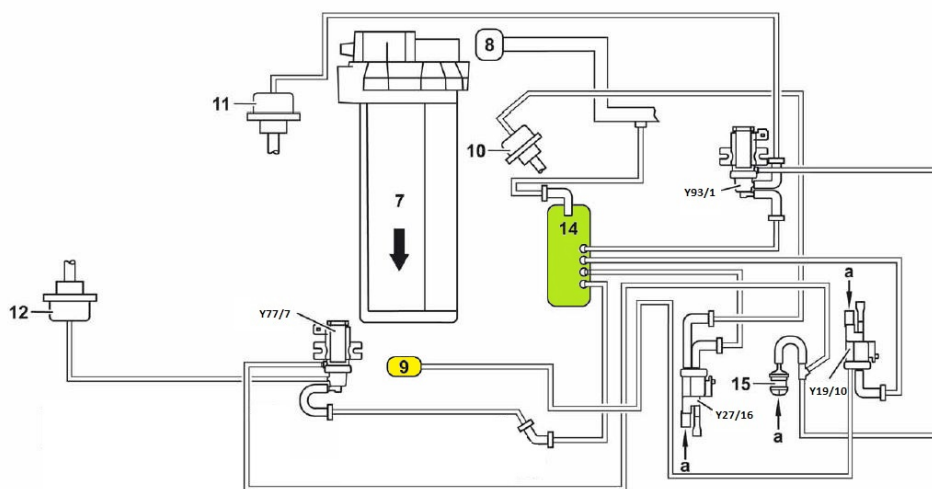
Sprinter OM651 vacuum diagram.jpg:

-Yellow color -> part #9 --> connection point behind the coolant pump bracket

-Green color --> part #14 --> vacuum reservoir

1- Inspect the vacuum system for loose connections or cracked hoses (See Vacuum Diagram)

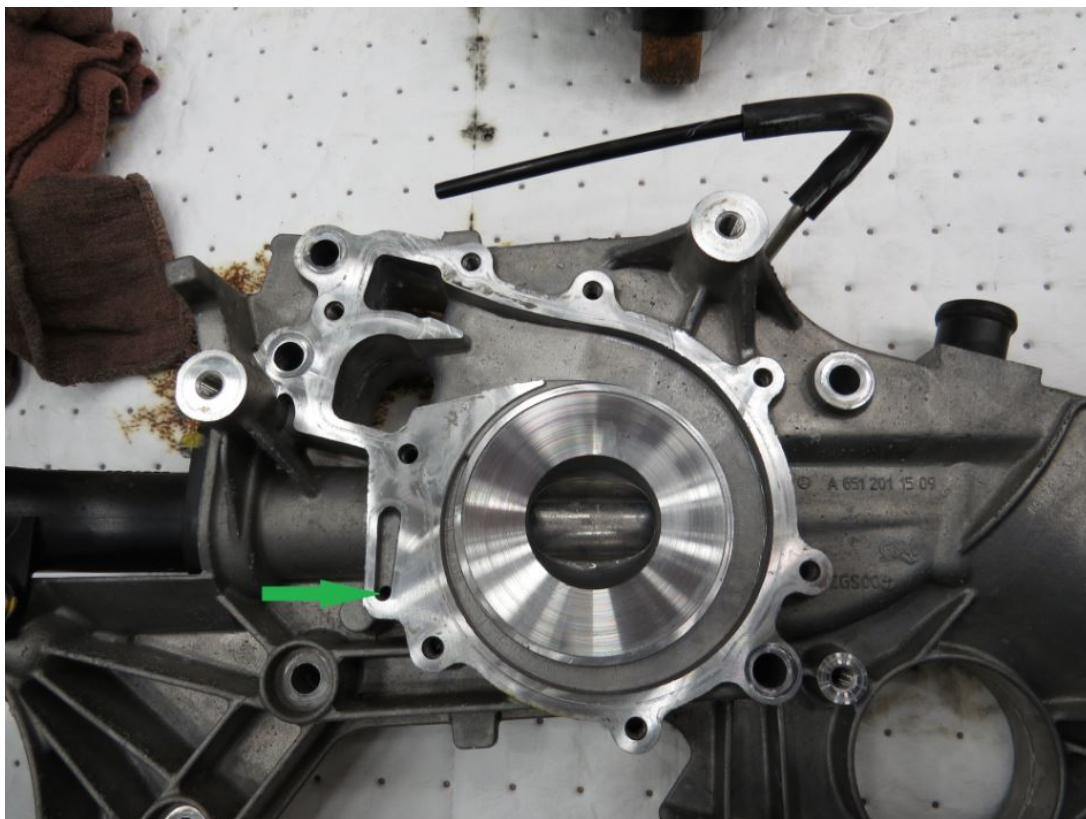
Mounting Plate.JPG:

-Water pump mounting plate

2- Smoke test or pressurize the system to detect a leak especially in the following known areas

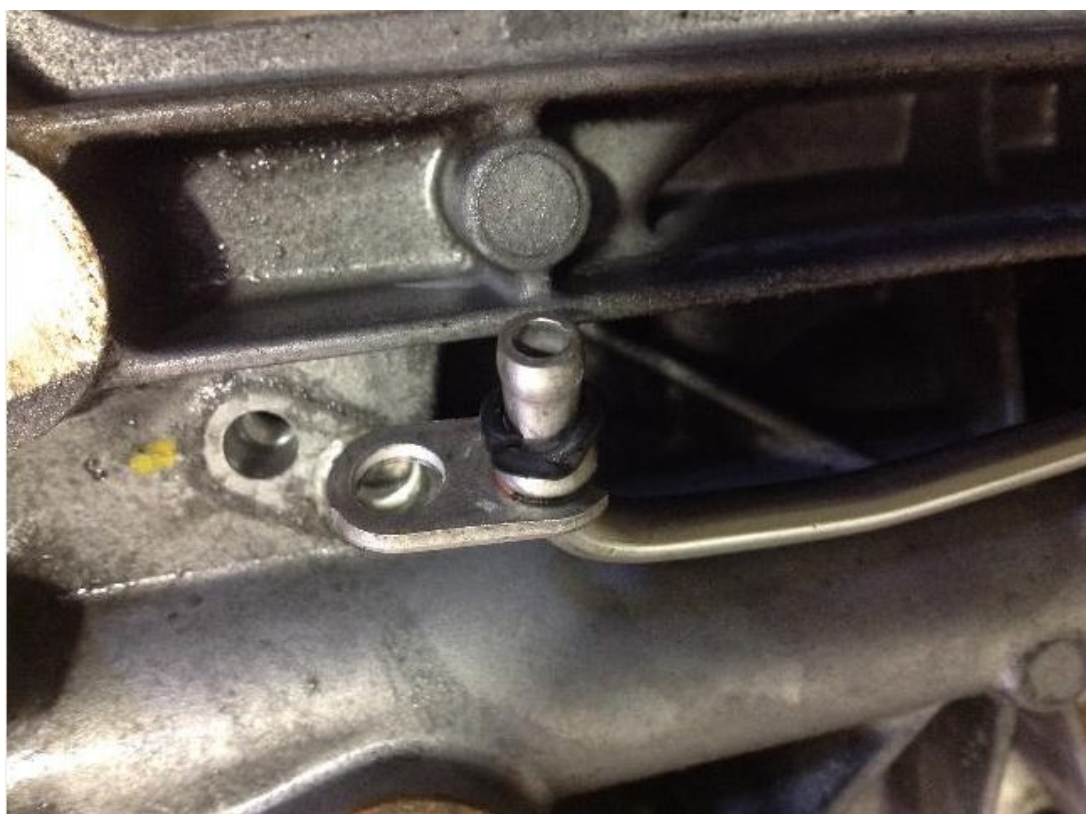
Vacuum connection on mounting plate.JPG:

-Vacuum connection on water pump mounting plate

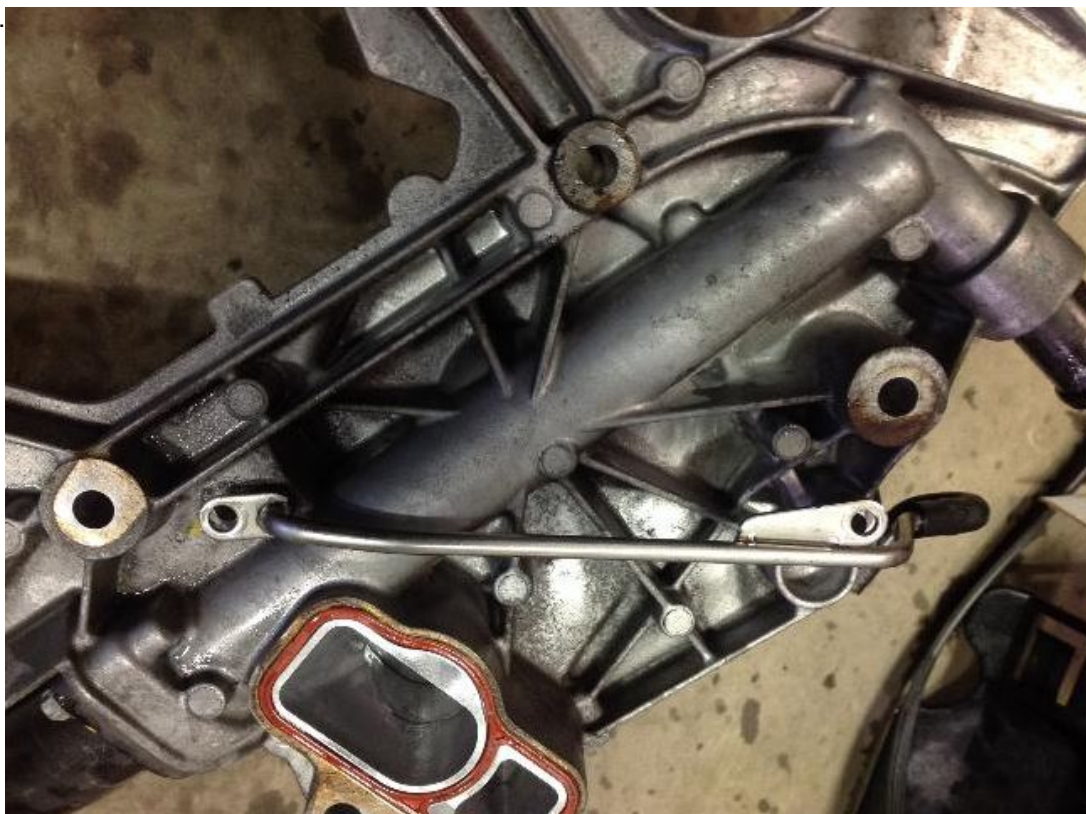
Water pump vacuum line.
JPG:

-Water pump vacuum line

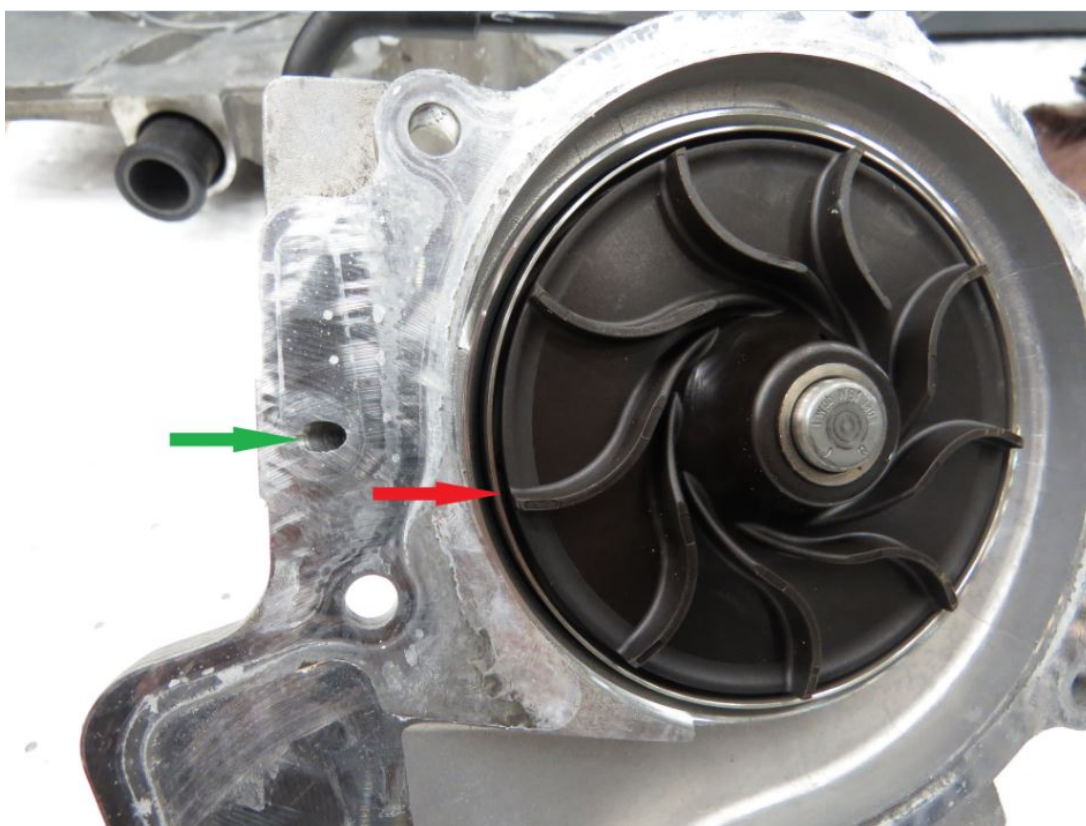
Water Pump.JPG:

-Water pump

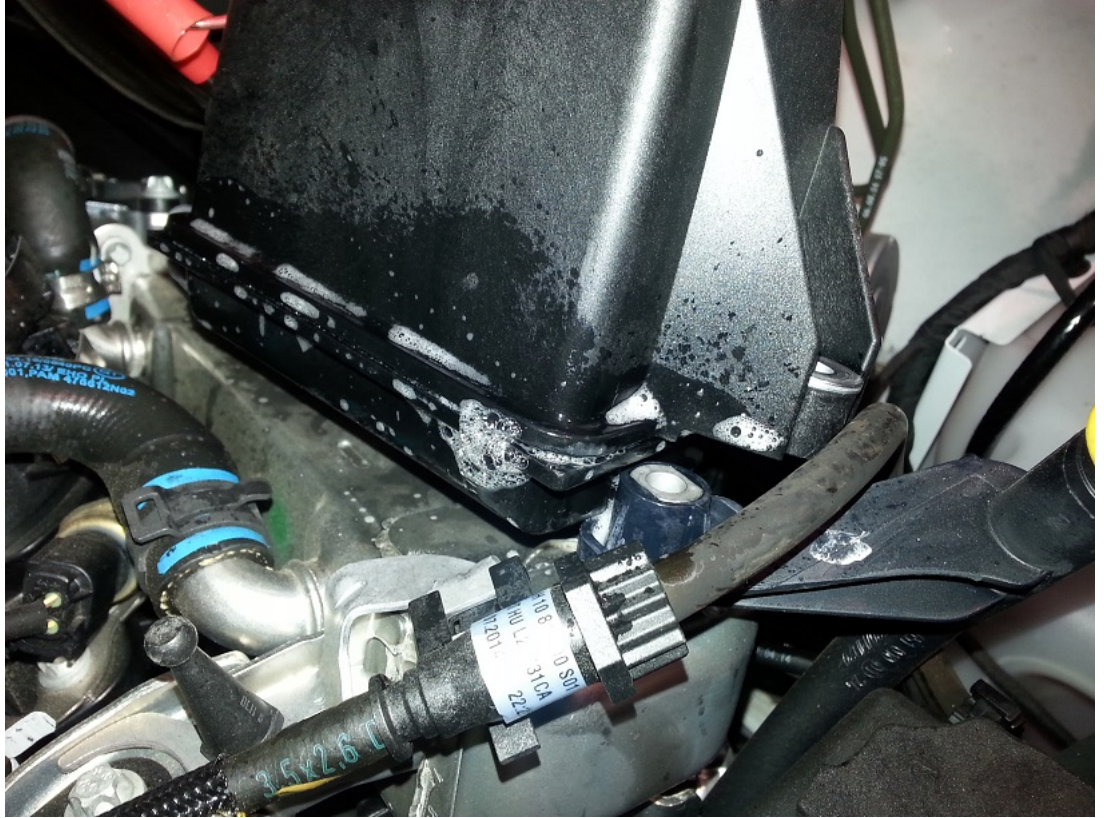
Leaking vaccum manifold.jpg:

-Vacuum manifold / Vacuum reservoir

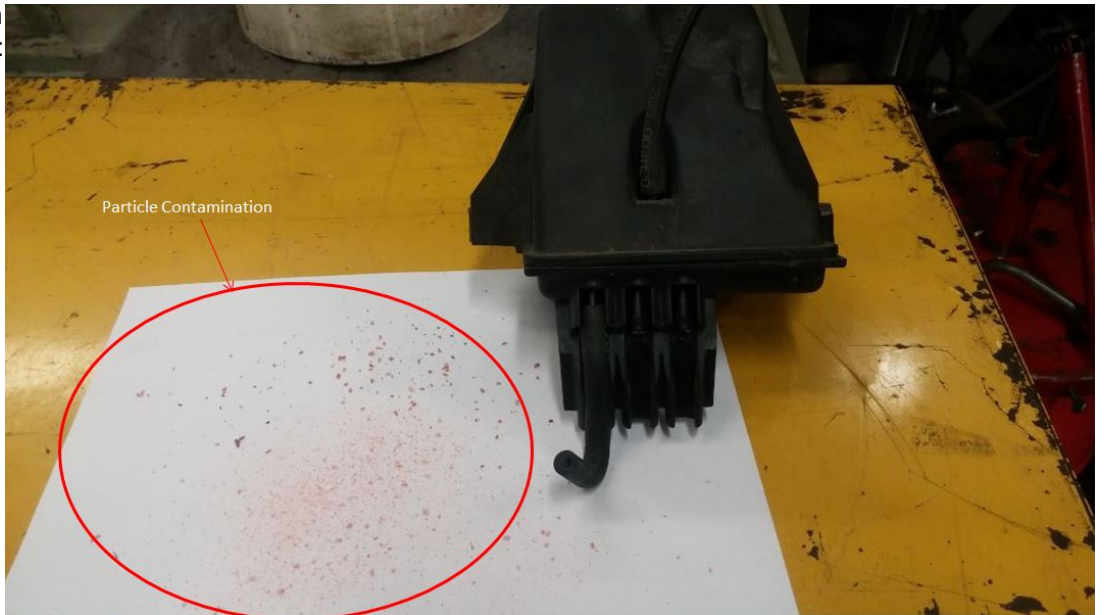
Particulate contamination of vacuum reservoir.JPG:

- Particulate matter

The vacuum reservoir is a sealed unit. Pictures attached show internal contamination of the vacuum reservoirs. The vacuum reservoirs were cut open for informational purposes only. DO NOT cut open the vacuum reservoir.

3- Remove vacuum hoses from vacuum reservoir and look for the following

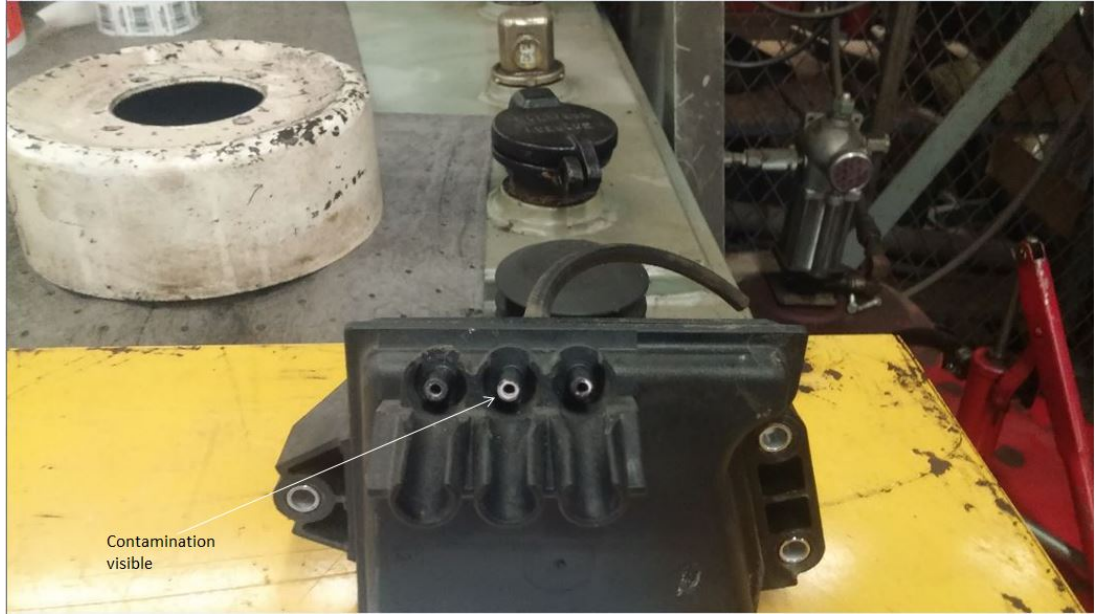
Vacuum reservoir contaminated output ports.jpg:

- Contamination of the inside of the vacuum connection

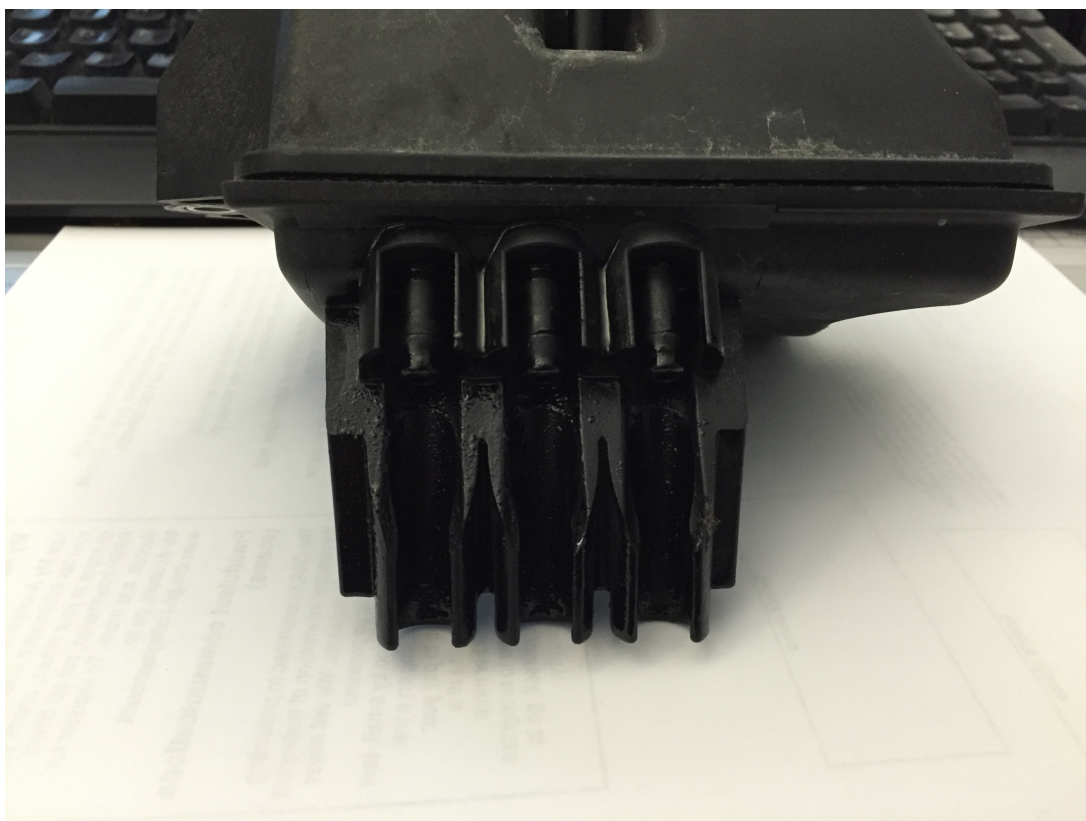
Liquid contamination vacuum reservoir.jpg:

- Any signs of coolant and / or oil on the inside of vacuum connections on the vacuum reservoir

5 - If coolant is found in the vacuum system replace the water pump, vacuum reservoir, change-over valve and clean the vacuum lines.

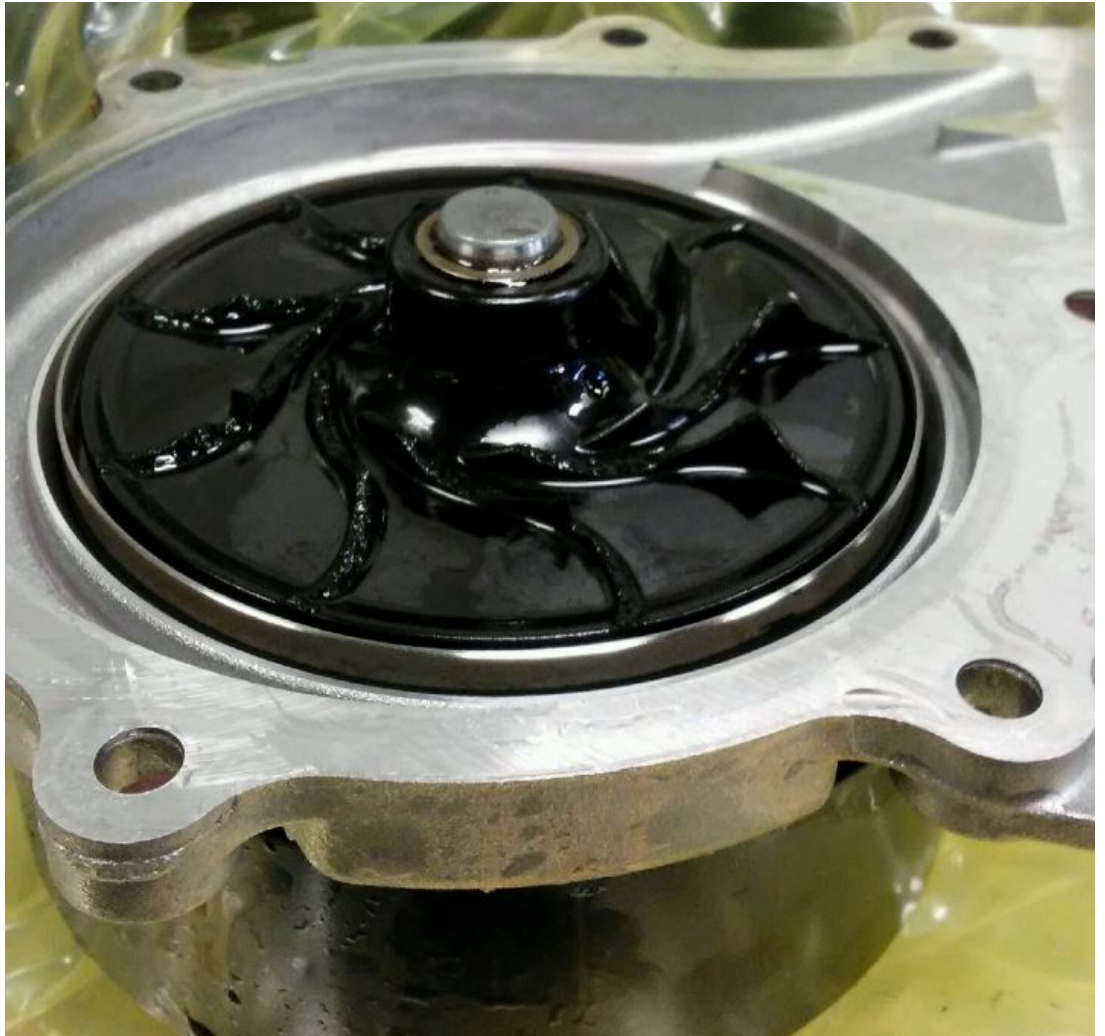
water pump impeller.
JPG:

water pump impeller.JPG	Damaged water pump impeller
Dashpot.JPG	Additional vacuum tank with oil contamination

7 - Remove and inspect water pump impeller for damage, replace as needed.
