Gap forms in seat cushion cover at side panel

Topic number	LI91.18-P-066760
Version	1
Design group	91.18 Seat covers
Date	07-18-2017
Validity	213.064, 213.088, 213.089, 213.264, 213.288, 213.289
Reason for change	
Reason for block

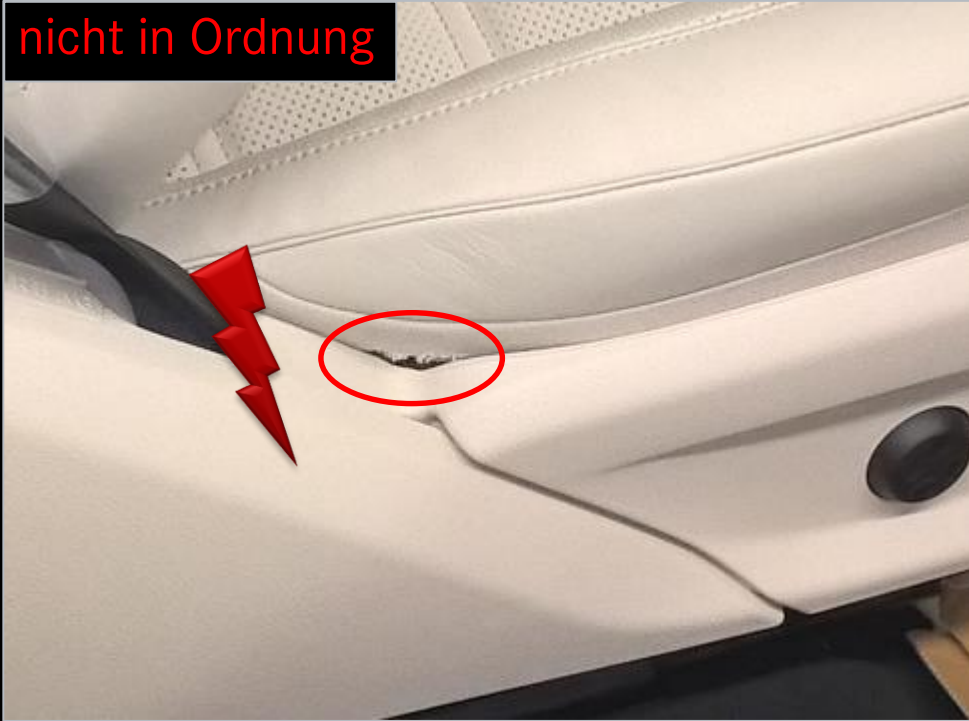
-> Clearly visible hole and/or fraying -> cover not OK (see instructions, page 1)

nicht in Ordnung

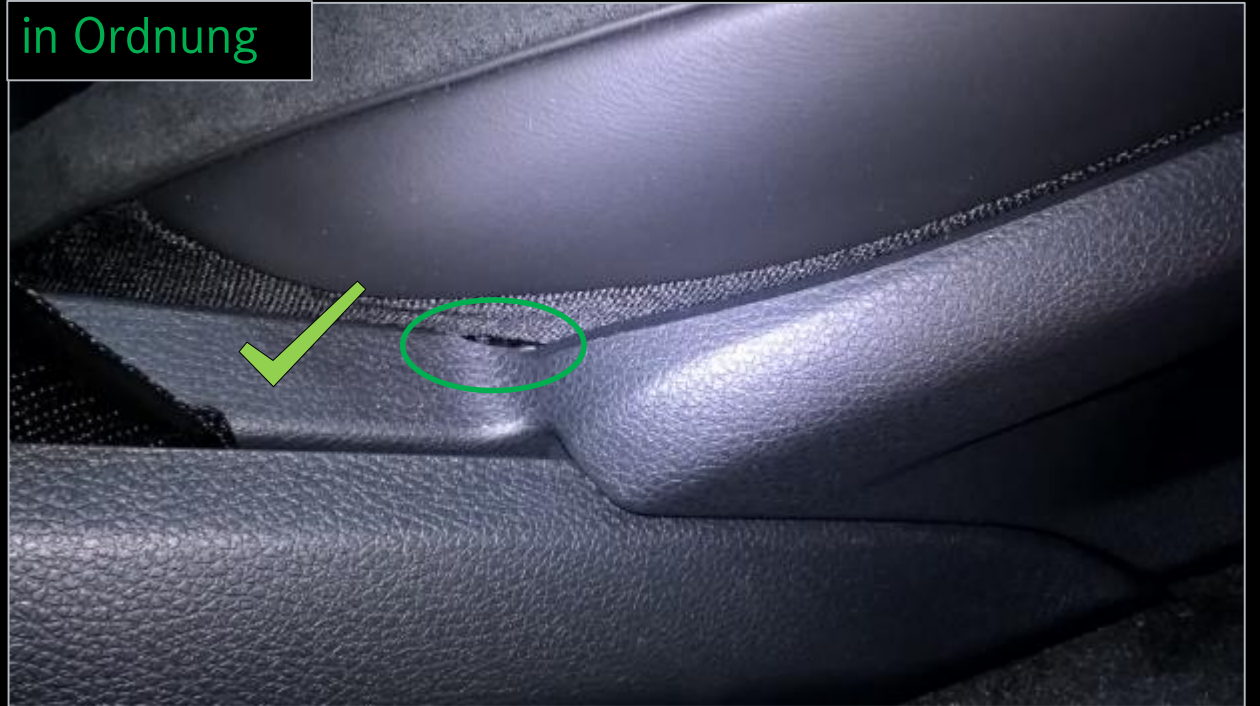
-> Narrow gap without fraying -> cover OK (see instructions, page 1)

in Ordnung
