## Wind noises on soft top as from approx. 50-75mph

| Topic number | LI77.30-P-066811 |
| Design group | 77.30 Vario roof, soft top - complete |

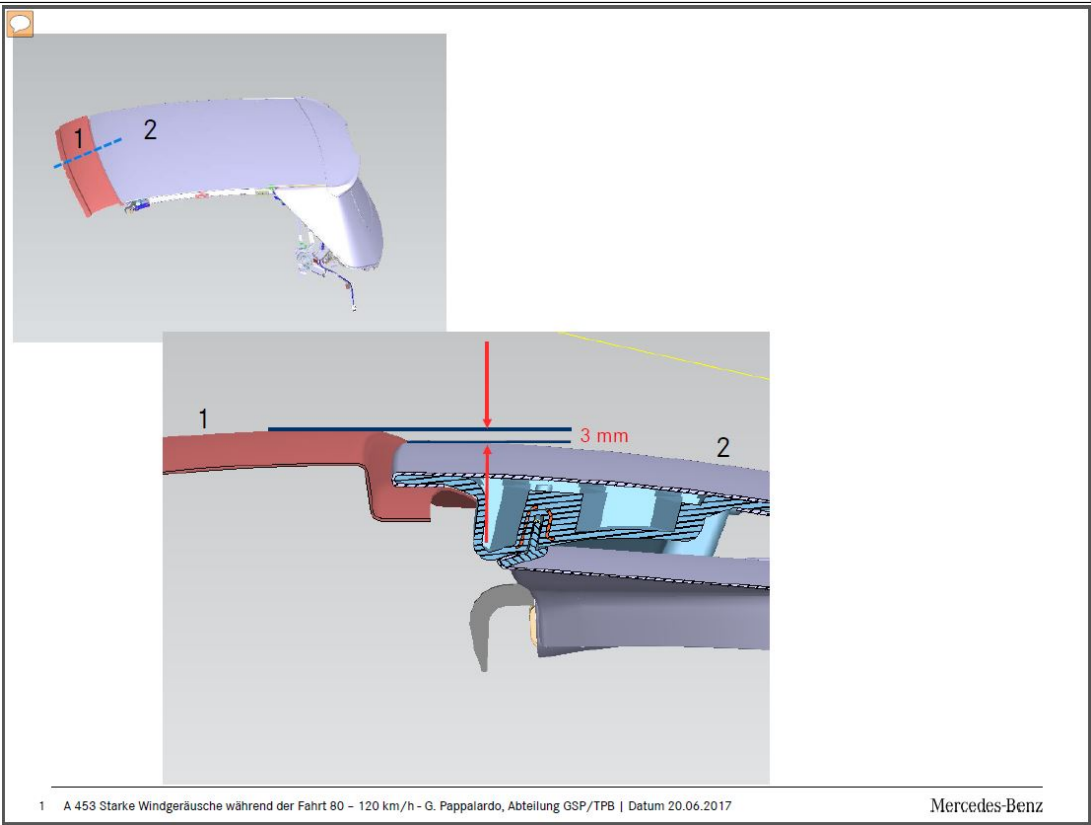
A453 Geräusche wäh-  
rend der Fahrt 50\_  
750mph 20\_06\_2017\_  
Bild.JPG:

Strong wind noises in front area of soft top when driving as from approx. 50-75mph

Adjustment of soft top transition to roof frame

1. Positioning the soft top supports on the A-pillar at the left and right, adjusts the gap of the soft top (2) to the roof frame (1).

The adjustment dimension / gap in the center of the soft top must be set to approx. 3 mm.

Set soft top in accordance with specification:

2. Tension soft top as specified, if necessary retension.

3. Perform a test drive.
