## Pop-up roof: Glass roof jams or cannot be opened, drive unit makes rattling noises

| Topic number | LI77.21-P-063617 |
| Function group | 77.21 Panoramic roof |

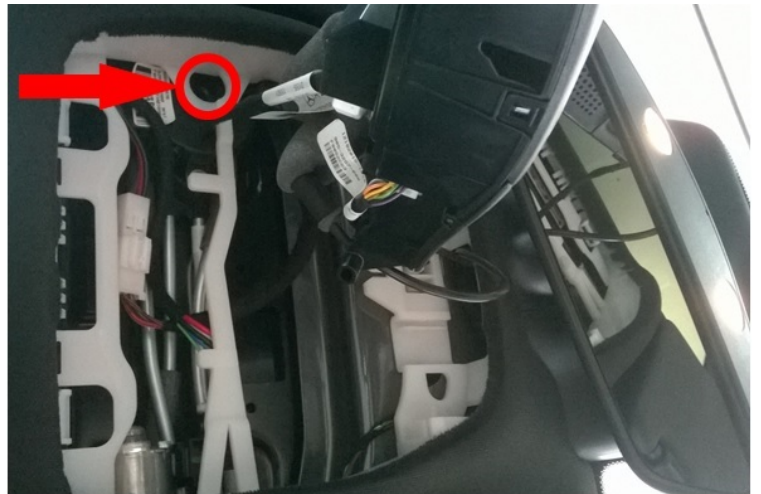
Notbetätigung ASD-Glasdach.jpg:

| Notbetätigung ASD-Glasdach.jpg | Emergency operation of pop-up glass roof at drive unit |

Unplug connectors of both drive motors, use a suitable tool to operate the emergency override of the drive unit (Figure 1, shown on the X253; on other models it may be necessary to lower the headliner) and open the glass roof far enough to allow access to the bolts of the glass roof. When doing this, have a second person push the glass roof upwards and backwards while supporting it at the front and rear.
