Whistling or Squeaking Noise in Engine Compartment From Drive Belt Area

Topic number	LI01.20-P-066784
Version	1
Design group	01.20 Crankcase ventilation, cylinder head cover
Date	07-20-2017
Validity	All vehicles with M133
Reason for change	
Reason for block

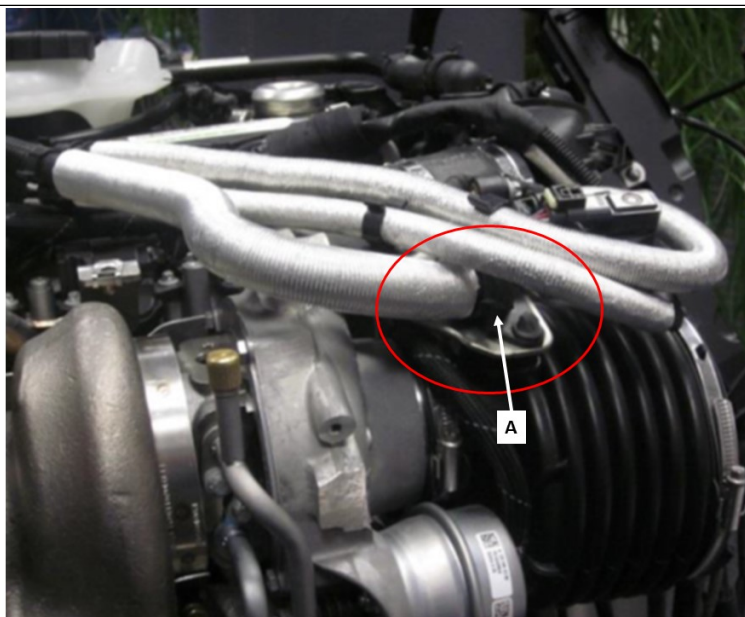
Abbildung_1.JPG:

- Detach full-load bleed line (A) at top (figure 1)
- Check whether a vacuum is produced at the connection during engine operation / idle and whether the noise changes when the connection is closed (by hand) => no vacuum / no change in noise => line probably clogged
- Engine OFF, apply pressure to cylinder crankcase (via dipstick), max. 0.1 bar and check whether the full-load bleed line is open / clear, i.e. whether oil is discharged
- Detach vent line (B) from connection of cylinder crankcase (figure 2)
- Detach full-load ventilation from oil separator (C) (EU variant) and close off line (figure 3)
- Apply pressure to full-load bleed line (position of adapter plate connection upstream of compressor) and check whether vent line is clear. => not clear => replace full-load bleed line (EU variant), replace oil separator, full-load and partial-load bleed line (US variant)

2. Check crankcase ventilation system for clogging; replace if necessary
