TO: Mercedes-Benz Dealer Principals, General Managers, Sales Managers, Service Managers, Parts Managers	FROM: Thomas Brunner, Department Manager, Vehicle Compliance and Analysis, Engineering Services
RE: Service Campaign 2016090006 Model 204 (C-Class) MY 2008 - 2009 Replace Driver-side and Passenger-side Airbag	DATE: January 6, 2017

Campaign No. 2016090006, **January** 2016

SUBJECT: **Model 204**
Model Years 2008 and 2009
Replace Driver-Side and Front Passenger Air Bag

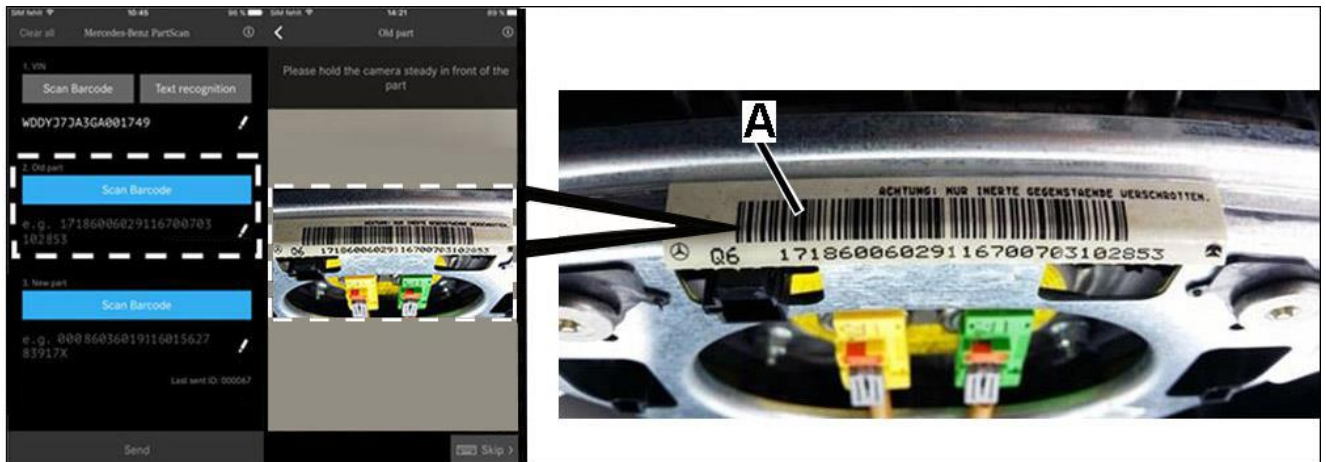
Figure 3 (Shown on model 203)

- Scan airbag bar code (A, Figure 3) from "old" airbag immediately after removing it from steering wheel by pressing "Scan Barcode" button (Figure 3).

- Ensure that smart phone is held parallel to bar code label (A, Figure 3) when scanning airbag bar code.
- It must be ensured that the lower barcode is scanned.
- The airbag part number can also be entered manually if required.
- This step can be omitted **ONLY** if bar code is incomplete, illegible, or missing.

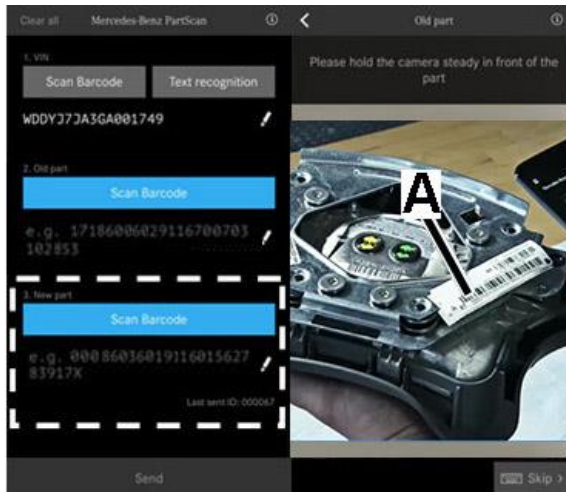
Figure 4 (Shown on model 203)

- Ensure that smart phone is held parallel to bar code label (A, Figure, 4) when scanning airbag bar codes. The part number label that needs to be scanned starts with: 000 860 36 01 9116.
- It must be ensured that the lower barcode (A, Figure 4) is scanned.
- The airbag part number can also be entered manually if required.

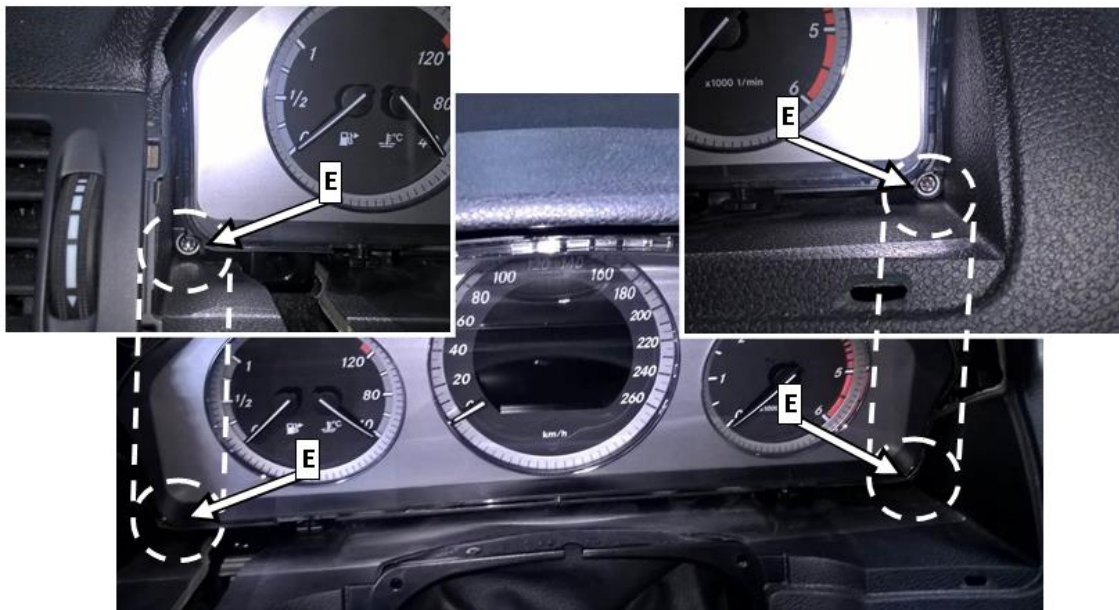
Figure 9

- These screws (E) are simultaneously fastening screws for the instrument panel.
- The upper two screws do not need to be loosened.

4. Remove the two bottom instrument cluster mounting screws (E, Figure 9).

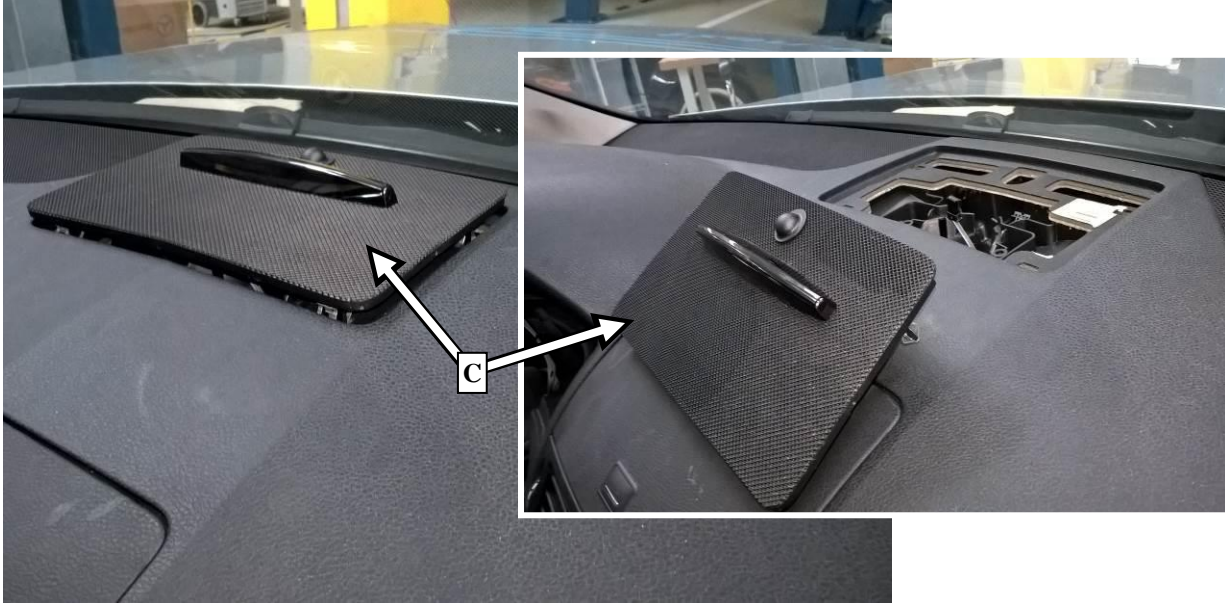
Figure 12

If equipped with sound system, also remove speaker under cover (C).

8. Unclip cover (C, Figure 12) on top of instrument panel and remove.

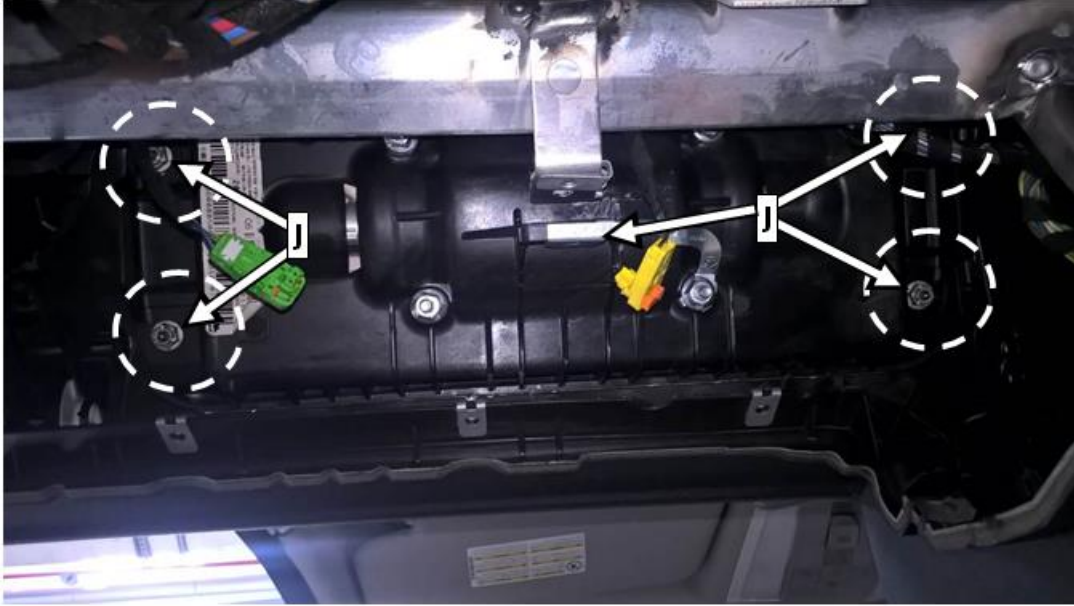
Figure 15

- Be sure to install new airbag mounting nuts (J, Figure 15) when installing “new” airbag to instrument panel.
- Torque airbag mounting nuts (J) to: **Nm** 5 Nm when installing “new” airbag to instrument panel.

13. Remove front passenger airbag mounting nuts (J, Figure 15).

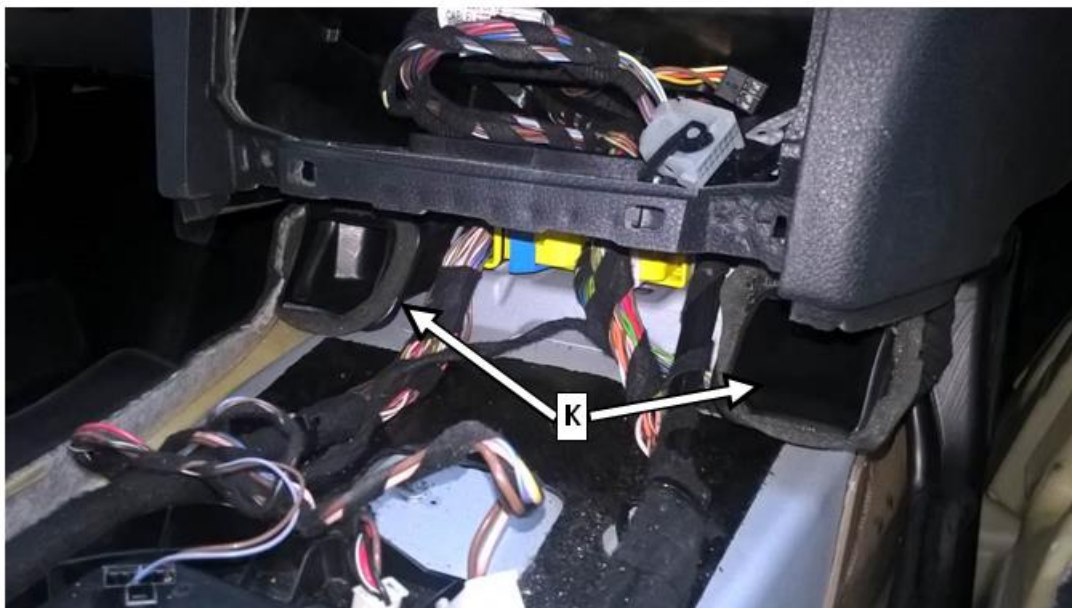
Figure 18

The air guide ducts are pulled out when the instrument panel is raised.

18. Place instrument panel back into position and install air guide ducts (K, Figure 18), ensuring position is correct
