## Detachment of surface material on instrument panel in BR 231

| Topic number | LI68.10-P-067111 |
| Validity | Model series 231 |

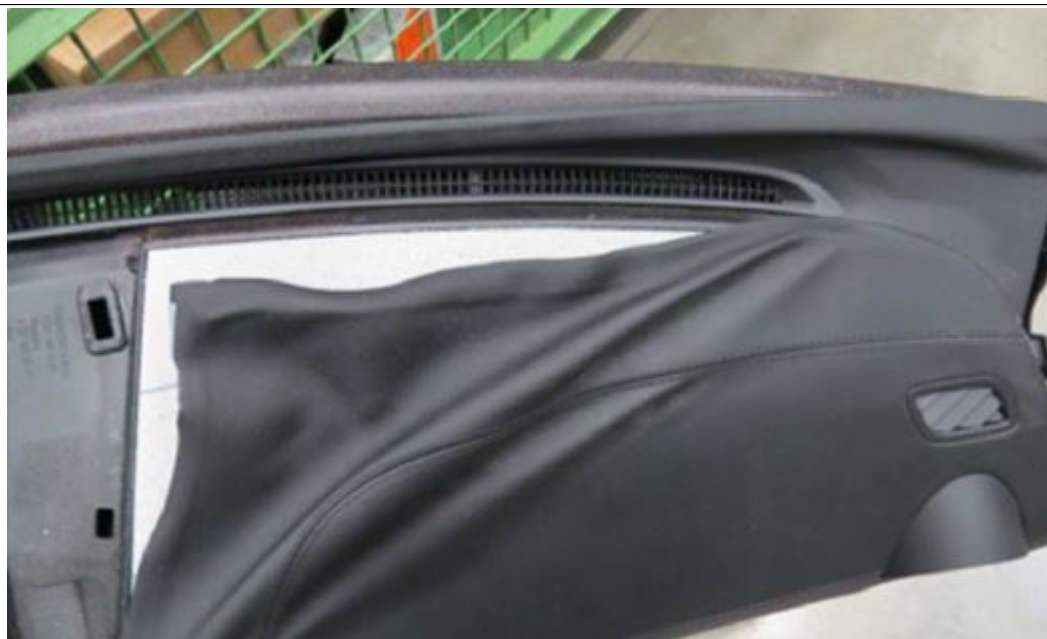
Delamination an der I-Tafel.jpg:

| Attachments | |
|---|---|
| Delamination an der I-Tafel.jpg | Surface damage on instrument panel |

Detachment of the surface material on the instrument panel in the central area of the windshield.

IMPORTANT: Please ask the customer about the precise usage behavior in which the complaint occurred:

Please take informative/ detailed photographs of the damage profile.

When these questions have been answered via PTSS, please wait for further instructions.
