Fault message "AIRMATIC" or "Active Curve System" in instrument cluster

Topic number	LI32.34-P-056198
Version	6
Function group	32.34 Anti roll governor (WR)
Date	10-18-2017
Validity	MODEL 166 with CODE 468 (Active Curve System) MODEL 292 with CODE 468 (Active Curve System)
Reason for change	CP updated.
Reason for block

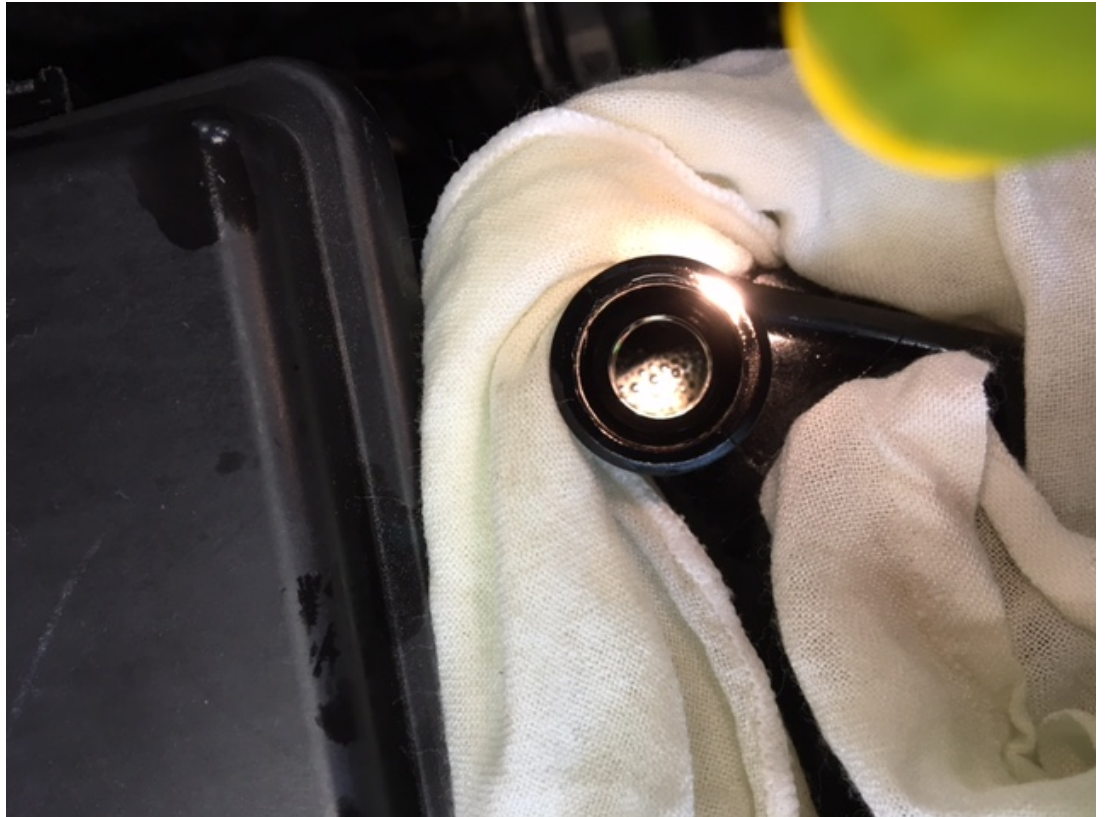
foam.JPG:

- Re. 1. Monitoring of pressures in ACS is too sensitive.
- Re. 2. Mechanical fault of rotation direction valve in valve block at front axle.
- Re. 3. Oil level too low, air in system.

Note: Excessive foaming can cause the system to draw in air bubbles.

- Re. 1. Perform XENTRY update: Flash software A166 902 5904 in ACS control unit.
- Re. 2. Check production date of valve block at front axle.
- Production date prior to 24.06.2017 - Replace valve block, see picture 1.
- Production date as of 24.06.2017 - Please create a PTSS case.
- Re. 3. Bleed hydraulic system with XENTRY (to be found in the roll control unit under the heading "Actuations").
- These instructions must be strictly observed:
- Check hydraulic fluid fill level and correct if necessary
 - If foam forms in the reservoir during the bleeding process (picture 2), the bleeding routine must be interrupted until the foam has dissipated.
- When only air bubbles can be seen in the oil (picture 3), the bleeding routine can be continued.
