Wind or airflow noises in area of doors

Topic number	LI72.10-P-062500
Version	9
Function group	72.10 Front door
Date	10-20-2017
Validity	MODEL 205.0/1/2; 253
Reason for change	Part numbers for MODEL 205.0/1/2 updated.
Reason for block

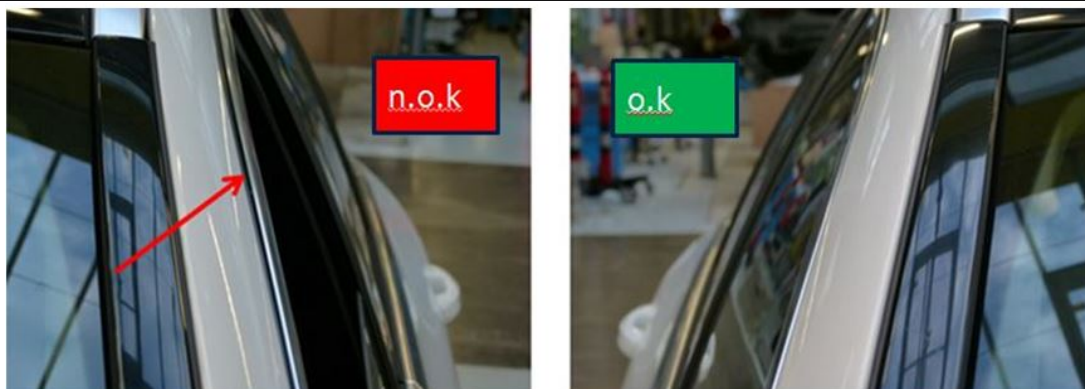
Bild 1.JPG:

1. Check door adjustment. Also check the transition from the doors to the A-pillar, see Figure 1, and correct if necessary by adjusting the doors in the y-direction.
2. Check outside mirror cover for parallelism and correct seating, see Figure 2, and adjust if necessary.
3. Check rib on mirror triangle seal for kinks as per arrows, see Figure 3, and replace if necessary.
4. Cut insulation to a length of 30 mm and attach to waistline trim strip at front on left and right according to the circles, see Figure 3 and Figure 4.
5. Perform a test drive. If the noise level is unchanged, continue with step 6.

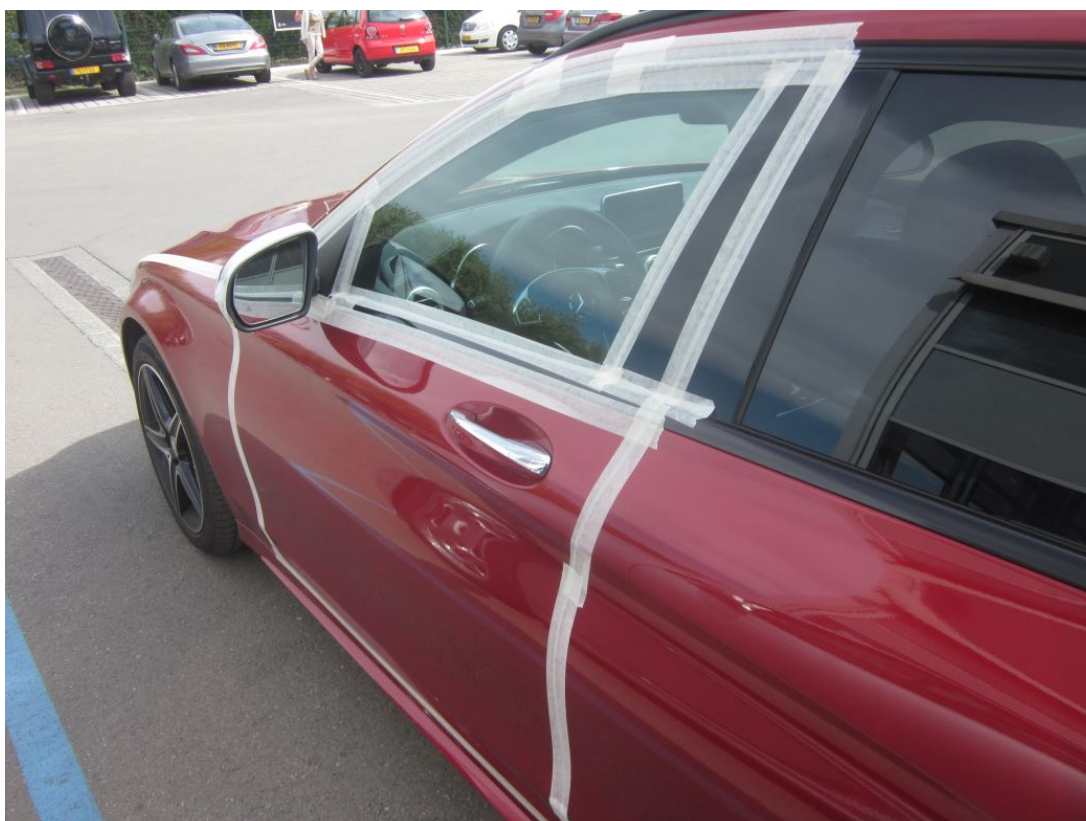
Bild 5.JPG:

6. Using suitable adhesive tape, cover the joints in the area of the front doors, outside mirrors, windshield and engine hood, see example in Figure 5, Figure 6 and Figure 7. Perform a test drive.
7. If the noise level is unchanged, install front side windows with code 851 (Acoustics package).
