# Service Campaign Bulletin

Campaign No. 2017080001, October 2017

SUBJECT: **Models 222, 217 Model Year 2017**  
**Rework Axle Floor Coating**

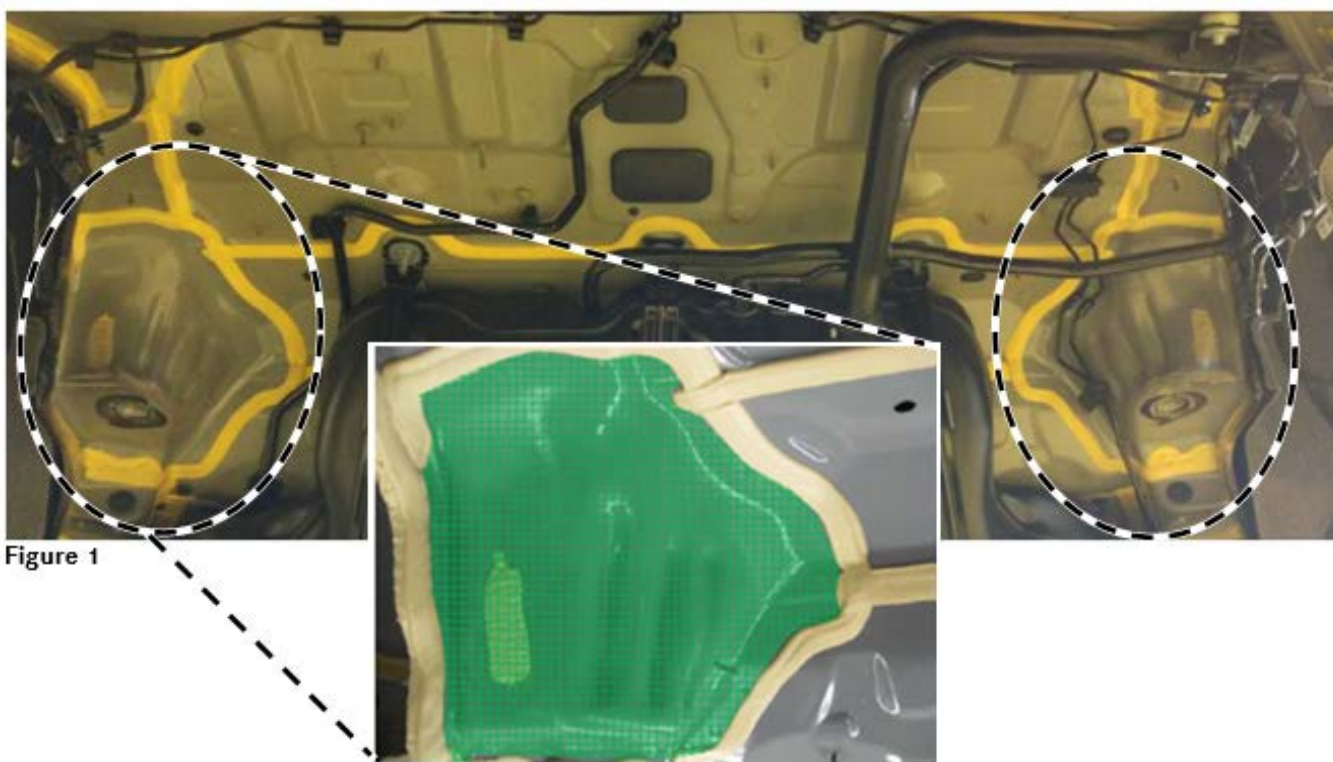
check for paintwork damage (Figure 1).

The damaged area has been highlighted in green (Figure 1).

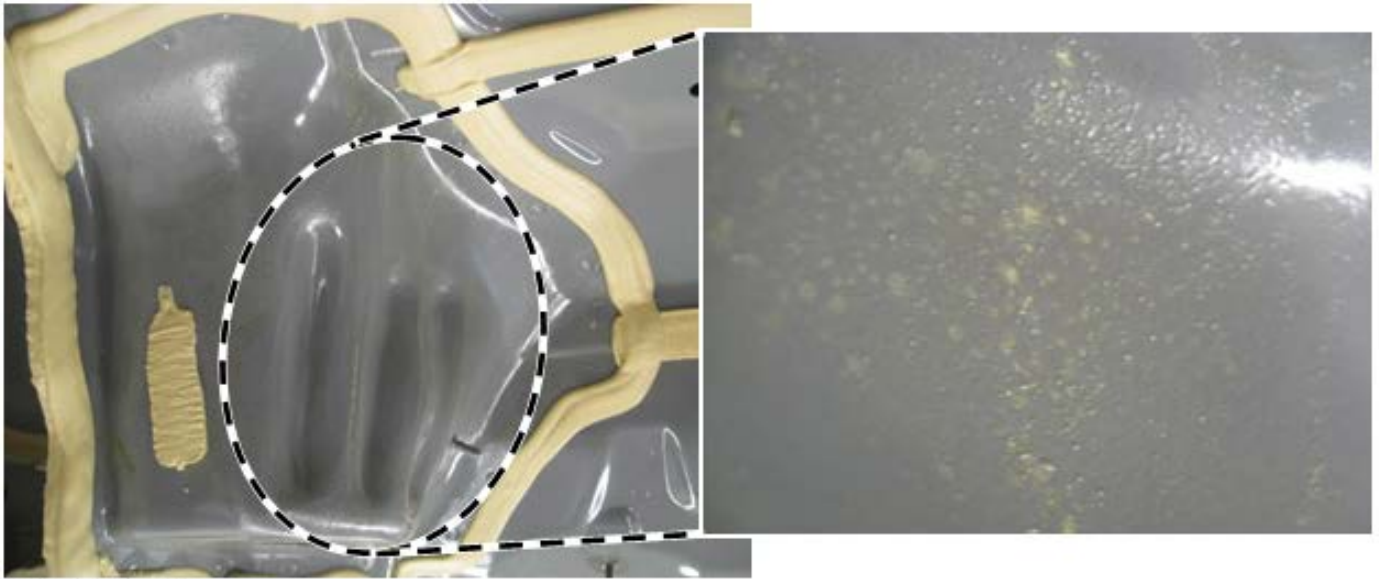
Figure 2 Not OK

See (Figure 2) for paintwork damage.

- a. Paintwork damaged: carry out procedure.
- b. Paintwork not damaged: check complete.
