Vehicle does not start, battery discharged.

Topic number	LI54.10-P-066344
Version	4
Function group	54.10 Battery, power supply, voltage converter
Date	10-26-2017
Validity	BR166/ BR292
Reason for change	Remedy for Cause 1 available
Reason for block

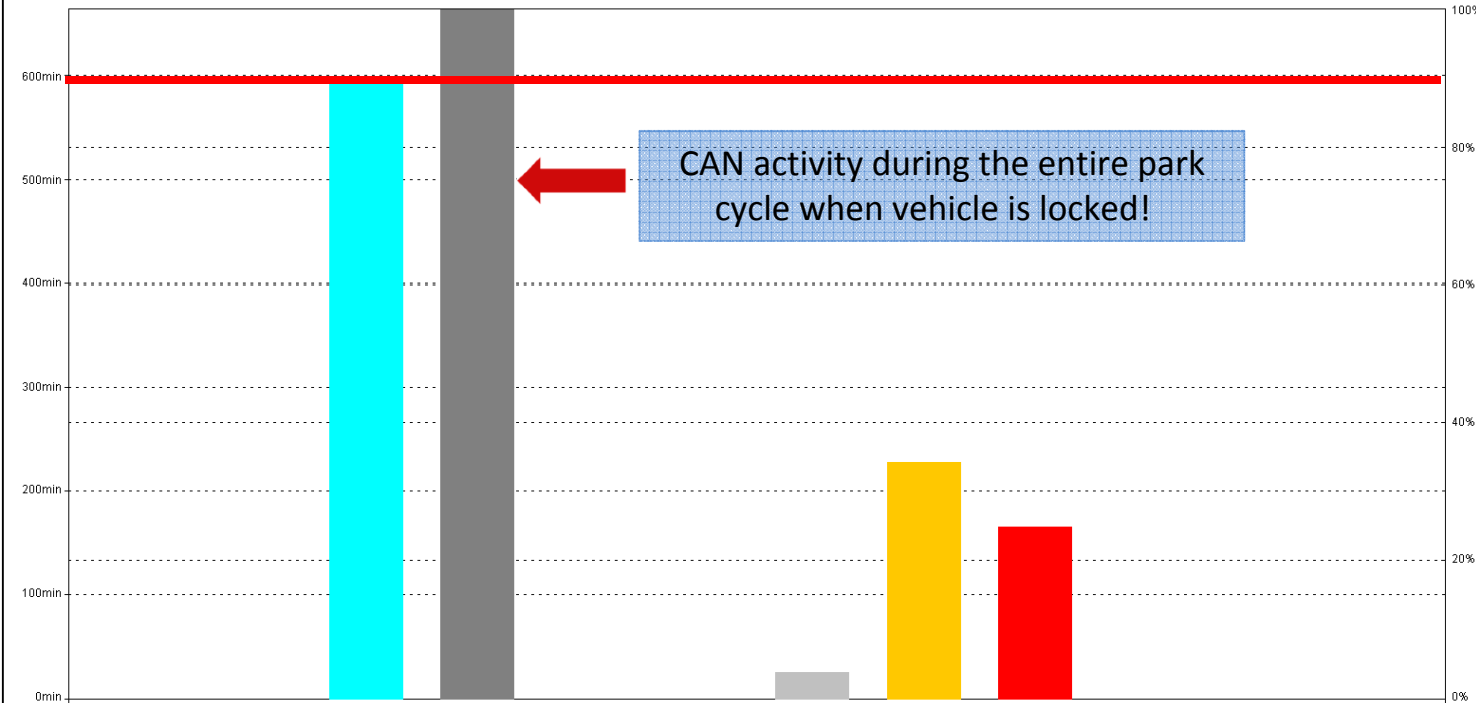
Gesamtwegstrecke:	1238km
Standzeit vor Motorstart:	664min
Ladebilanz:	-40Ah
Ruhestromwert bei Klemme 30g EIN:	-26.0000kA
Ruhestromwert bei Klemme 30g AUS:	-42.0000kA

Innenraum-CAN-Bus ungewöhnlich lang WACH

Ladebilanz AUFFÄLLIG

Interior CAN bus is awake unusually long. Charging balance suspicious.
