# Technical Bulletin

**24 17 04** June 29, 2017 **2045138** Supersedes Technical Bulletin 24-17-03 (V241703) dated March 6, 2017 for information regarding a new style solenoid valve for Intake Manifold Flap -**N316**.

**MIL ON DTCs P2004, P2014 and or P2015 Stored in ECM Fault Memory**

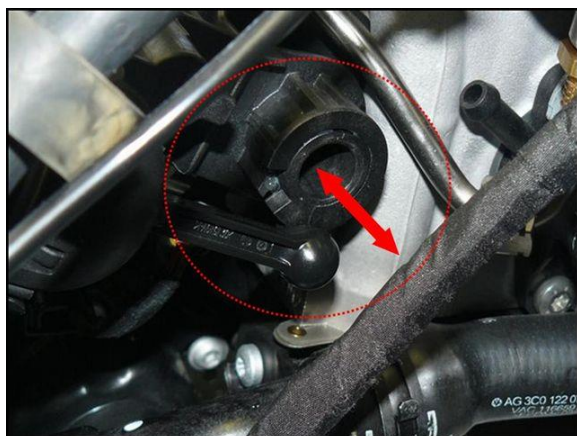
Figure 3.

- Remove the engine cover. See Repair Group 10 Engine Assembly in Elsa.
- Move the carrier plate by hand in an axial direction (Figure 3, red arrow) to check if the carrier plate can be pulled out.

If the carrier plate can be pulled out, the flap has separated and the intake manifold must be replaced. See Repair Group 24 Multiport Fuel Injection in Elsa.
