Service Update

17217 Water Leak at Passenger Side A-Pillar to Plenum Intersection

Reference Number: N172096880

Models: 2017 Cadillac XT5
2017 GMC Acadia

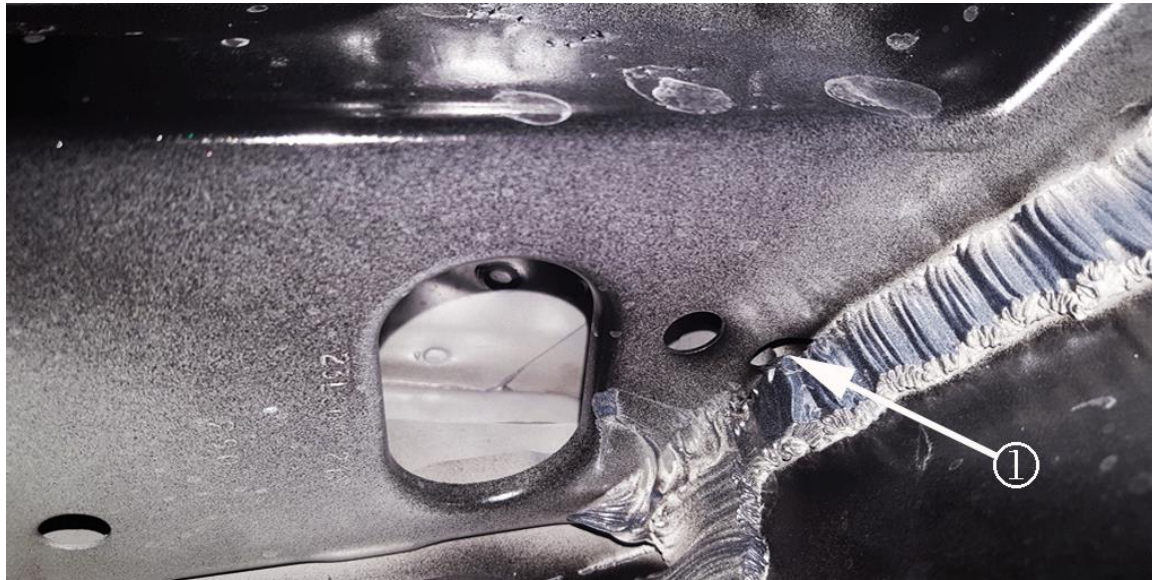
4811586

2. Locate the area in question on the passenger side of the vehicle.

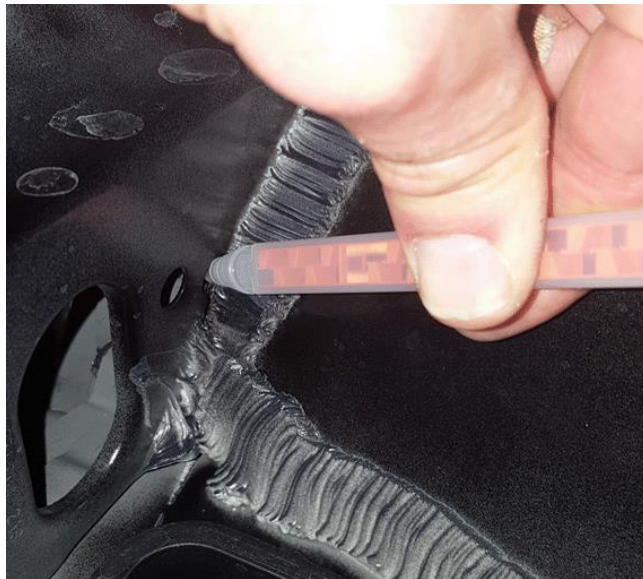
4811587

Condition	Some vehicles may experience a water leak from the passenger side A-Pillar area due to incomplete sealing within the plenum. The leak may be observed in the passenger front footwall, causing the carpet and sound deadener pad to become wet.
Correction	Reseal the A-pillar to Plenum intersecting sheet metal.

3. Remove any clear seam sealer or expandable foam out of the hole (1).
4. Prepare the Ure-Foam nozzle and application gun per the manufacturer's instructions.

5. After the application gun has been purged and the mixing tube is full of material, insert the mixing tube into the hole and pump the application gun 5 times.
