Service Update

17259 OnStar Secondary Battery Input Feeding Current Back

Reference Number: N172098770

Release Date: June 2017

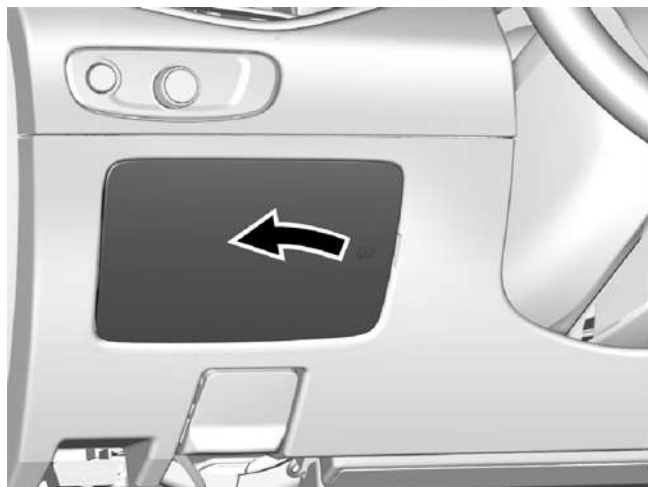
Condition	Some 2017 model year Chevrolet Malibu vehicles may have excessive current feedback to the DC-DC converter module through the OnStar battery backup wiring connected to the main battery. The driver may experience the stop/start functionality inhibited and the malfunction indicator lamp (MIL) illuminated.
Correction	Remove the F18 fuse.

1. Remove instrument panel fuse block cover.
