# Service Update

## 17176 Transmission Performance, Shifting, Noise

Reference Number: N172088580

Release Date: June 2017  
Revision: 00

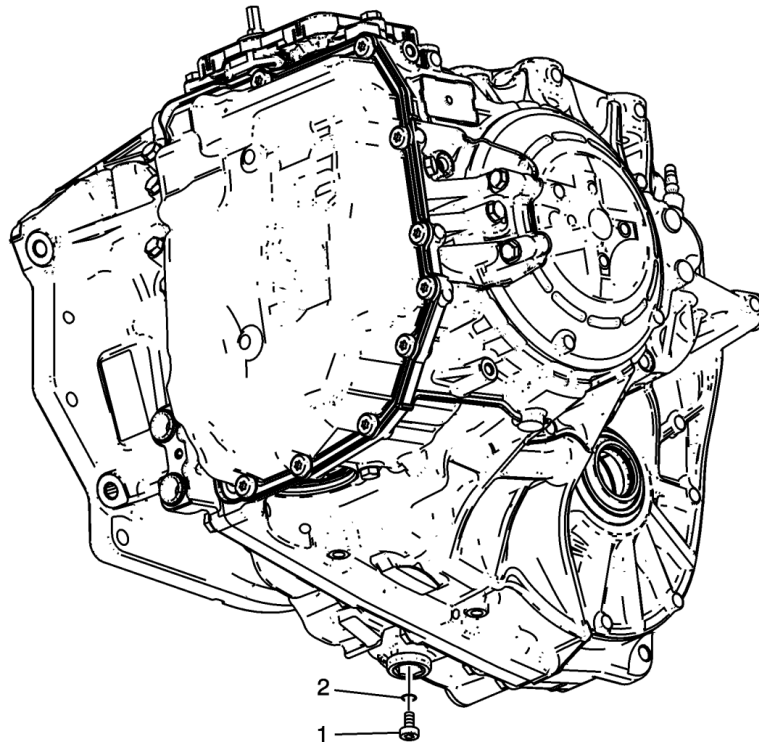
4176042

2. Loosen, but do NOT remove the transmission oil drain plug (1) to collect a small amount of fluid (less than 1 oz.) into a clear or translucent container.
3. Tighten the transmission oil drain plug (1) to 8 Nm (6 lb ft).

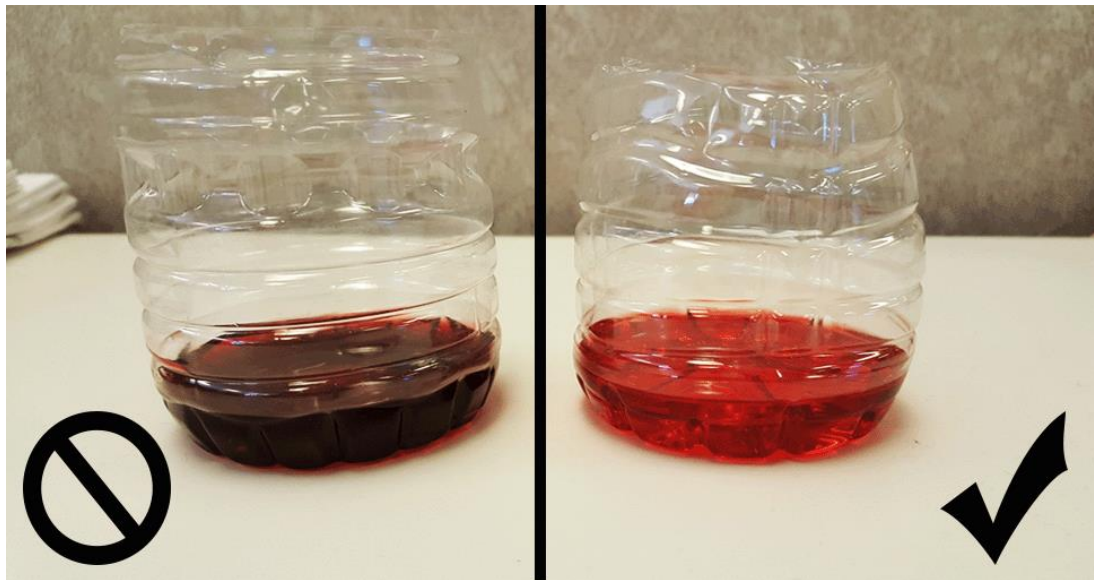
4. Inspect the color of the transmission fluid sample.
  - If the color of the fluid sample is clear and light pink (pictured on the right above), proceed to the next step.
  - If the color of the fluid is dark red or brown (pictured on the left above), proceed to step 6.
5. Inspect the fluid sample for a burnt odor or any odor that is different from new AW-1 Automatic Transmission Fluid (ATF).
  - If the fluid sample odor is the same as new AW-1 ATF, no further action is required.
  - If the fluid sample has a burnt odor or is different from new AW-1 ATF, proceed to the next step

6. Replace the transmission. Refer to *Transmission Replacement (Front Wheel Drive)* or *Transmission Replacement (All Wheel Drive)* in SI.
7. Flush and flow test the transmission oil cooler lines. Refer to *Transmission Fluid Cooler Flow Test and Flushing (AF50-8)* in SI.
8. Replace the transmission fluid cooler inlet and outlet pipe. Refer to *Transmission Fluid Cooler Inlet and Outlet Pipe Replacement* in SI.
