# 17246 Electric Power Steering Assist Motor Improper Service Torque

Reference Number: N17209600

Release Date: June 2017

Models: 2016 Chevrolet Malibu

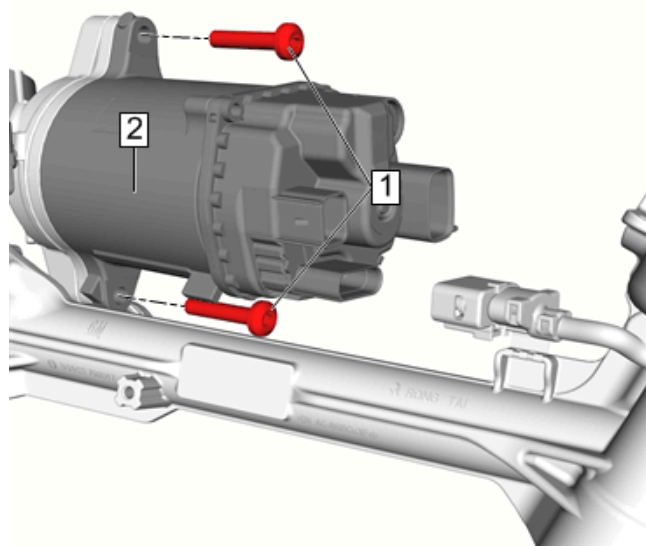
4780983

<b>Condition</b>	Vehicles that have been serviced for an electric power steering (EPS) motor condition, may have had the motor installed/reinstalled with the incorrect fastener torque, resulting in insufficient clamp load.
<b>Correction</b>	Dealers are to tighten the fasteners to the revised specification, to achieve the specified torque.

4. Verify the torque of the power steering assist motor bolts (1) is 15 Nm (11 lb ft).
  - If the torque of the power steering assist motor bolts is at least 15 Nm (11 lb ft), proceed to step 7.
  - If the torque of the power steering assist motor bolts is NOT at least 15 Nm (11 lb ft), proceed to the next step.
5. Remove the power steering assist motor. Refer to *Power Steering Assist Motor Replacement* in SI.
